Profile/Photo Observation Report

Street:	Cleveland Ave.	Flow Control:	Not Controlled
City:	Hobart, IN	Year Renewed:	
Location:	Light Highway	Tape/Media #:	
Purpose:	Routine Assessment	Dia/Height:	10"
Use:	Sanitary	Material:	PVC
Drain Area:	NA	Lining:	
Category:	NA		
Comment:

Location Details:		Direction of Survey:	Downstream
US MH:	M-1004-027	DS MH:	M-1004-028
		Total Length Surveyed (ft):	298.3

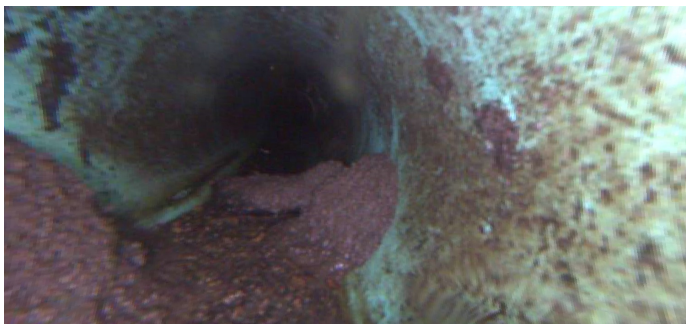
Code: **AMH**
Description: **Manhole**

Distance (ft): **.0**
Structural Grade: **0**
O&M Grade: **0**
Clock Start/From:
Clock To:
1st Value:
2nd Value:
Value Percent:
Continuous Index:
Within 8" of Joint: **NO**
Remarks: **M-1004-027**

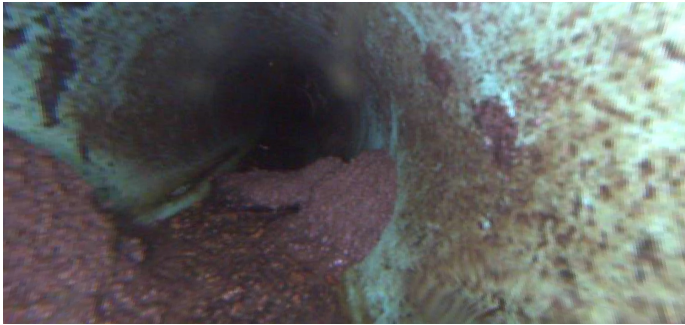
Code:	MWL
Description:	Water Level

Distance (ft):	.0
Structural Grade:	0
O&M Grade:	0
Clock Start/From:	
Clock To:	
1st Value:	
2nd Value:	
Value Percent:	5.000
Continuous Index:	
Within 8" of Joint:	NO
Remarks:

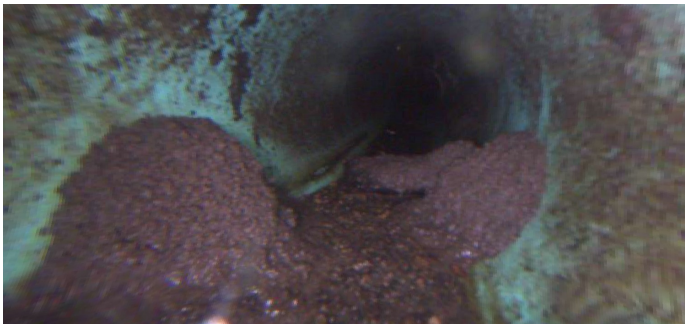
Code:	RMJ
Description:	Roots Medium Joint

Distance (ft):	.0
Structural Grade:	0
O&M Grade:	3
Clock Start/From:	3
Clock To:	9
1st Value:	
2nd Value:	
Value Percent:	20.000
Continuous Index:	
Within 8" of Joint:	YES
Remarks:

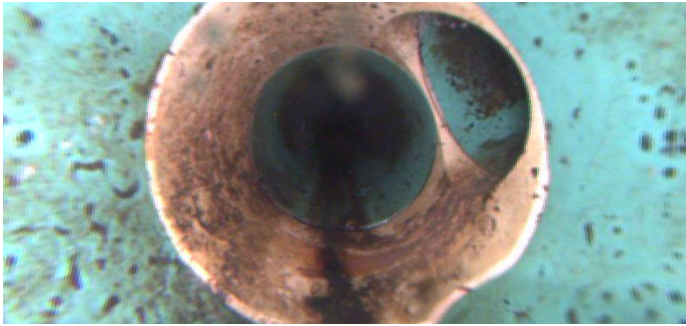
Code: **TF**
Description: **Tap Factory**

Distance (ft): **5.0**
Structural Grade: **0**
O&M Grade: **0**
Clock Start/From: **2**
Clock To:
1st Value: **4.000**
2nd Value:
Value Percent:
Continuous Index:
Within 8" of Joint:
Remarks:

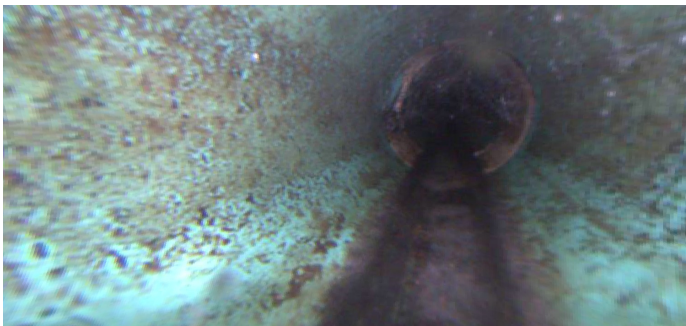
Code: **TF**
Description: **Tap Factory**

Distance (ft): **14.1**
Structural Grade: **0**
O&M Grade: **0**
Clock Start/From: **9**
Clock To:
1st Value: **4.000**
2nd Value:
Value Percent:
Continuous Index:
Within 8" of Joint:
Remarks:

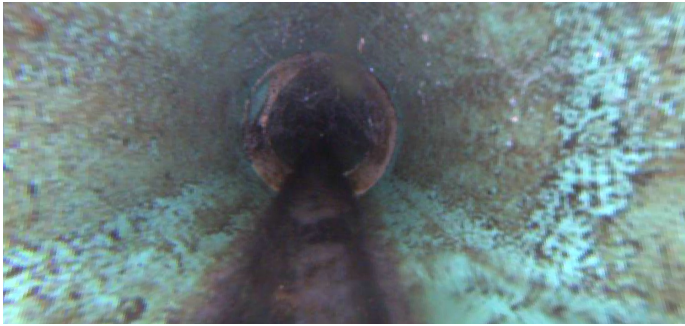
Code: **TF**
Description: **Tap Factory**

Distance (ft): **14.4**
Structural Grade: **0**
O&M Grade: **0**
Clock Start/From: **10**
Clock To:
1st Value: **4.000**
2nd Value:
Value Percent:
Continuous Index:
Within 8" of Joint:
Remarks:

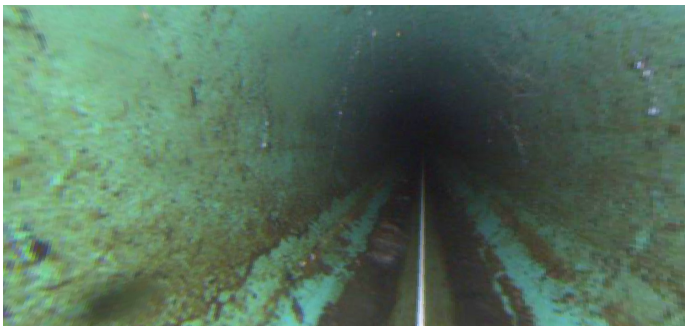
Code: **MGO**
Description: **General Observation**

Distance (ft): **30.6**
Structural Grade: **0**
O&M Grade: **0**
Clock Start/From:
Clock To:
1st Value:
2nd Value:
Value Percent:
Continuous Index:
Within 8" of Joint: **NO**
Remarks: **switching to rear view**

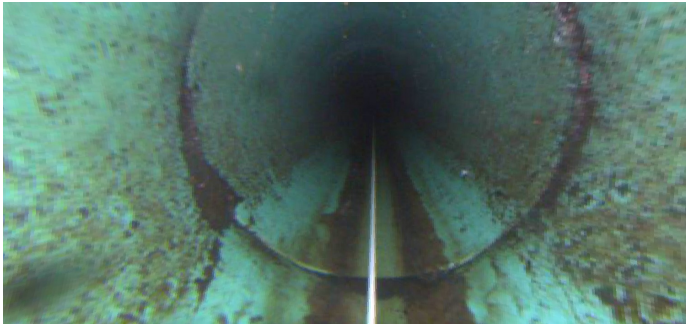
Code: **RFJ**
Description: **Roots Fine Joint**

Distance (ft): **37.9**
Structural Grade: **0**
O&M Grade: **1**
Clock Start/From: **8**
Clock To: **4**
1st Value:
2nd Value:
Value Percent:
Continuous Index:
Within 8" of Joint: **YES**
Remarks:

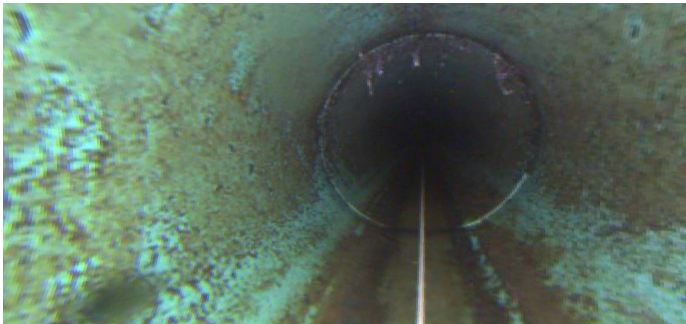
Code: **RFJ**
Description: **Roots Fine Joint**

Distance (ft): **63.0**
Structural Grade: **0**
O&M Grade: **1**
Clock Start/From: **9**
Clock To: **4**
1st Value:
2nd Value:
Value Percent:
Continuous Index:
Within 8" of Joint: **YES**
Remarks:

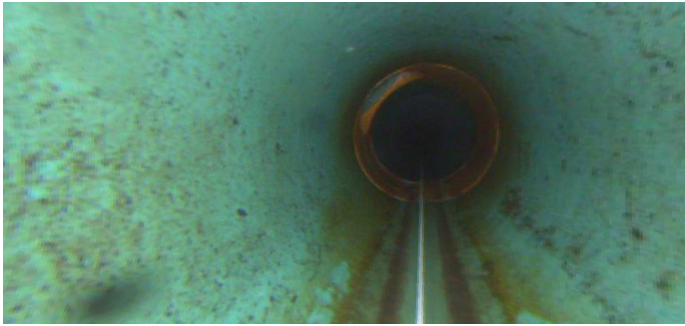
Code: **TF**
Description: **Tap Factory**

Distance (ft): **80.6**
Structural Grade: **0**
O&M Grade: **0**
Clock Start/From: **10**
Clock To:
1st Value: **4.000**
2nd Value:
Value Percent:
Continuous Index:
Within 8" of Joint:
Remarks:

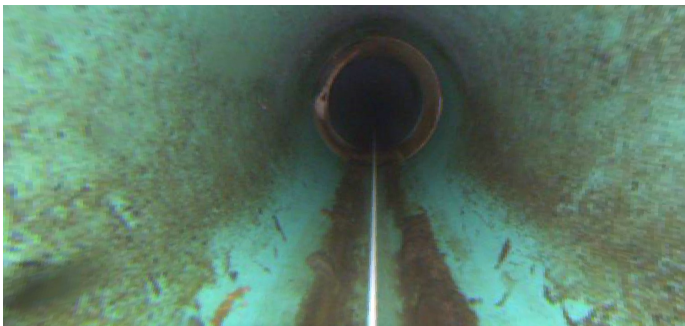
Code: **TF**
Description: **Tap Factory**

Distance (ft): **106.5**
Structural Grade: **0**
O&M Grade: **0**
Clock Start/From: **10**
Clock To:
1st Value: **4.000**
2nd Value:
Value Percent:
Continuous Index:
Within 8" of Joint:
Remarks:

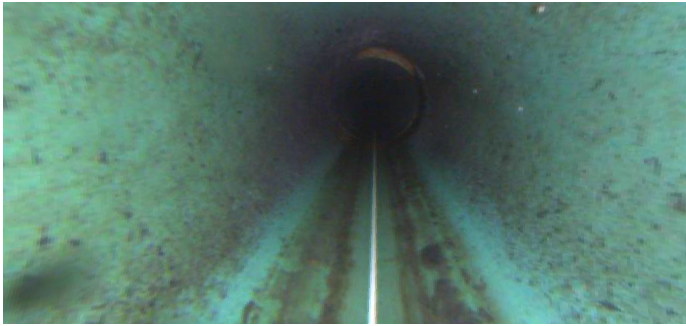
Code: **TF**
Description: **Tap Factory**

Distance (ft): **139.8**
Structural Grade: **0**
O&M Grade: **0**
Clock Start/From: **1**
Clock To:
1st Value: **4.000**
2nd Value:
Value Percent:
Continuous Index:
Within 8" of Joint:
Remarks:

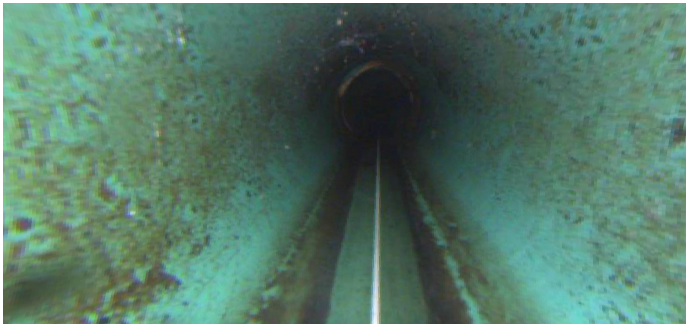
Code: **TF**
Description: **Tap Factory**

Distance (ft): **180.2**
Structural Grade: **0**
O&M Grade: **0**
Clock Start/From: **11**
Clock To:
1st Value: **4.000**
2nd Value:
Value Percent:
Continuous Index:
Within 8" of Joint:
Remarks:

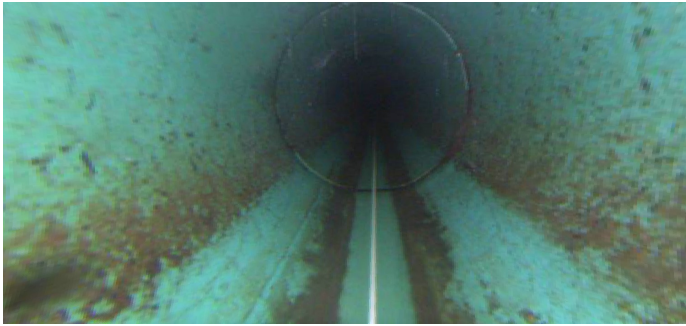
Code: **RFJ**
Description: **Roots Fine Joint**

Distance (ft): **200.2**
Structural Grade: **0**
O&M Grade: **1**
Clock Start/From: **8**
Clock To: **4**
1st Value:
2nd Value:
Value Percent:
Continuous Index:
Within 8" of Joint: **YES**
Remarks:

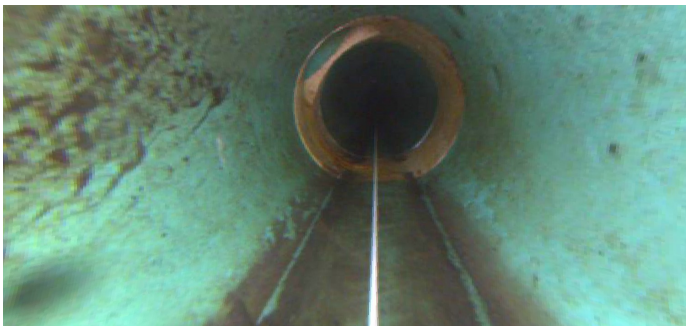
Code: **TF**
Description: **Tap Factory**

Distance (ft): **260.9**
Structural Grade: **0**
O&M Grade: **0**
Clock Start/From: **10**
Clock To:
1st Value: **4.000**
2nd Value:
Value Percent:
Continuous Index:
Within 8" of Joint:
Remarks:

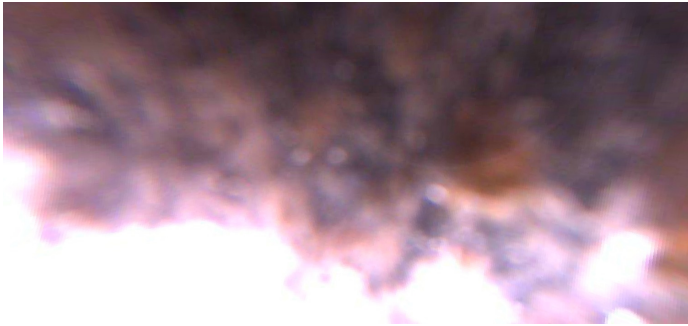
Code:	AMH
Description:	Manhole
Distance (ft):	298.3
Structural Grade:	0
O&M Grade:	0
Clock Start/From:	
Clock To:	
1st Value:	
2nd Value:	
Value Percent:	
Continuous Index:	
Within 8" of Joint:	NO
Remarks:	M-1004-028
