Profile/Photo Observation Report

Date:	04/14/2018	Weather:		Coding:	PACP 6.0
Pipe Length (ft):	344.7	Owner:	NA	Pre Clean:	Not Known
P.O.#:		Surveyor:	Jen Costello	PSR:	P-1004-029-030
Customer:		Clean Date:	01/01/1900	Shape:	C

Street:	E CLEVELAND AVE	Flow Control:	Not Controlled
City:	Hobart, IN	Year Renewed:	
Location:	Other	Tape/Media #:	
Purpose:	Not Known	Dia/Height:	10"
Use:	Sanitary	Material:	PVC
Drain Area:	NA	Lining:	
Category:	NA		
Comment:

Location Details:		Direction of Survey:	Upstream
US MH:	M-1004-029	DS MH:	M-1004-030
		Total Length Surveyed (ft):	331.5

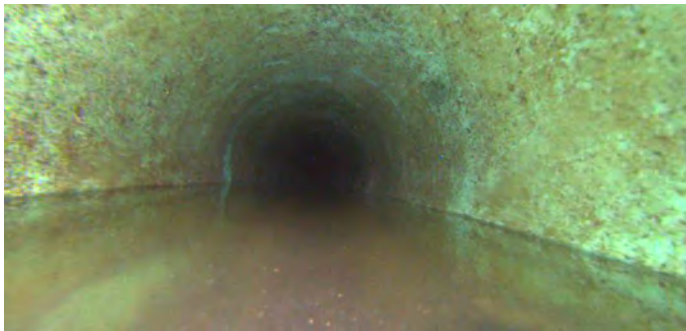
Code: **AMH**
Description: **Manhole**

Distance (ft): **.0**
Structural Grade: **0**
O&M Grade: **0**
Clock Start/From:
Clock To:
1st Value:
2nd Value:
Value Percent:
Continuous Index:
Within 8" of Joint: **NO**
Remarks: **M-1004-030**

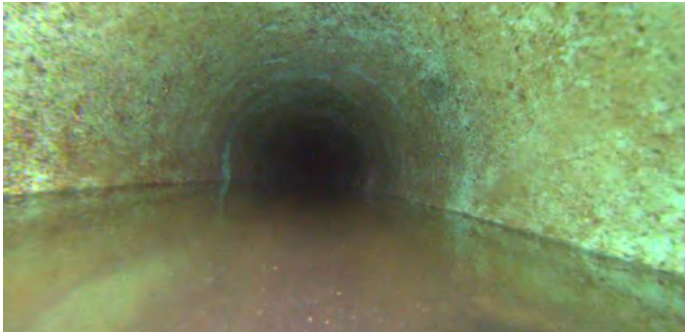
Code:	MWL
Description:	Water Level

Distance (ft):	.0
Structural Grade:	0
O&M Grade:	0
Clock Start/From:	
Clock To:	
1st Value:	
2nd Value:	
Value Percent:	40.000
Continuous Index:	
Within 8" of Joint:	NO
Remarks:

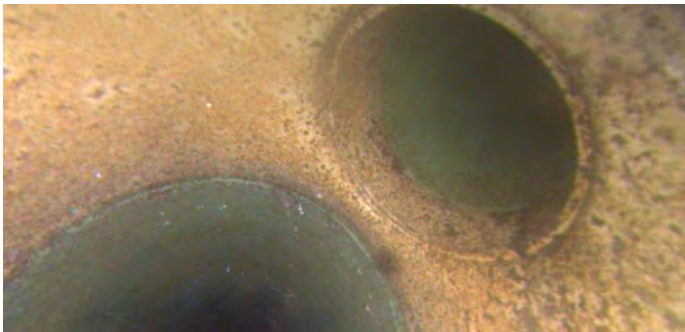
Code:	TF
Description:	Tap Factory

Distance (ft):	24.2
Structural Grade:	0
O&M Grade:	0
Clock Start/From:	2
Clock To:	
1st Value:	4.000
2nd Value:	
Value Percent:	
Continuous Index:	
Within 8" of Joint:	
Remarks:

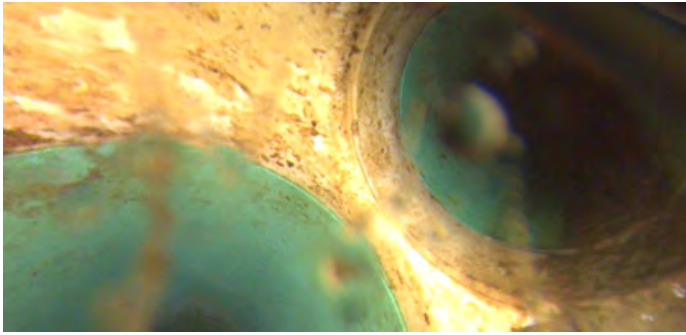
Code: **TF**
Description: **Tap Factory**

Distance (ft): **92.6**
Structural Grade: **0**
O&M Grade: **0**
Clock Start/From: **2**
Clock To:
1st Value: **4.000**
2nd Value:
Value Percent:
Continuous Index:
Within 8" of Joint:
Remarks:

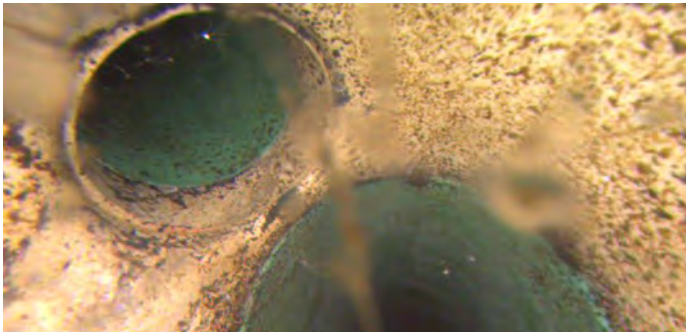
Code: **TF**
Description: **Tap Factory**

Distance (ft): **102.9**
Structural Grade: **0**
O&M Grade: **0**
Clock Start/From: **11**
Clock To:
1st Value: **4.000**
2nd Value:
Value Percent:
Continuous Index:
Within 8" of Joint:
Remarks:

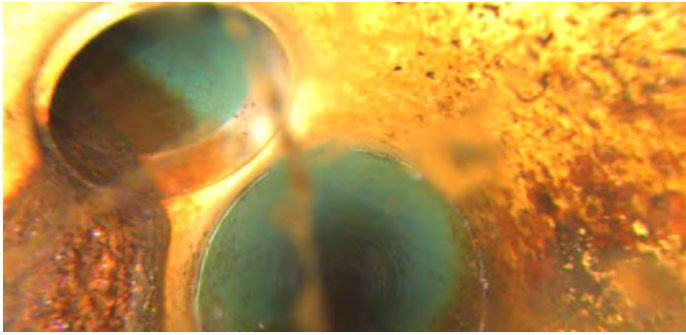
Code: **TF**
Description: **Tap Factory**

Distance (ft): **150.8**
Structural Grade: **0**
O&M Grade: **0**
Clock Start/From: **10**
Clock To:
1st Value: **4.000**
2nd Value:
Value Percent:
Continuous Index:
Within 8" of Joint:
Remarks:

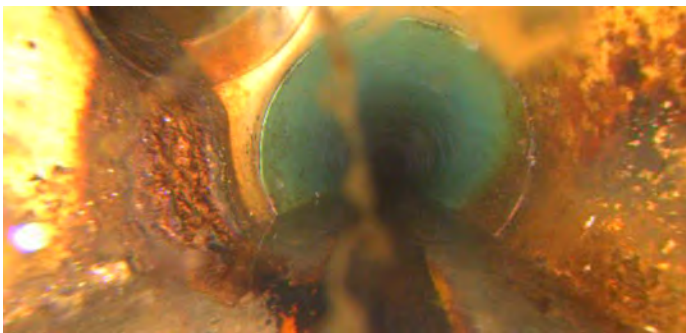
Code: **DAE**
Description: **Deposits Attached Encrustation**

Distance (ft): **150.8**
Structural Grade: **0**
O&M Grade: **2**
Clock Start/From: **8**
Clock To: **9**
1st Value:
2nd Value:
Value Percent: **5.000**
Continuous Index:
Within 8" of Joint: **NO**
Remarks:

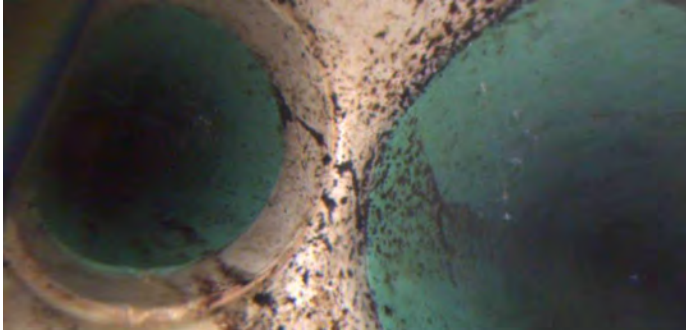
Code: **TF**
Description: **Tap Factory**

Distance (ft): **166.5**
Structural Grade: **0**
O&M Grade: **0**
Clock Start/From: **3**
Clock To:
1st Value: **4.000**
2nd Value:
Value Percent:
Continuous Index:
Within 8" of Joint:
Remarks:

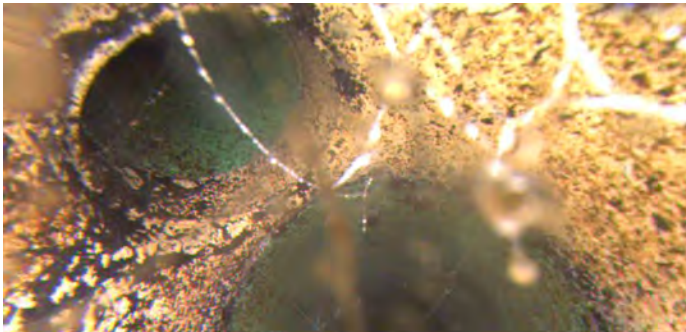
Code: **TF**
Description: **Tap Factory**

Distance (ft): **198.9**
Structural Grade: **0**
O&M Grade: **0**
Clock Start/From: **10**
Clock To:
1st Value: **4.000**
2nd Value:
Value Percent:
Continuous Index:
Within 8" of Joint:
Remarks:

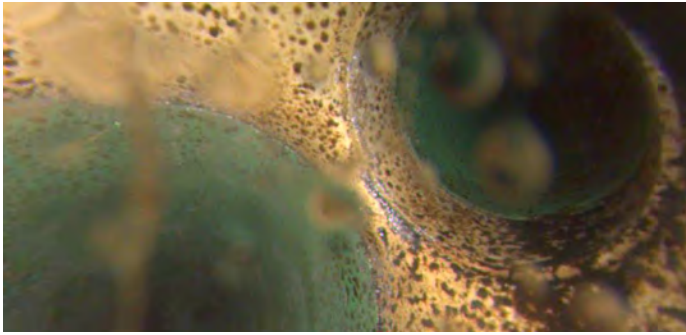
Code: **TF**
Description: **Tap Factory**

Distance (ft): **241.7**
Structural Grade: **0**
O&M Grade: **0**
Clock Start/From: **2**
Clock To:
1st Value: **4.000**
2nd Value:
Value Percent:
Continuous Index:
Within 8" of Joint:
Remarks:

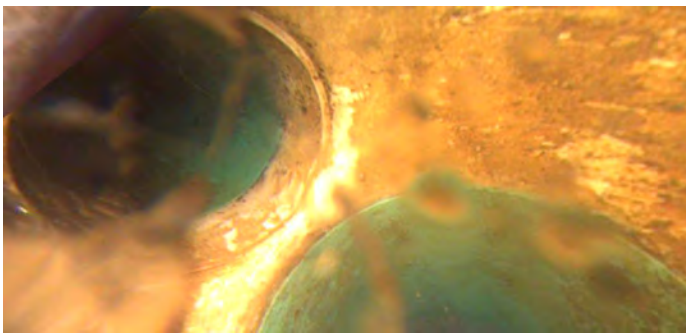
Code: **TF**
Description: **Tap Factory**

Distance (ft): **266.1**
Structural Grade: **0**
O&M Grade: **0**
Clock Start/From: **10**
Clock To:
1st Value: **4.000**
2nd Value:
Value Percent:
Continuous Index:
Within 8" of Joint:
Remarks:

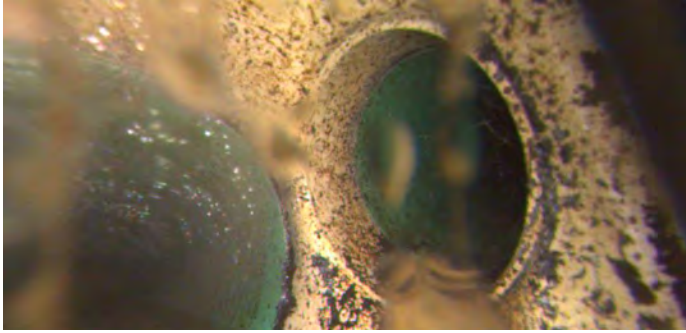
Code: **TF**
Description: **Tap Factory**

Distance (ft): **317.6**
Structural Grade: **0**
O&M Grade: **0**
Clock Start/From: **3**
Clock To:
1st Value: **4.000**
2nd Value:
Value Percent:
Continuous Index:
Within 8" of Joint:
Remarks:

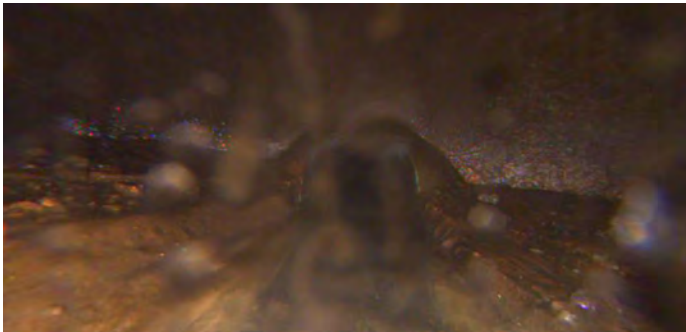
Code: **AMH**
Description: **Manhole**

Distance (ft): **331.5**
Structural Grade: **0**
O&M Grade: **0**
Clock Start/From:
Clock To:
1st Value:
2nd Value:
Value Percent:
Continuous Index:
Within 8" of Joint: **NO**
Remarks: **M-1004-029**
