## Profile/Photo Observation Report

Date:	<b>04/14/2018</b>	Weather:		Coding:	<b>PACP 6.0</b>
Pipe Length (ft):	<b>344.7</b>	Owner:	<b>NA</b>	Pre Clean:	<b>Not Known</b>
P.O.#:		Surveyor:	<b>Jen Costello</b>	PSR:	<b>P-1004-029-030</b>
Customer:		Clean Date:	<b>01/01/1900</b>	Shape:	<b>C</b>

Street:	<b>E Cleveland Ave.</b>	Flow Control:	<b>Not Controlled</b>
City:	<b>Hobart, IN</b>	Year Renewed:	
Location:	<b>Other</b>	Tape/Media #:	
Purpose:	<b>Not Known</b>	Dia/Height:	<b>10"</b>
Use:	<b>Sanitary</b>	Material:	<b>PVC</b>
Drain Area:	<b>NA</b>	Lining:	
Category:	<b>NA</b>		
Comment:

Location Details:		Direction of Survey:	<b>Upstream</b>
US MH:	<b>M-1004-029</b>	DS MH:	<b>M-1004-030</b>
		Total Length Surveyed (ft):	<b>331.5</b>

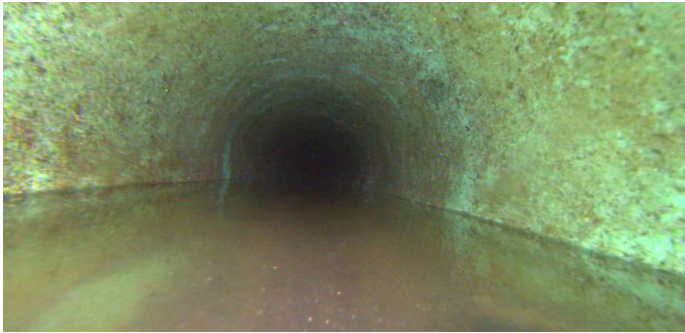
Code:	<b>MWL</b>
Description:	<b>Water Level</b>

Distance (ft):	<b>.0</b>
Structural Grade:	<b>0</b>
O&M Grade:	<b>0</b>
Clock Start/From:	
Clock To:	
1st Value:	
2nd Value:	
Value Percent:	<b>40.000</b>
Continuous Index:	
Within 8" of Joint:	<b>NO</b>
Remarks:

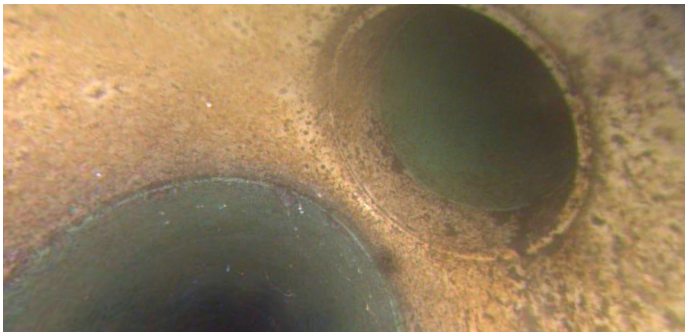
Code:	<b>TF</b>
Description:	<b>Tap Factory</b>

Distance (ft):	<b>24.2</b>
Structural Grade:	<b>0</b>
O&M Grade:	<b>0</b>
Clock Start/From:	<b>2</b>
Clock To:	
1st Value:	<b>4.000</b>
2nd Value:	
Value Percent:	
Continuous Index:	
Within 8" of Joint:	
Remarks:

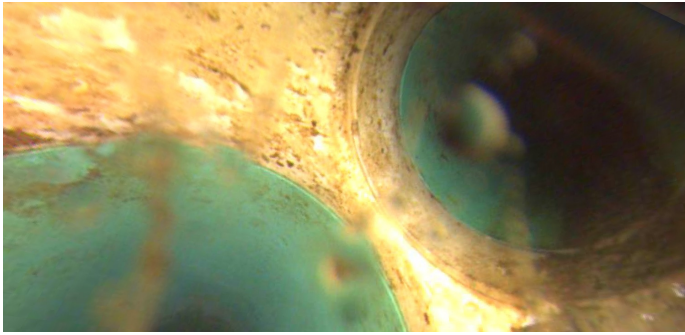
Code: **TF**  
Description: **Tap Factory**

Distance (ft): **92.6**  
Structural Grade: **0**  
O&M Grade: **0**  
Clock Start/From: **2**  
Clock To:  
1st Value: **4.000**  
2nd Value:  
Value Percent:  
Continuous Index:  
Within 8" of Joint:  
Remarks:

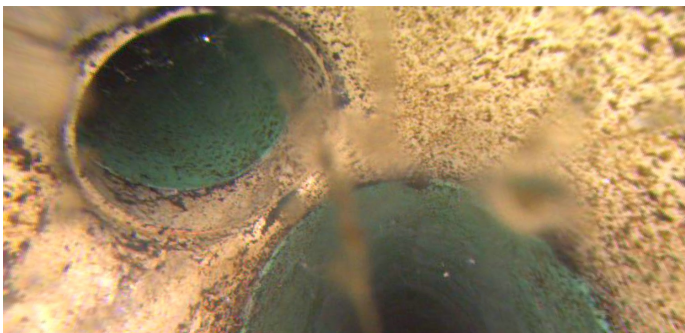
Code: **TF**  
Description: **Tap Factory**

Distance (ft): **102.9**  
Structural Grade: **0**  
O&M Grade: **0**  
Clock Start/From: **11**  
Clock To:  
1st Value: **4.000**  
2nd Value:  
Value Percent:  
Continuous Index:  
Within 8" of Joint:  
Remarks:

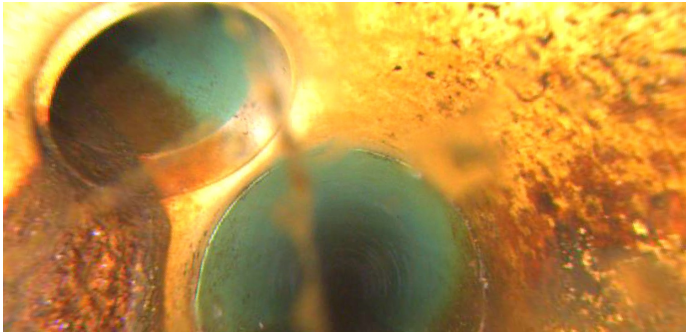
Code: **TF**  
Description: **Tap Factory**

Distance (ft): **150.8**  
Structural Grade: **0**  
O&M Grade: **0**  
Clock Start/From: **10**  
Clock To:  
1st Value: **4.000**  
2nd Value:  
Value Percent:  
Continuous Index:  
Within 8" of Joint:  
Remarks:

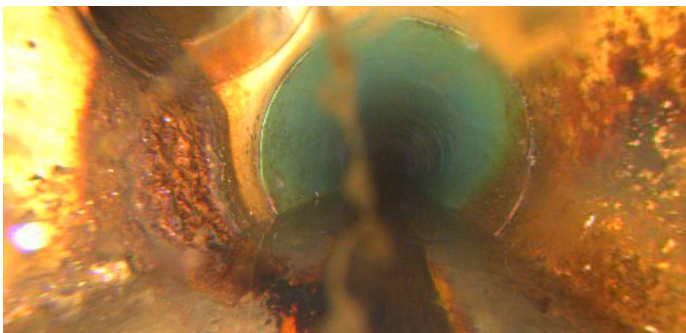
Code: **DAE**  
Description: **Deposits Attached Encrustation**

Distance (ft): **150.8**  
Structural Grade: **0**  
O&M Grade: **2**  
Clock Start/From: **8**  
Clock To: **9**  
1st Value:  
2nd Value:  
Value Percent: **5.000**  
Continuous Index:  
Within 8" of Joint: **NO**  
Remarks:

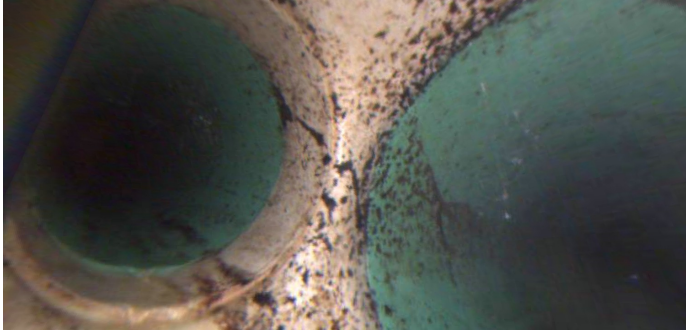
Code: **TF**  
Description: **Tap Factory**

Distance (ft): **166.5**  
Structural Grade: **0**  
O&M Grade: **0**  
Clock Start/From: **3**  
Clock To:  
1st Value: **4.000**  
2nd Value:  
Value Percent:  
Continuous Index:  
Within 8" of Joint:  
Remarks:

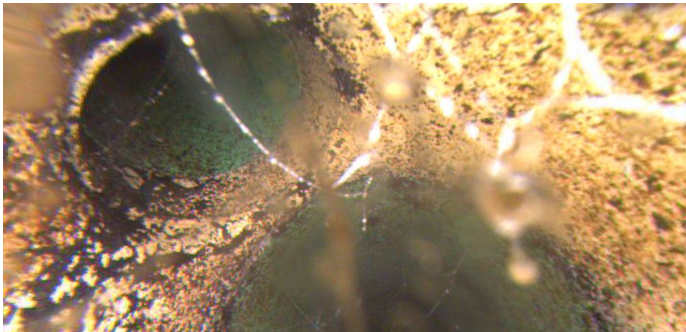
Code: **TF**  
Description: **Tap Factory**

Distance (ft): **198.9**  
Structural Grade: **0**  
O&M Grade: **0**  
Clock Start/From: **10**  
Clock To:  
1st Value: **4.000**  
2nd Value:  
Value Percent:  
Continuous Index:  
Within 8" of Joint:  
Remarks:

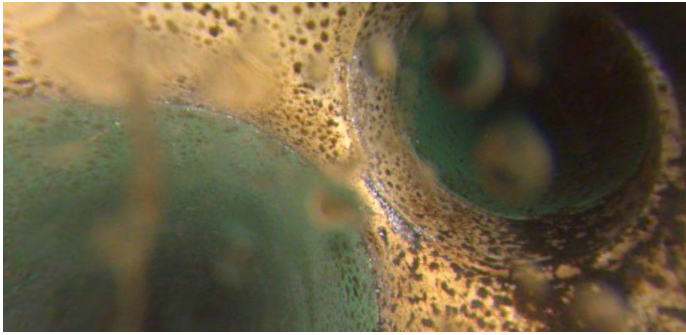
Code: **TF**  
Description: **Tap Factory**

Distance (ft): **241.7**  
Structural Grade: **0**  
O&M Grade: **0**  
Clock Start/From: **2**  
Clock To:  
1st Value: **4.000**  
2nd Value:  
Value Percent:  
Continuous Index:  
Within 8" of Joint:  
Remarks:

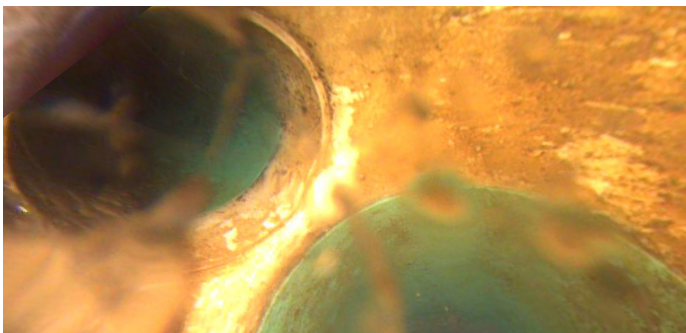
Code: **TF**  
Description: **Tap Factory**

Distance (ft): **266.1**  
Structural Grade: **0**  
O&M Grade: **0**  
Clock Start/From: **10**  
Clock To:  
1st Value: **4.000**  
2nd Value:  
Value Percent:  
Continuous Index:  
Within 8" of Joint:  
Remarks:

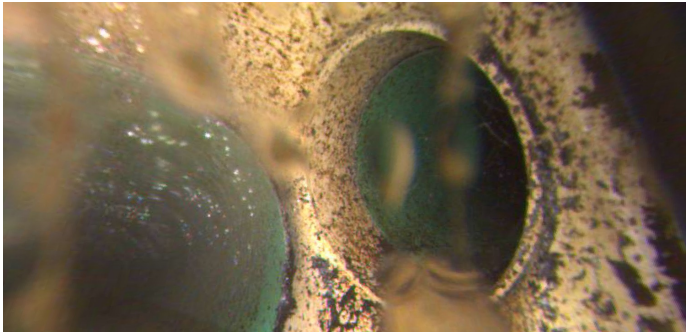
Code: **TF**  
Description: **Tap Factory**

Distance (ft): **317.6**  
Structural Grade: **0**  
O&M Grade: **0**  
Clock Start/From: **3**  
Clock To:  
1st Value: **4.000**  
2nd Value:  
Value Percent:  
Continuous Index:  
Within 8" of Joint:  
Remarks:

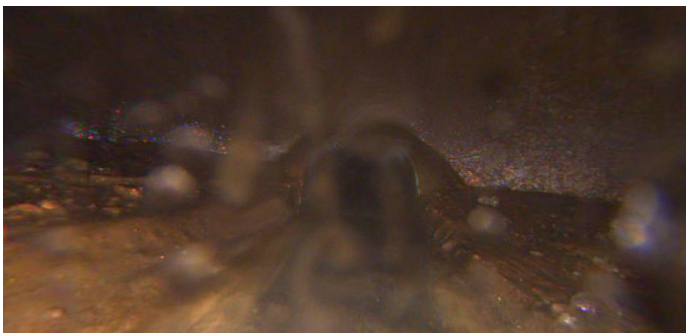
Code: **AMH**  
Description: **Manhole**

Distance (ft): **331.5**  
Structural Grade: **0**  
O&M Grade: **0**  
Clock Start/From:  
Clock To:  
1st Value:  
2nd Value:  
Value Percent:  
Continuous Index:  
Within 8" of Joint: **NO**  
Remarks: **M-1004-029**
