Profile/Photo Observation Report

Date:	04/14/2018	Weather:		Coding:	PACP 6.0
Pipe Length (ft):	352.6	Owner:	NA	Pre Clean:	Not Known
P.O.#:		Surveyor:	Jen Costello	PSR:	P-1004-030-031
Customer:		Clean Date:	01/01/1900	Shape:	C

Street:	E CLEVELAND AVE	Flow Control:	Not Controlled
City:	Hobart, IN	Year Renewed:	
Location:	Other	Tape/Media #:	
Purpose:	Not Known	Dia/Height:	10"
Use:	Sanitary	Material:	PVC
Drain Area:	NA	Lining:	
Category:	NA		
Comment:

Location Details:		Direction of Survey:	Downstream
US MH:	M-1004-030	DS MH:	M-1004-031
		Total Length Surveyed (ft):	346.6

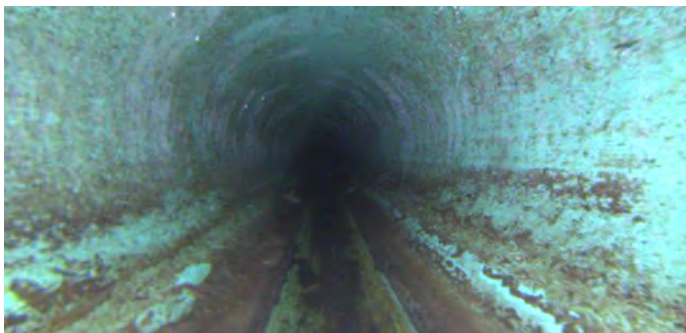
Code: **AMH**
Description: **Manhole**

Distance (ft): **.0**
Structural Grade: **0**
O&M Grade: **0**
Clock Start/From:
Clock To:
1st Value:
2nd Value:
Value Percent:
Continuous Index:
Within 8" of Joint: **NO**
Remarks: **M-1004-030**

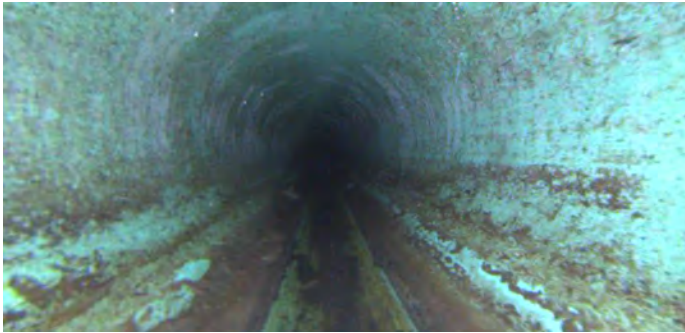
Code:	MWL
Description:	Water Level

Distance (ft):	.0
Structural Grade:	0
O&M Grade:	0
Clock Start/From:	
Clock To:	
1st Value:	
2nd Value:	
Value Percent:	5.000
Continuous Index:	
Within 8" of Joint:	NO
Remarks:

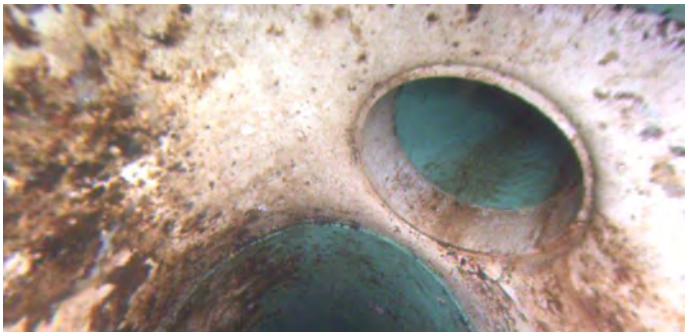
Code:	TF
Description:	Tap Factory

Distance (ft):	12.7
Structural Grade:	0
O&M Grade:	0
Clock Start/From:	1
Clock To:	
1st Value:	4.000
2nd Value:	
Value Percent:	
Continuous Index:	
Within 8" of Joint:	
Remarks:

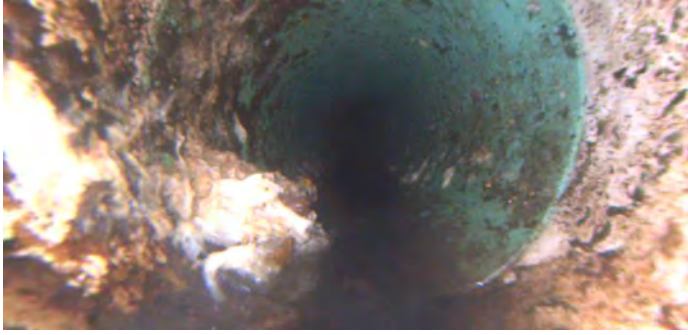
Code: **DAGS**
Description: **Deposits Attached Grease**

Distance (ft): **13.0**
Structural Grade: **0**
O&M Grade: **2**
Clock Start/From: **7**
Clock To: **9**
1st Value:
2nd Value:
Value Percent: **10.000**
Continuous Index:
Within 8" of Joint: **NO**
Remarks:

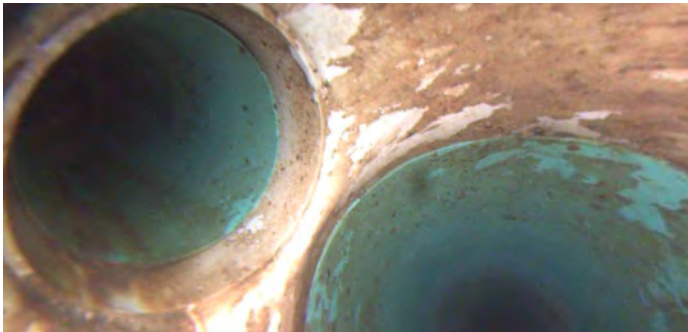
Code: **TF**
Description: **Tap Factory**

Distance (ft): **42.5**
Structural Grade: **0**
O&M Grade: **0**
Clock Start/From: **10**
Clock To:
1st Value: **4.000**
2nd Value:
Value Percent:
Continuous Index:
Within 8" of Joint:
Remarks:

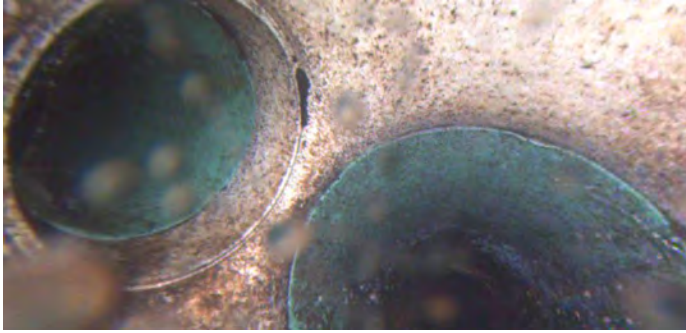
Code: **TF**
Description: **Tap Factory**

Distance (ft): **129.1**
Structural Grade: **0**
O&M Grade: **0**
Clock Start/From: **10**
Clock To:
1st Value: **4.000**
2nd Value:
Value Percent:
Continuous Index:
Within 8" of Joint:
Remarks:

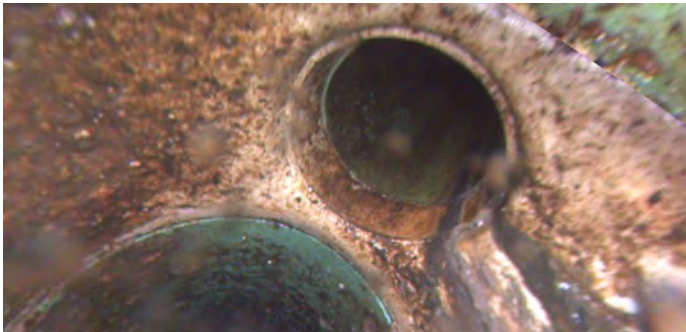
Code: **TF**
Description: **Tap Factory**

Distance (ft): **132.3**
Structural Grade: **0**
O&M Grade: **0**
Clock Start/From: **1**
Clock To:
1st Value: **4.000**
2nd Value:
Value Percent:
Continuous Index:
Within 8" of Joint:
Remarks:

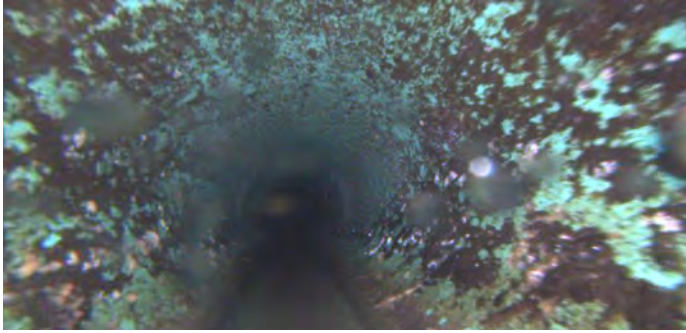
Code: **DAGS**
Description: **Deposits Attached Grease**

Distance (ft): **134.2**
Structural Grade: **0**
O&M Grade: **2**
Clock Start/From: **8**
Clock To: **4**
1st Value:
2nd Value:
Value Percent: **5.000**
Continuous Index:
Within 8" of Joint: **NO**
Remarks:

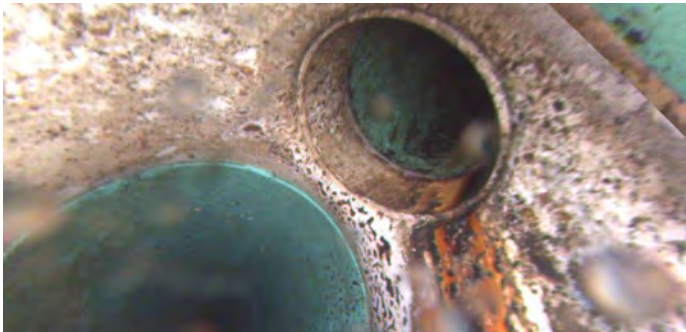
Code: **TF**
Description: **Tap Factory**

Distance (ft): **178.3**
Structural Grade: **0**
O&M Grade: **0**
Clock Start/From: **1**
Clock To:
1st Value: **4.000**
2nd Value:
Value Percent:
Continuous Index:
Within 8" of Joint:
Remarks:

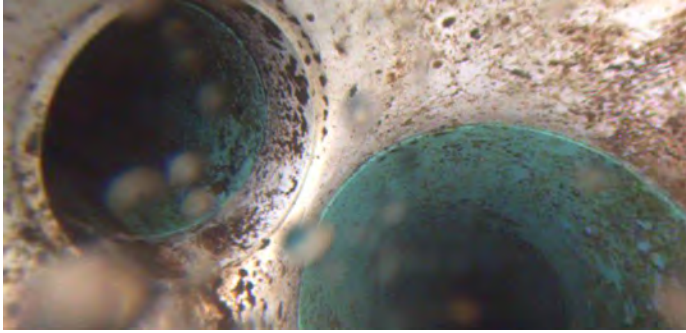
Code: **TF**
Description: **Tap Factory**

Distance (ft): **211.2**
Structural Grade: **0**
O&M Grade: **0**
Clock Start/From: **10**
Clock To:
1st Value: **4.000**
2nd Value:
Value Percent:
Continuous Index:
Within 8" of Joint:
Remarks:

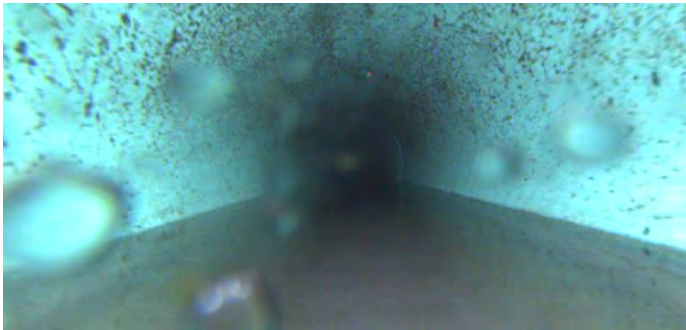
Code: **MWL**
Description: **Water Level**

Distance (ft): **246.3**
Structural Grade: **0**
O&M Grade: **0**
Clock Start/From:
Clock To:
1st Value:
2nd Value:
Value Percent: **30.000**
Continuous Index:
Within 8" of Joint: **NO**
Remarks:

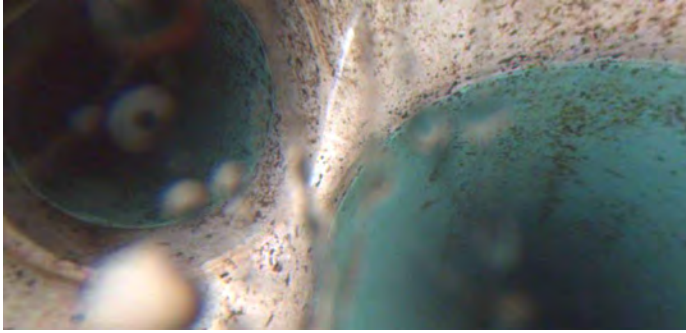
Code: **TF**
Description: **Tap Factory**

Distance (ft): **329.0**
Structural Grade: **0**
O&M Grade: **0**
Clock Start/From: **10**
Clock To:
1st Value: **4.000**
2nd Value:
Value Percent:
Continuous Index:
Within 8" of Joint:
Remarks:

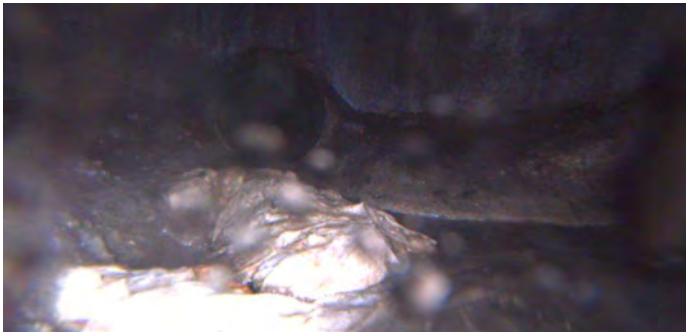
Code: **AMH**
Description: **Manhole**

Distance (ft): **346.6**
Structural Grade: **0**
O&M Grade: **0**
Clock Start/From:
Clock To:
1st Value:
2nd Value:
Value Percent:
Continuous Index:
Within 8" of Joint: **NO**
Remarks: **M-1004-031**
