Profile/Photo Observation Report

Date:	04/14/2018	Weather:		Coding:	PACP 6.0
Pipe Length (ft):	352.6	Owner:	NA	Pre Clean:	Not Known
P.O.#:		Surveyor:	Jen Costello	PSR:	P-1004-030-031
Customer:		Clean Date:	01/01/1900	Shape:	C

Street:	E Cleveland Ave.	Flow Control:	Not Controlled
City:	Hobart, IN	Year Renewed:	
Location:	Other	Tape/Media #:	
Purpose:	Not Known	Dia/Height:	10"
Use:	Sanitary	Material:	PVC
Drain Area:	NA	Lining:	
Category:	NA		
Comment:

Location Details:		Direction of Survey:	Downstream
US MH:	M-1004-030	DS MH:	M-1004-031
		Total Length Surveyed (ft):	346.6

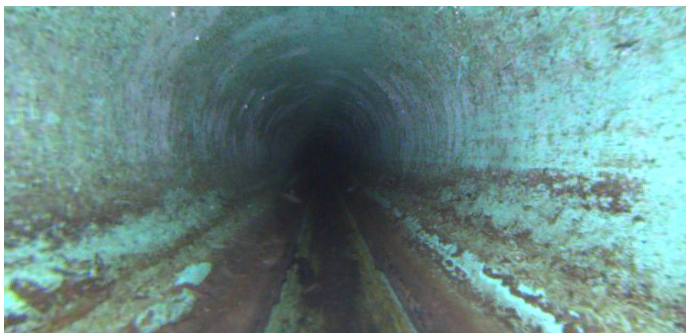
Code: **AMH**
Description: **Manhole**

Distance (ft): **.0**
Structural Grade: **0**
O&M Grade: **0**
Clock Start/From:
Clock To:
1st Value:
2nd Value:
Value Percent:
Continuous Index:
Within 8" of Joint: **NO**
Remarks: **M-1004-030**

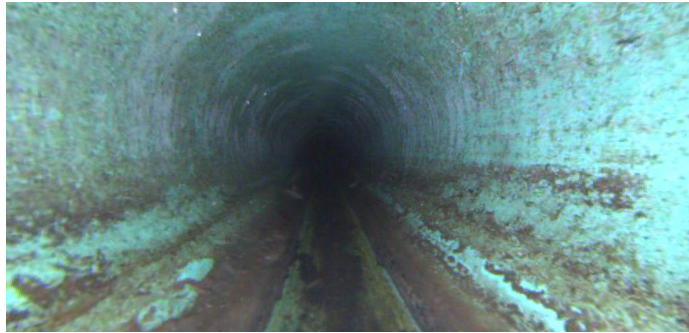
Code: **MWL**
Description: **Water Level**

Distance (ft): **.0**
Structural Grade: **0**
O&M Grade: **0**
Clock Start/From:
Clock To:
1st Value:
2nd Value:
Value Percent: **5.000**
Continuous Index:
Within 8" of Joint: **NO**
Remarks:

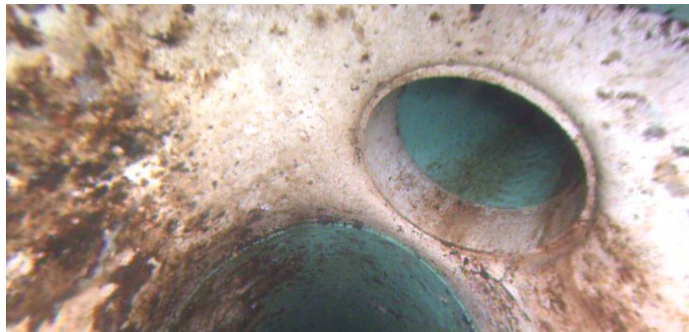
Code: **TF**
Description: **Tap Factory**

Distance (ft): **12.7**
Structural Grade: **0**
O&M Grade: **0**
Clock Start/From: **1**
Clock To:
1st Value: **4.000**
2nd Value:
Value Percent:
Continuous Index:
Within 8" of Joint:
Remarks:

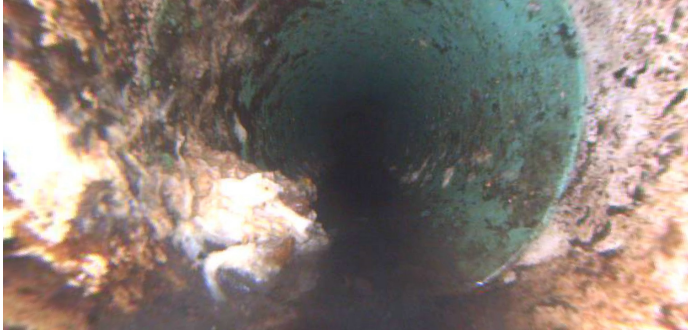
Code: **DAGS**
Description: **Deposits Attached Grease**

Distance (ft): **13.0**
Structural Grade: **0**
O&M Grade: **2**
Clock Start/From: **7**
Clock To: **9**
1st Value:
2nd Value:
Value Percent: **10.000**
Continuous Index:
Within 8" of Joint: **NO**
Remarks:

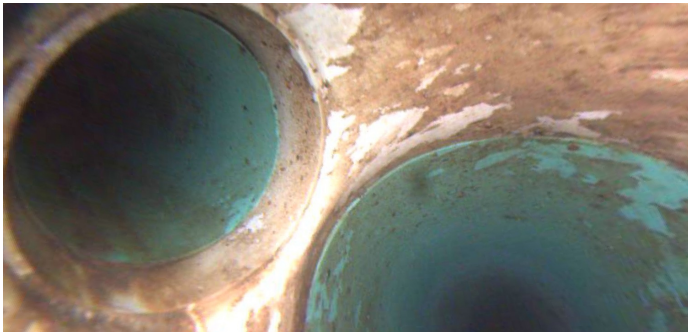
Code: **TF**
Description: **Tap Factory**

Distance (ft): **42.5**
Structural Grade: **0**
O&M Grade: **0**
Clock Start/From: **10**
Clock To:
1st Value: **4.000**
2nd Value:
Value Percent:
Continuous Index:
Within 8" of Joint:
Remarks:

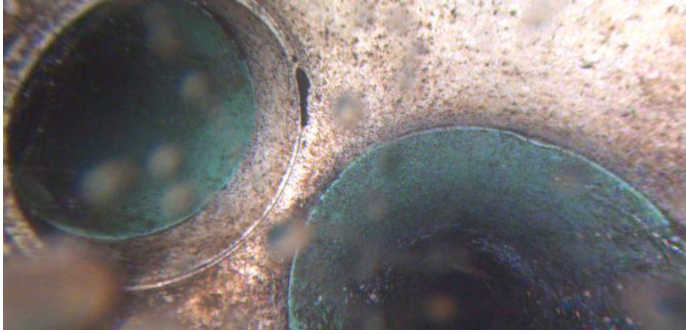
Code: **TF**
Description: **Tap Factory**

Distance (ft): **129.1**
Structural Grade: **0**
O&M Grade: **0**
Clock Start/From: **10**
Clock To:
1st Value: **4.000**
2nd Value:
Value Percent:
Continuous Index:
Within 8" of Joint:
Remarks:

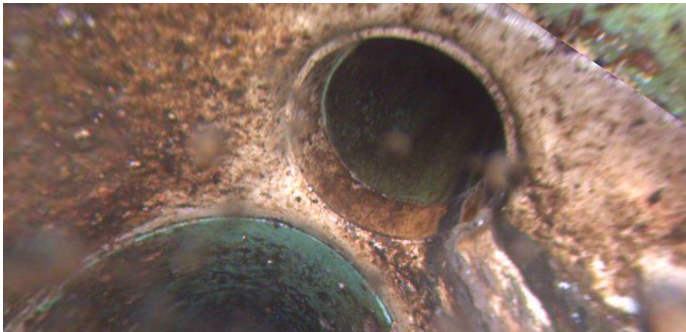
Code: **TF**
Description: **Tap Factory**

Distance (ft): **132.3**
Structural Grade: **0**
O&M Grade: **0**
Clock Start/From: **1**
Clock To:
1st Value: **4.000**
2nd Value:
Value Percent:
Continuous Index:
Within 8" of Joint:
Remarks:

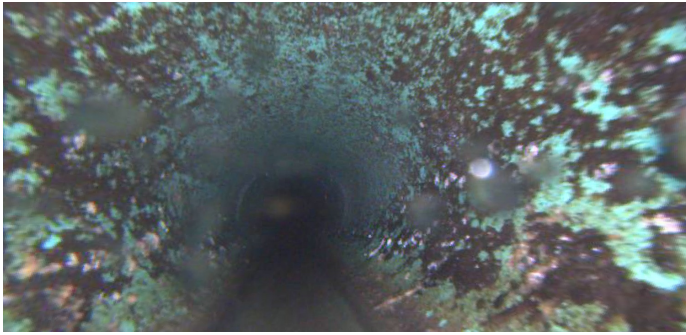
Code: **DAGS**
Description: **Deposits Attached Grease**

Distance (ft): **134.2**
Structural Grade: **0**
O&M Grade: **2**
Clock Start/From: **8**
Clock To: **4**
1st Value:
2nd Value:
Value Percent: **5.000**
Continuous Index:
Within 8" of Joint: **NO**
Remarks:

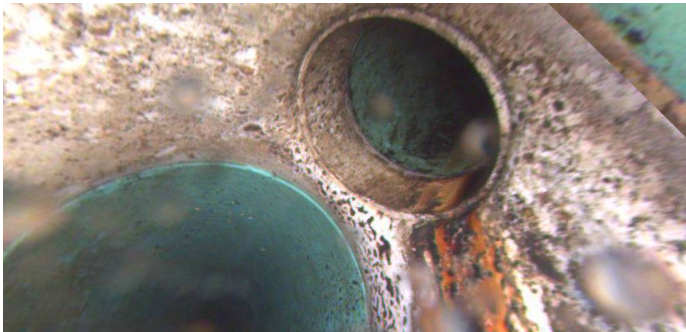
Code: **TF**
Description: **Tap Factory**

Distance (ft): **178.3**
Structural Grade: **0**
O&M Grade: **0**
Clock Start/From: **1**
Clock To:
1st Value: **4.000**
2nd Value:
Value Percent:
Continuous Index:
Within 8" of Joint:
Remarks:

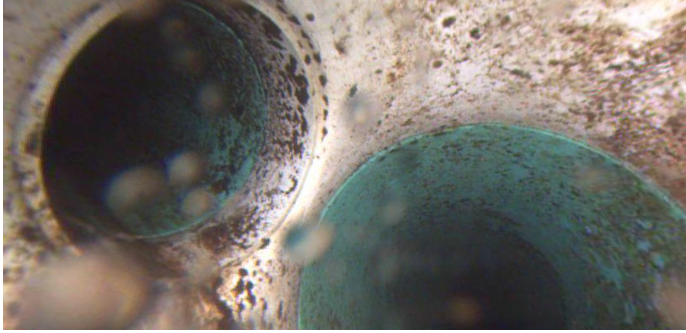
Code: **TF**
Description: **Tap Factory**

Distance (ft): **211.2**
Structural Grade: **0**
O&M Grade: **0**
Clock Start/From: **10**
Clock To:
1st Value: **4.000**
2nd Value:
Value Percent:
Continuous Index:
Within 8" of Joint:
Remarks:

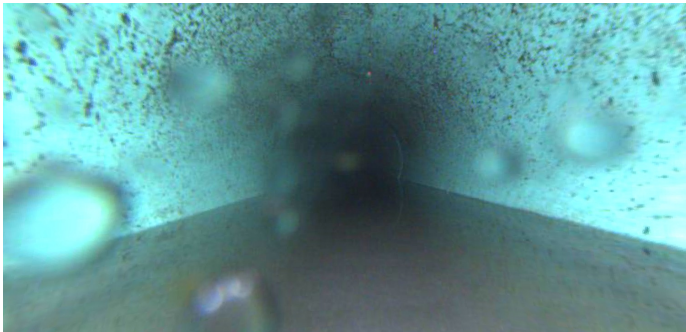
Code: **MWL**
Description: **Water Level**

Distance (ft): **246.3**
Structural Grade: **0**
O&M Grade: **0**
Clock Start/From:
Clock To:
1st Value:
2nd Value:
Value Percent: **30.000**
Continuous Index:
Within 8" of Joint: **NO**
Remarks:

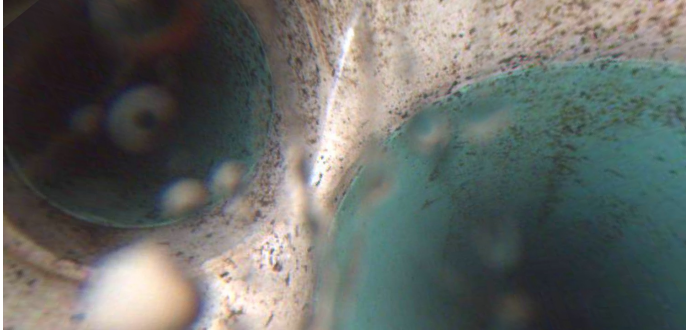
Code: **TF**
Description: **Tap Factory**

Distance (ft): **329.0**
Structural Grade: **0**
O&M Grade: **0**
Clock Start/From: **10**
Clock To:
1st Value: **4.000**
2nd Value:
Value Percent:
Continuous Index:
Within 8" of Joint:
Remarks:

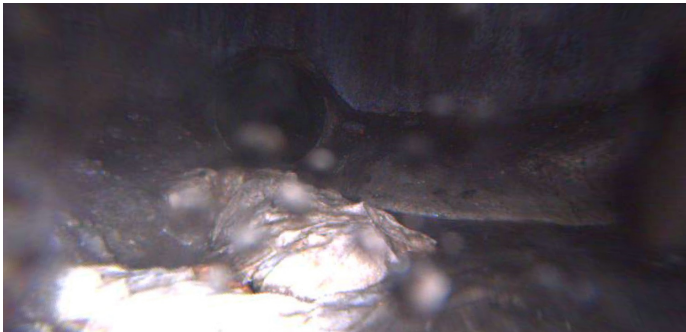
Code: **AMH**
Description: **Manhole**

Distance (ft): **346.6**
Structural Grade: **0**
O&M Grade: **0**
Clock Start/From:
Clock To:
1st Value:
2nd Value:
Value Percent:
Continuous Index:
Within 8" of Joint: **NO**
Remarks: **M-1004-031**
