Profile/Photo Observation Report

Date:	04/14/2018	Weather:		Coding:	PACP 6.0
Pipe Length (ft):	254.4	Owner:	NA	Pre Clean:	Not Known
P.O.#:		Surveyor:	Jen Costello	PSR:	P-1004-032-031
Customer:		Clean Date:	01/01/1900	Shape:	C

Street:	E Cleveland Ave.	Flow Control:	Not Controlled
City:	Hobart, IN	Year Renewed:	
Location:	Other	Tape/Media #:	
Purpose:	Not Known	Dia/Height:	8"
Use:	Sanitary	Material:	PVC
Drain Area:	NA	Lining:	
Category:	NA		
Comment:

Location Details:		Direction of Survey:	Downstream
US MH:	M-1004-031	DS MH:	M-1004-032
		Total Length Surveyed (ft):	248.8

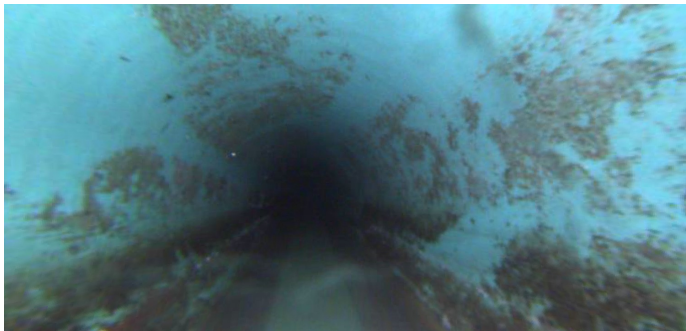
Code: **AMH**
Description: **Manhole**

Distance (ft): **.0**
Structural Grade: **0**
O&M Grade: **0**
Clock Start/From:
Clock To:
1st Value:
2nd Value:
Value Percent:
Continuous Index:
Within 8" of Joint: **NO**
Remarks: **M-1004-031**

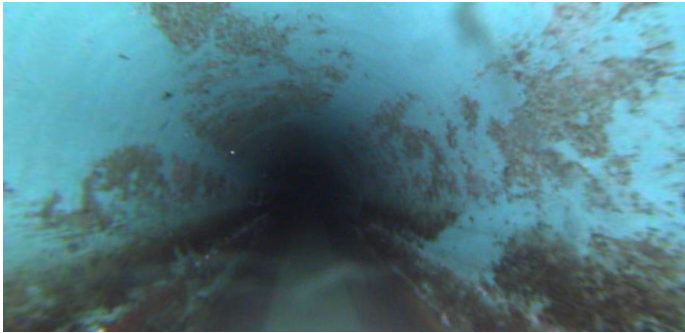
Code:	MWL
Description:	Water Level

Distance (ft):	.0
Structural Grade:	0
O&M Grade:	0
Clock Start/From:	
Clock To:	
1st Value:	
2nd Value:	
Value Percent:	5.000
Continuous Index:	
Within 8" of Joint:	NO
Remarks:

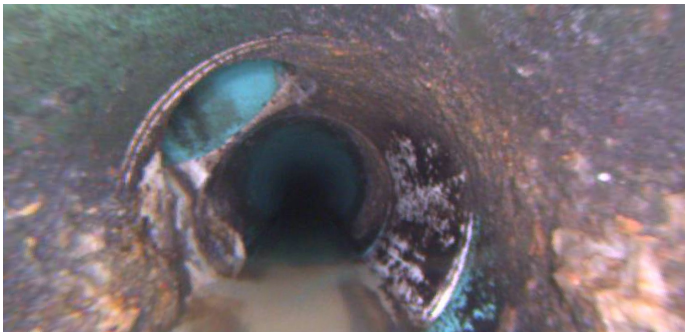
Code:	DAGS
Description:	Deposits Attached Grease

Distance (ft):	79.3
Structural Grade:	0
O&M Grade:	2
Clock Start/From:	8
Clock To:	4
1st Value:	
2nd Value:	
Value Percent:	5.000
Continuous Index:	
Within 8" of Joint:	NO
Remarks:

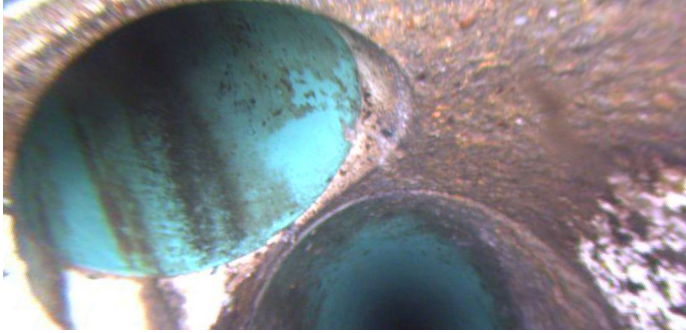
Code: **TF**
Description: **Tap Factory**

Distance (ft): **79.8**
Structural Grade: **0**
O&M Grade: **0**
Clock Start/From: **10**
Clock To:
1st Value: **4.000**
2nd Value:
Value Percent:
Continuous Index:
Within 8" of Joint:
Remarks:

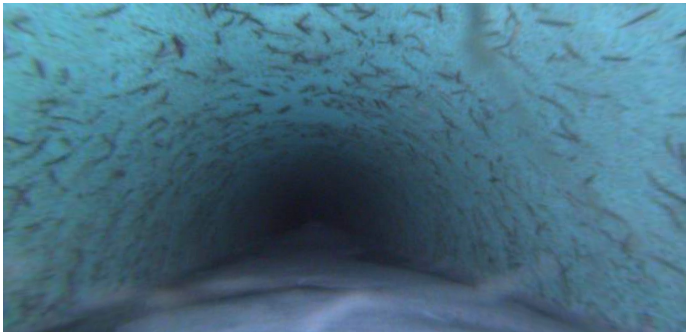
Code: **MWL**
Description: **Water Level**

Distance (ft): **111.1**
Structural Grade: **0**
O&M Grade: **0**
Clock Start/From:
Clock To:
1st Value:
2nd Value:
Value Percent: **40.000**
Continuous Index:
Within 8" of Joint: **NO**
Remarks:

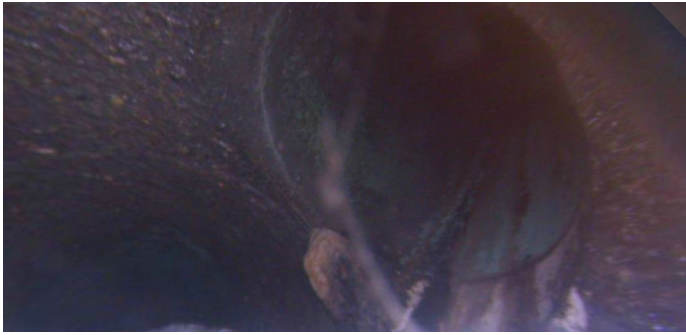
Code: **TF**
Description: **Tap Factory**

Distance (ft): **114.7**
Structural Grade: **0**
O&M Grade: **0**
Clock Start/From: **2**
Clock To:
1st Value: **4.000**
2nd Value:
Value Percent:
Continuous Index:
Within 8" of Joint:
Remarks:

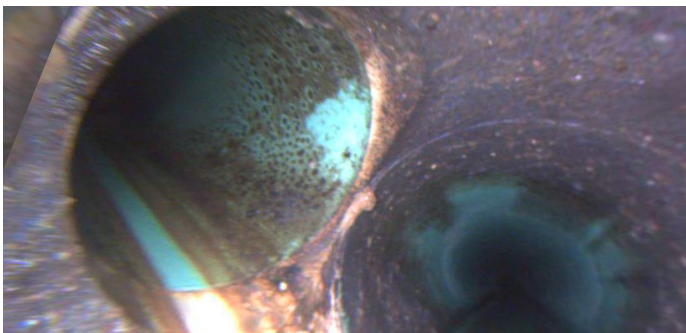
Code: **TF**
Description: **Tap Factory**

Distance (ft): **166.9**
Structural Grade: **0**
O&M Grade: **0**
Clock Start/From: **10**
Clock To:
1st Value: **4.000**
2nd Value:
Value Percent:
Continuous Index:
Within 8" of Joint:
Remarks:

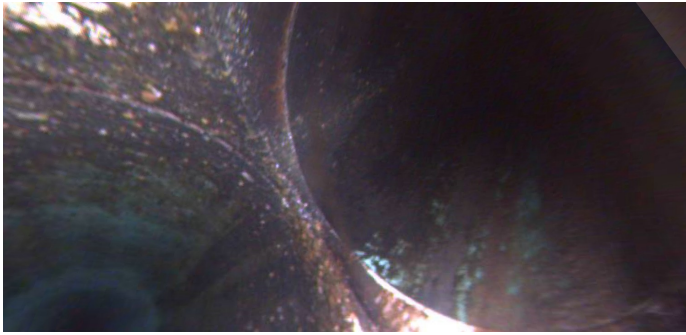
Code: **TF**
Description: **Tap Factory**

Distance (ft): **190.2**
Structural Grade: **0**
O&M Grade: **0**
Clock Start/From: **2**
Clock To:
1st Value: **4.000**
2nd Value:
Value Percent:
Continuous Index:
Within 8" of Joint:
Remarks:

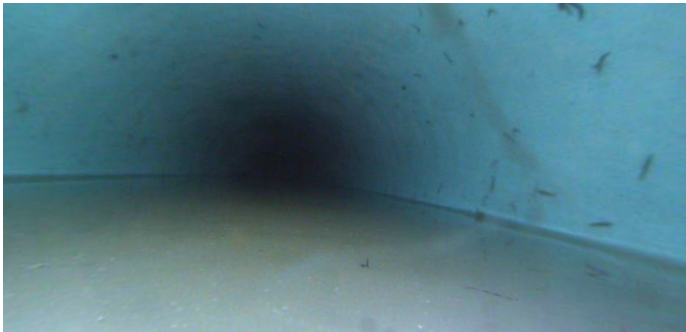
Code: **MWL**
Description: **Water Level**

Distance (ft): **211.4**
Structural Grade: **0**
O&M Grade: **0**
Clock Start/From:
Clock To:
1st Value:
2nd Value:
Value Percent: **40.000**
Continuous Index:
Within 8" of Joint: **NO**
Remarks:

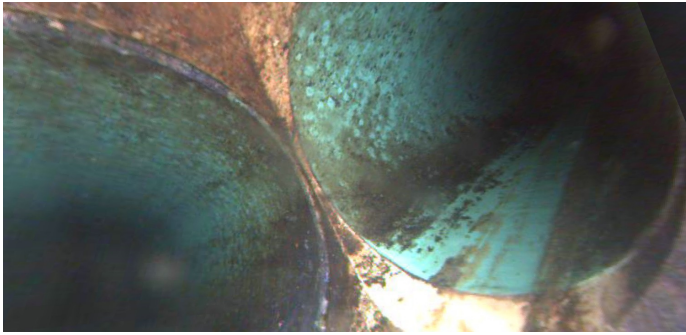
Code: **TF**
Description: **Tap Factory**

Distance (ft): **245.1**
Structural Grade: **0**
O&M Grade: **0**
Clock Start/From: **10**
Clock To:
1st Value: **4.000**
2nd Value:
Value Percent:
Continuous Index:
Within 8" of Joint:
Remarks:

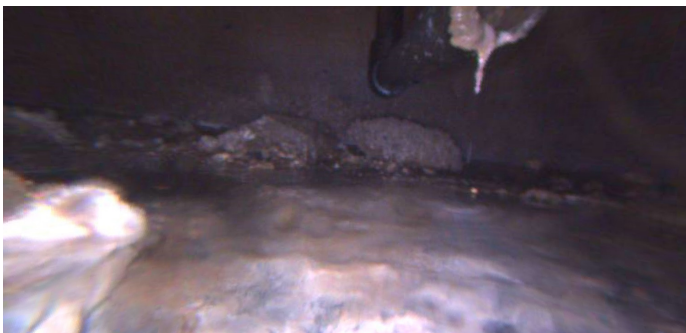
Code: **AMH**
Description: **Manhole**

Distance (ft): **248.8**
Structural Grade: **0**
O&M Grade: **0**
Clock Start/From:
Clock To:
1st Value:
2nd Value:
Value Percent:
Continuous Index:
Within 8" of Joint: **NO**
Remarks: **M-1004-032**
