Profile/Photo Observation Report

Date:	04/14/2018	Weather:		Coding:	PACP 6.0
Pipe Length (ft):	370.3	Owner:	NA	Pre Clean:	Not Known
P.O.#:		Surveyor:	Jen Costello	PSR:	P-1004-031-034
Customer:		Clean Date:	01/01/1900	Shape:	C

Street:	HILLCREST ST	Flow Control:	Not Controlled
City:	Hobart, IN	Year Renewed:	
Location:	Other	Tape/Media #:	
Purpose:	Not Known	Dia/Height:	10"
Use:	Sanitary	Material:	PVC
Drain Area:	NA	Lining:	
Category:	NA		
Comment:

Location Details:		Direction of Survey:	Upstream
US MH:	M-1004-031	DS MH:	M-1004-034
		Total Length Surveyed (ft):	360.8

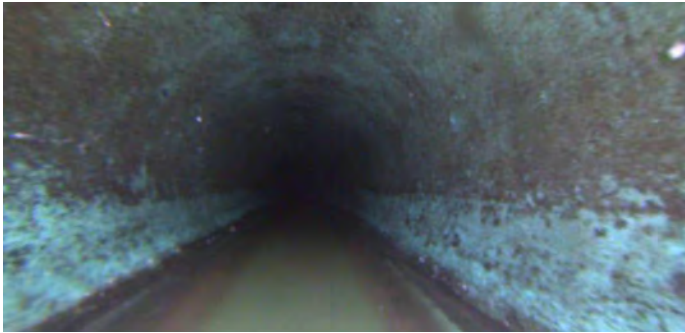
Code:	MWL
Description:	Water Level

Distance (ft):	.0
Structural Grade:	0
O&M Grade:	0
Clock Start/From:	
Clock To:	
1st Value:	
2nd Value:	
Value Percent:	10.000
Continuous Index:	
Within 8" of Joint:	NO
Remarks:

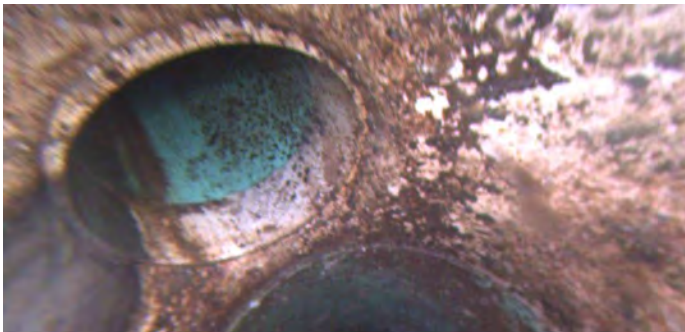
Code:	TF
Description:	Tap Factory

Distance (ft):	103.7
Structural Grade:	0
O&M Grade:	0
Clock Start/From:	11
Clock To:	
1st Value:	4.000
2nd Value:	
Value Percent:	
Continuous Index:	
Within 8" of Joint:	
Remarks:

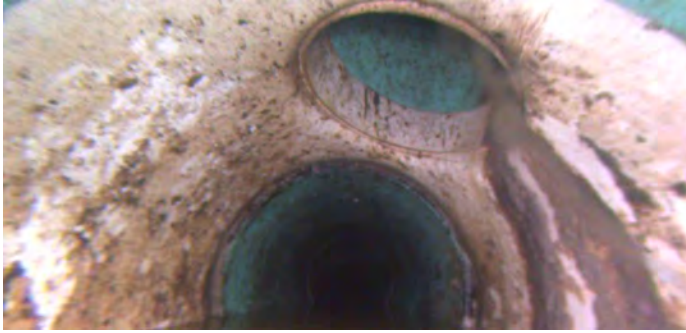
Code: **TF**
Description: **Tap Factory**

Distance (ft): **107.1**
Structural Grade: **0**
O&M Grade: **0**
Clock Start/From: **1**
Clock To:
1st Value: **4.000**
2nd Value:
Value Percent:
Continuous Index:
Within 8" of Joint:
Remarks:

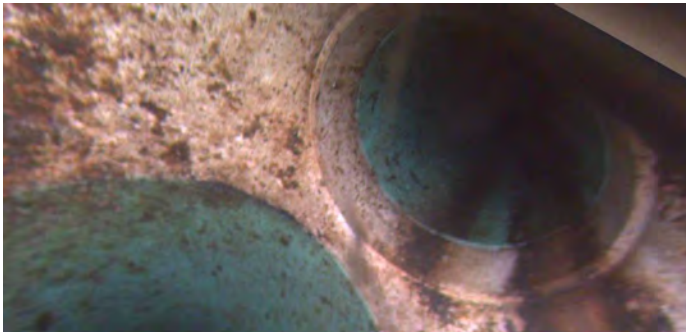
Code: **TF**
Description: **Tap Factory**

Distance (ft): **129.7**
Structural Grade: **0**
O&M Grade: **0**
Clock Start/From: **2**
Clock To:
1st Value: **4.000**
2nd Value:
Value Percent:
Continuous Index:
Within 8" of Joint:
Remarks:

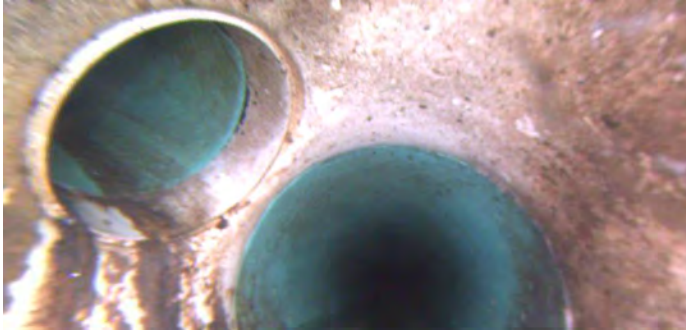
Code: **TF**
Description: **Tap Factory**

Distance (ft): **175.1**
Structural Grade: **0**
O&M Grade: **0**
Clock Start/From: **10**
Clock To:
1st Value: **4.000**
2nd Value:
Value Percent:
Continuous Index:
Within 8" of Joint:
Remarks:

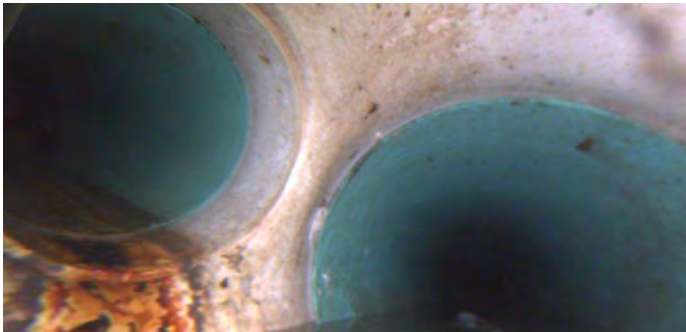
Code: **TFA**
Description: **Tap Factory Active**

Distance (ft): **258.0**
Structural Grade: **0**
O&M Grade: **0**
Clock Start/From: **9**
Clock To:
1st Value: **4.000**
2nd Value:
Value Percent:
Continuous Index:
Within 8" of Joint:
Remarks:

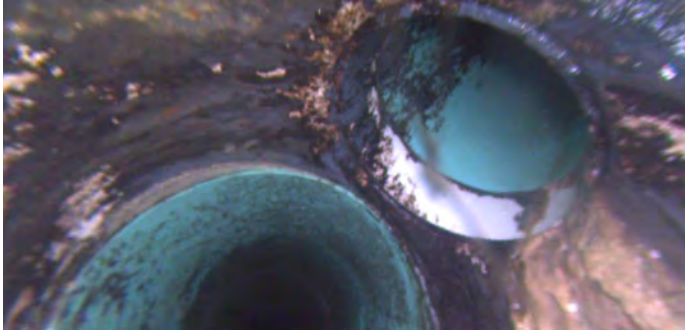
Code: **TF**
Description: **Tap Factory**

Distance (ft): **279.6**
Structural Grade: **0**
O&M Grade: **0**
Clock Start/From: **1**
Clock To:
1st Value: **4.000**
2nd Value:
Value Percent:
Continuous Index:
Within 8" of Joint:
Remarks:

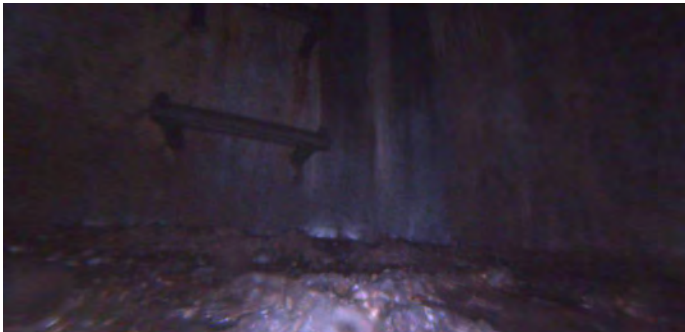
Code: **AMH**
Description: **Manhole**

Distance (ft): **360.8**
Structural Grade: **0**
O&M Grade: **0**
Clock Start/From:
Clock To:
1st Value:
2nd Value:
Value Percent:
Continuous Index:
Within 8" of Joint: **NO**
Remarks: **M-1004-031**
