Profile/Photo Observation Report

Date: 05/07/2018 Weather: **PACP 4.2** Coding: Pipe Length (ft): 143.5 Owner: **City of Hobart** Pre Clean: No Pre-Cleaning P.O.#: 2004 SAN PSR: P-1004-024-033 Surveyor: Customer: **Red Zone** Clean Date: Shape: 2637 McAffee Dr Flow Control: **Not Controlled** Street: City: **Hobart In** Year Renewed: Tape/Media #: Deliverable 1 Location: **Light Highway** Purpose: **Routine Assessment** Dia/Height: 16" **PVC** Use: Sanitary Material: Northeast Drain Area: Lining: NA Category: Comment: 452-2 **Location Details: Edge of street** Direction of Survey: Upstream M-1004-024 Total Length Surveyed (ft): US MH: DS MH: M-1004-033 143.5 2.00 2C00 46.00 O&M Index: O&M Quick: O&M Rating: 0.00 0000 0.00 Structural Index: Structural Quick: Structural Rating:

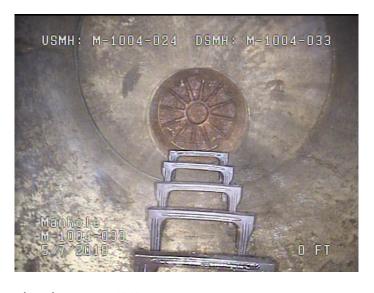
Code:

Description:	Manhole
Distance (ft):	.0
Structural Grade:	0
O&M Grade:	0
Clock Start/From:	
Clock To:	
1st Value:	
2nd Value:	
Value Percent:	
Continuous Index:	
Within 8" of Joint:	NO
Remarks:	M-1004-033

AMH

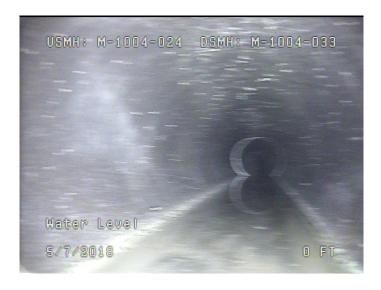
Code: MWL

Description: **Water Level**

Distance (ft): .0 Structural Grade: 0 O&M Grade: 0

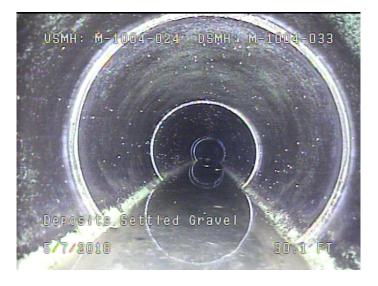
Code: **DSGV**

Description: **Deposits Settled Gravel**

Distance (ft): 30.1 Structural Grade: 0 O&M Grade: 2 Clock Start/From: 6

Value Percent: 10.000 Continuous Index: **S01** Within 8" of Joint: NO

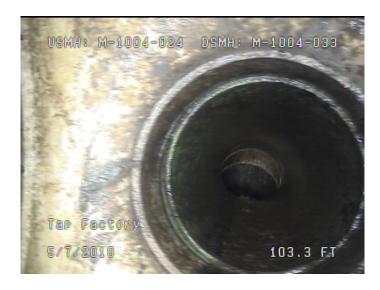
Code: **TF**

Description: Tap Factory

Distance (ft): 103.3
Structural Grade: 0
O&M Grade: 0
Clock Start/From: 1

1st Value: **4.000**

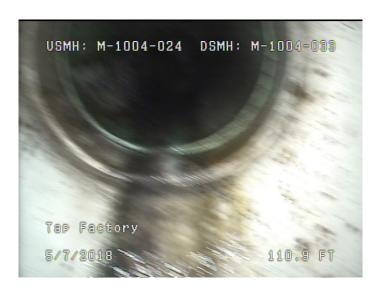
Code: TF

Description: **Tap Factory**

Distance (ft): 110.9
Structural Grade: 0
O&M Grade: 0
Clock Start/From: 11

1st Value: **4.000**

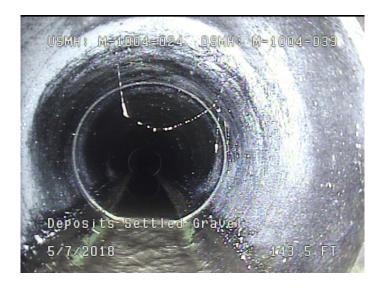
Code: **DSGV**

Description: Deposits Settled Gravel

Distance (ft): 143.5
Structural Grade: 0
O&M Grade: 2
Clock Start/From: 6

Value Percent: 10.000
Continuous Index: F01
Within 8" of Joint: NO

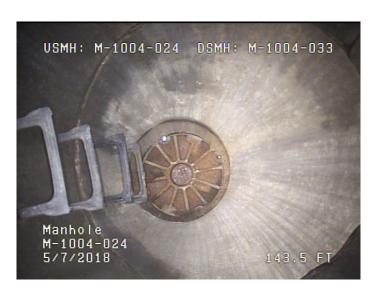
Code: AMH
Description: Manhole

Distance (ft): 143.5
Structural Grade: 0
O&M Grade: 0

Remarks: M-1004-024
