## Profile/Photo Observation Report

Date:	<b>05/07/2018</b>	Weather:		Coding:	<b>PACP 4.2</b>
Pipe Length (ft):	<b>359.0</b>	Owner:	<b>City of Hobart</b>	Pre Clean:	<b>No Pre-Cleaning</b>
P.O.#:	<b>2004</b>	Surveyor:	<b>SAN</b>	PSR:	<b>P-1004-033-034</b>
Customer:	<b>Red Zone</b>	Clean Date:		Shape:	<b>C</b>

Street:	<b>2615 Drexel Dr</b>	Flow Control:	<b>Not Controlled</b>
City:	<b>Hobart In</b>	Year Renewed:	
Location:	<b>Light Highway</b>	Tape/Media #:	<b>Deliverable 1</b>
Purpose:	<b>Routine Assessment</b>	Dia/Height:	<b>16"</b>
Use:	<b>Sanitary</b>	Material:	<b>PVC</b>
Drain Area:	<b>Northeast</b>	Lining:	
Category:	<b>NA</b>		
Comment:	<b>452-1</b>		
Location Details:	<b>Edge of street</b>	Direction of Survey:	<b>Upstream</b>
US MH:	<b>M-1004-033</b>	DS MH:	<b>M-1004-034</b>
		Total Length Surveyed (ft):	<b>359.0</b>

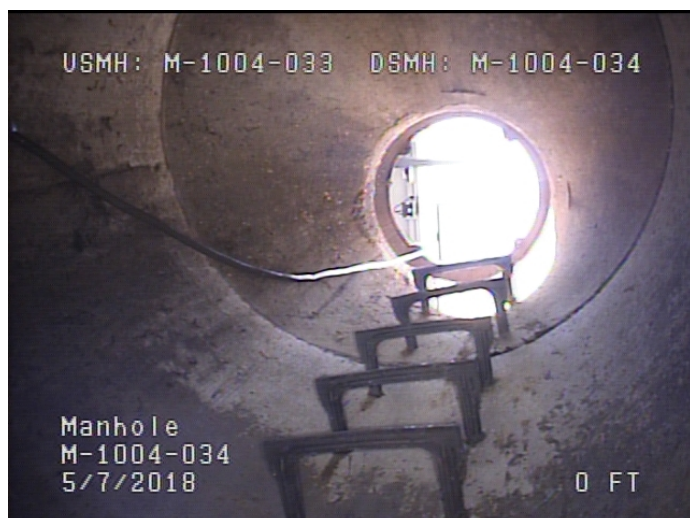
Code: **AMH**  
Description: **Manhole**

Distance (ft): **.0**  
Structural Grade: **0**  
O&M Grade: **0**  
Clock Start/From:  
Clock To:  
1st Value:  
2nd Value:  
Value Percent:  
Continuous Index:  
Within 8" of Joint: **NO**  
Remarks: **M-1004-034**

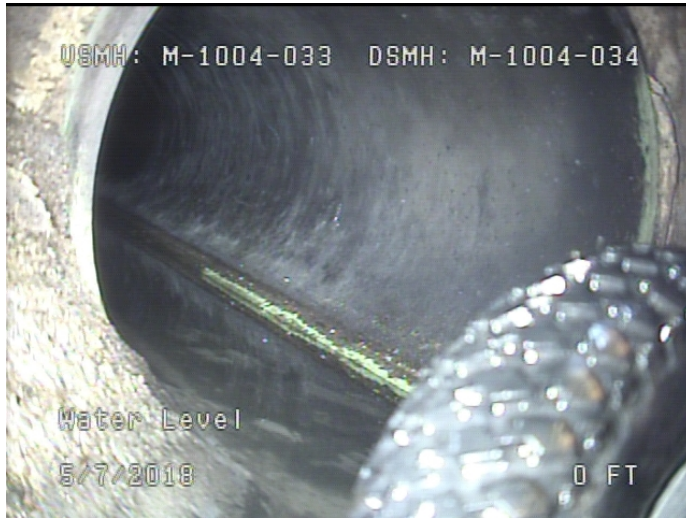
Code:	<b>MWL</b>
Description:	<b>Water Level</b>
Distance (ft):	<b>.0</b>
Structural Grade:	<b>0</b>
O&M Grade:	<b>0</b>
Clock Start/From:	
Clock To:	
1st Value:	
2nd Value:	
Value Percent:	<b>5.000</b>
Continuous Index:	
Within 8" of Joint:	<b>NO</b>
Remarks:

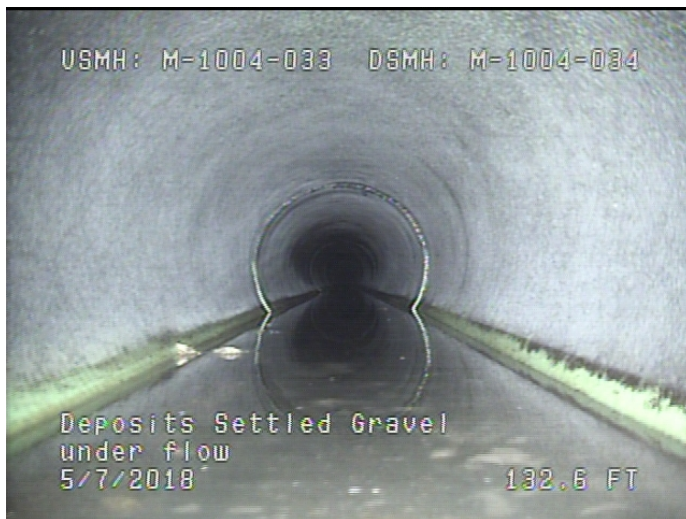
Code:	<b>DSGV</b>
Description:	<b>Deposits Settled Gravel</b>
Distance (ft):	<b>132.6</b>
Structural Grade:	<b>0</b>
O&M Grade:	<b>2</b>
Clock Start/From:	<b>6</b>
Clock To:	
1st Value:	
2nd Value:	
Value Percent:	<b>10.000</b>
Continuous Index:	<b>S01</b>
Within 8" of Joint:	<b>NO</b>
Remarks:	<b>under flow</b>

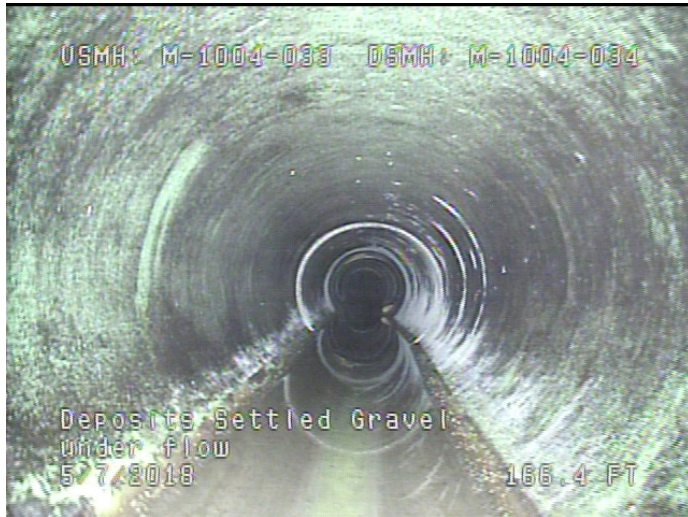
Code:	<b>DSGV</b>
Description:	<b>Deposits Settled Gravel</b>
Distance (ft):	<b>166.4</b>
Structural Grade:	<b>0</b>
O&M Grade:	<b>2</b>
Clock Start/From:	<b>6</b>
Clock To:	
1st Value:	
2nd Value:	
Value Percent:	<b>10.000</b>
Continuous Index:	<b>F01</b>
Within 8" of Joint:	<b>NO</b>
Remarks:	<b>under flow</b>

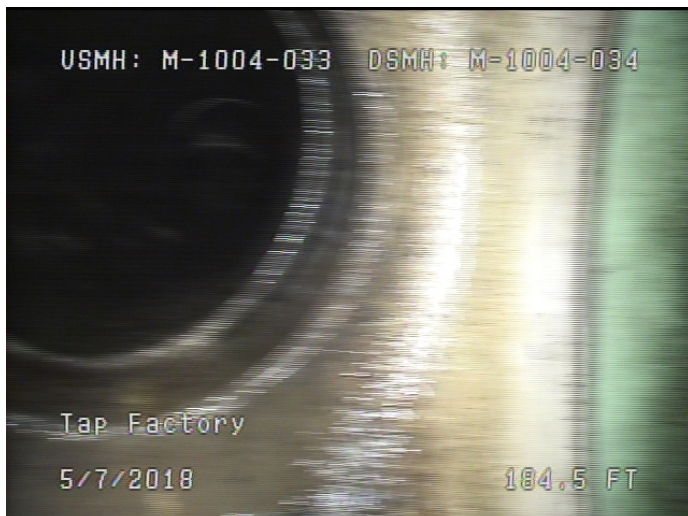
Code:	<b>TF</b>
Description:	<b>Tap Factory</b>
Distance (ft):	<b>184.5</b>
Structural Grade:	<b>0</b>
O&M Grade:	<b>0</b>
Clock Start/From:	<b>11</b>
Clock To:	
1st Value:	<b>4.000</b>
2nd Value:	
Value Percent:	
Continuous Index:	
Within 8" of Joint:	<b>NO</b>
Remarks:

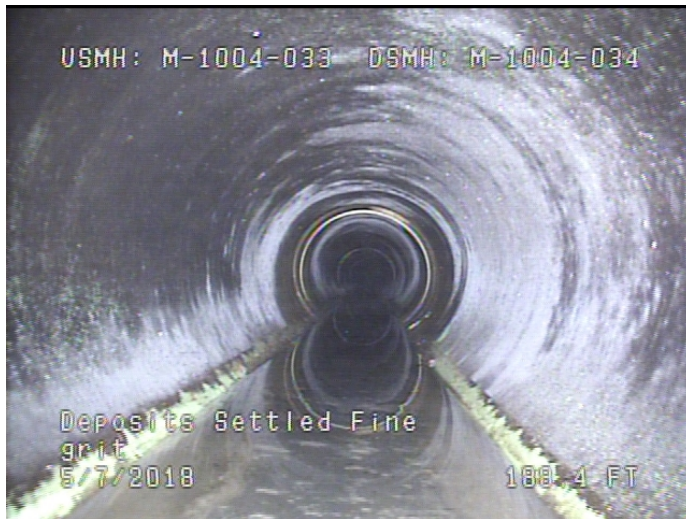
Code:	<b>DSF</b>
Description:	<b>Deposits Settled Fine</b>
Distance (ft):	<b>188.4</b>
Structural Grade:	<b>0</b>
O&M Grade:	<b>2</b>
Clock Start/From:	<b>6</b>
Clock To:	
1st Value:	
2nd Value:	
Value Percent:	<b>5.000</b>
Continuous Index:	<b>S02</b>
Within 8" of Joint:	<b>NO</b>
Remarks:	<b>grit</b>

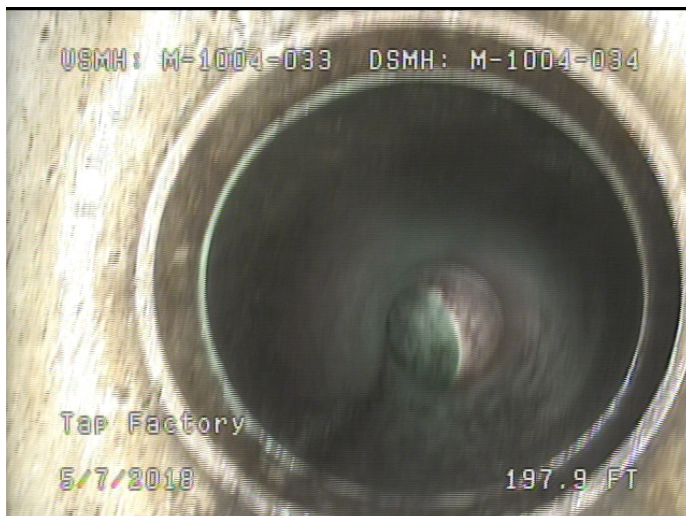
Code:	<b>TF</b>
Description:	<b>Tap Factory</b>
Distance (ft):	<b>197.9</b>
Structural Grade:	<b>0</b>
O&M Grade:	<b>0</b>
Clock Start/From:	<b>1</b>
Clock To:	
1st Value:	<b>4.000</b>
2nd Value:	
Value Percent:	
Continuous Index:	
Within 8" of Joint:	<b>NO</b>
Remarks:

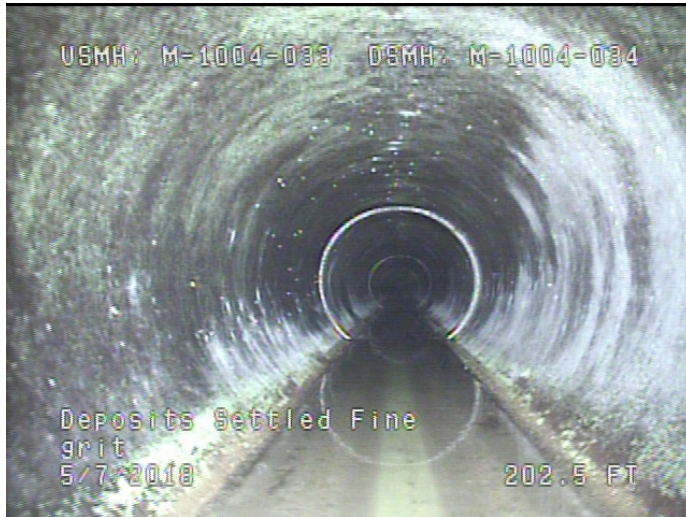
Code:	<b>DSF</b>
Description:	<b>Deposits Settled Fine</b>
Distance (ft):	<b>202.5</b>
Structural Grade:	<b>0</b>
O&M Grade:	<b>2</b>
Clock Start/From:	<b>6</b>
Clock To:	
1st Value:	
2nd Value:	
Value Percent:	<b>5.000</b>
Continuous Index:	<b>F02</b>
Within 8" of Joint:	<b>NO</b>
Remarks:	<b>grit</b>

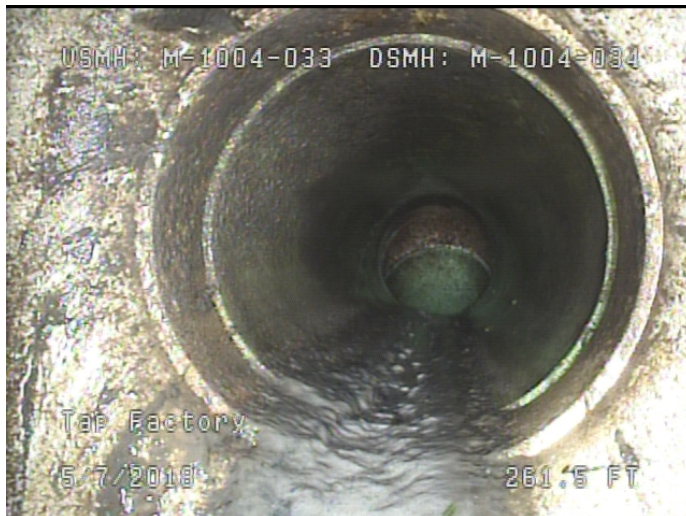
Code:	<b>TF</b>
Description:	<b>Tap Factory</b>
Distance (ft):	<b>261.5</b>
Structural Grade:	<b>0</b>
O&M Grade:	<b>0</b>
Clock Start/From:	<b>11</b>
Clock To:	
1st Value:	<b>4.000</b>
2nd Value:	
Value Percent:	
Continuous Index:	
Within 8" of Joint:	<b>NO</b>
Remarks:

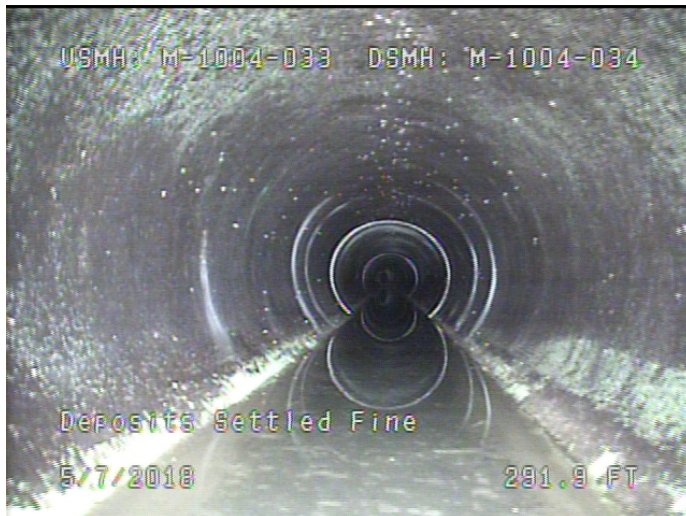
Code:	<b>DSF</b>
Description:	<b>Deposits Settled Fine</b>
Distance (ft):	<b>291.9</b>
Structural Grade:	<b>0</b>
O&M Grade:	<b>2</b>
Clock Start/From:	<b>6</b>
Clock To:	
1st Value:	
2nd Value:	
Value Percent:	<b>5.000</b>
Continuous Index:	<b>S03</b>
Within 8" of Joint:	<b>NO</b>
Remarks:

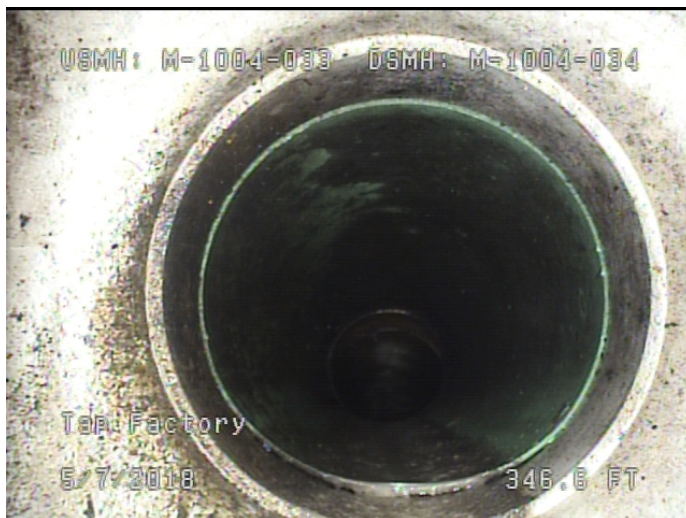
Code:	<b>TF</b>
Description:	<b>Tap Factory</b>
Distance (ft):	<b>346.6</b>
Structural Grade:	<b>0</b>
O&M Grade:	<b>0</b>
Clock Start/From:	<b>11</b>
Clock To:	
1st Value:	<b>4.000</b>
2nd Value:	
Value Percent:	
Continuous Index:	
Within 8" of Joint:	<b>NO</b>
Remarks:

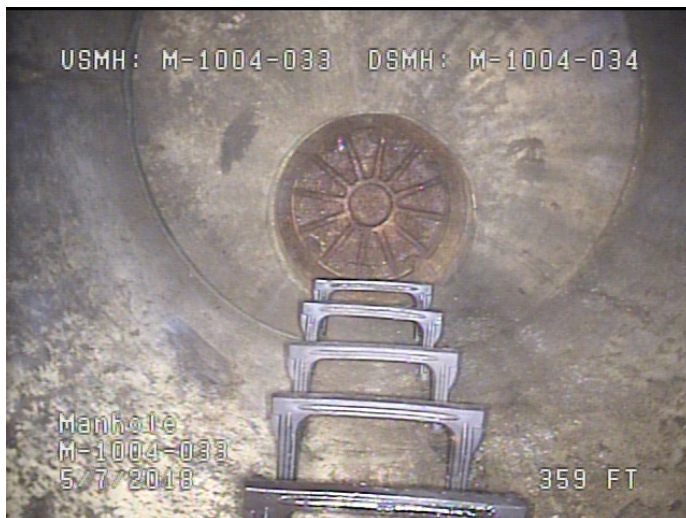
Code:	<b>AMH</b>
Description:	<b>Manhole</b>
Distance (ft):	<b>359.0</b>
Structural Grade:	<b>0</b>
O&M Grade:	<b>0</b>
Clock Start/From:	
Clock To:	
1st Value:	
2nd Value:	
Value Percent:	
Continuous Index:	
Within 8" of Joint:	<b>NO</b>
Remarks:	<b>M-1004-033</b>
