Profile/Photo Observation Report

Street:	Coral Dr	Flow Control:	Not Controlled
City:	Hobart In	Year Renewed:	
Location:	Light Highway	Tape/Media #:	Deliverable 1
Purpose:	Routine Assessment	Dia/Height:	15"
Use:	Sanitary	Material:	PVC
Drain Area:	Northeast	Lining:	
Category:	NA		
Comment:	419-2		
Location Details:	Center of street	Direction of Survey:	Downstream
US MH:	M-1004-038	DS MH:	M-1004-036
		Total Length Surveyed (ft):	392.5

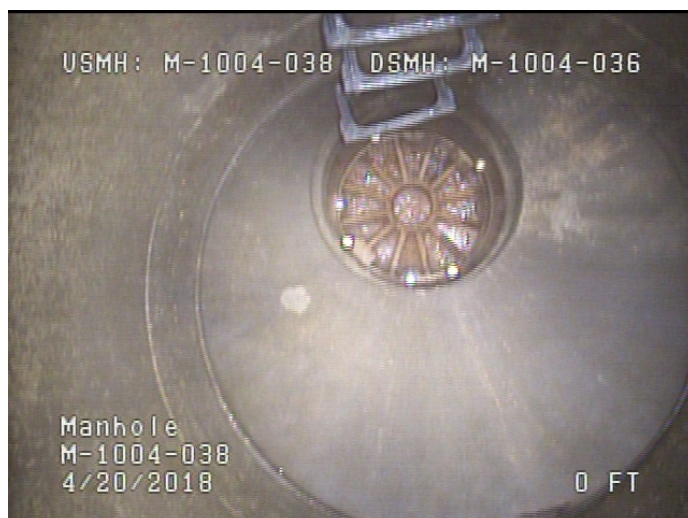
Code: **AMH**
Description: **Manhole**

Distance (ft): **.0**
Structural Grade: **0**
O&M Grade: **0**
Clock Start/From:
Clock To:
1st Value:
2nd Value:
Value Percent:
Continuous Index:
Within 8" of Joint: **NO**
Remarks: **M-1004-038**

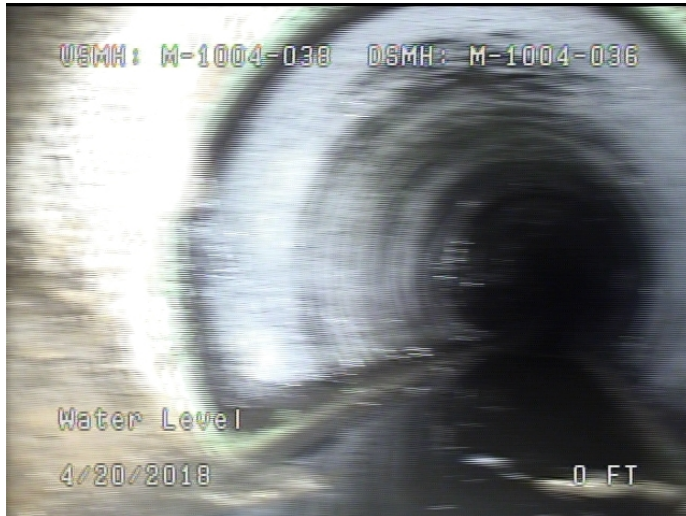
Code:	MWL
Description:	Water Level
Distance (ft):	.0
Structural Grade:	0
O&M Grade:	0
Clock Start/From:	
Clock To:	
1st Value:	
2nd Value:	
Value Percent:	10.000
Continuous Index:	
Within 8" of Joint:	NO
Remarks:

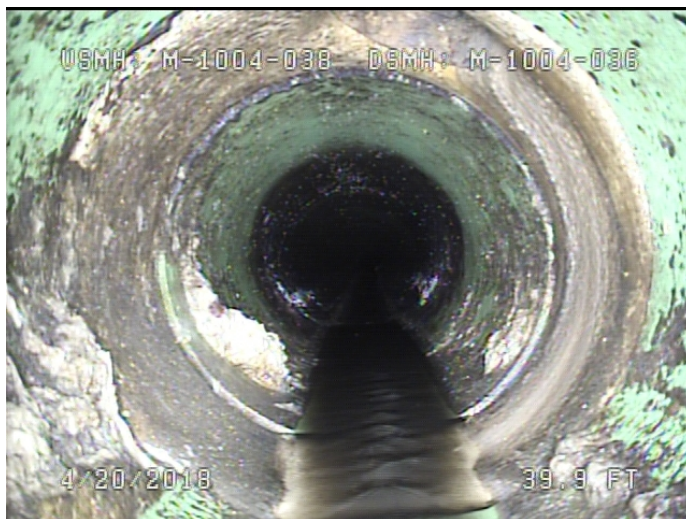
Code:	TF
Description:	Tap Factory
Distance (ft):	39.9
Structural Grade:	0
O&M Grade:	0
Clock Start/From:	1
Clock To:	
1st Value:	4.000
2nd Value:	
Value Percent:	
Continuous Index:	
Within 8" of Joint:	NO
Remarks:

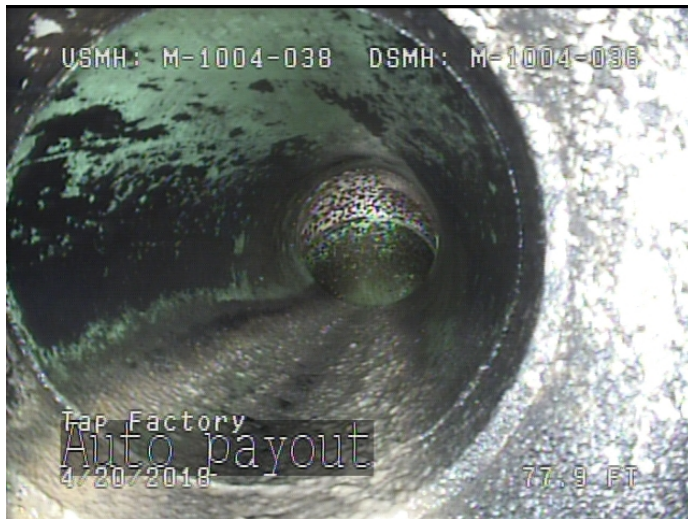
Code:	TF
Description:	Tap Factory
Distance (ft):	77.9
Structural Grade:	0
O&M Grade:	0
Clock Start/From:	11
Clock To:	
1st Value:	4.000
2nd Value:	
Value Percent:	
Continuous Index:	
Within 8" of Joint:	NO
Remarks:

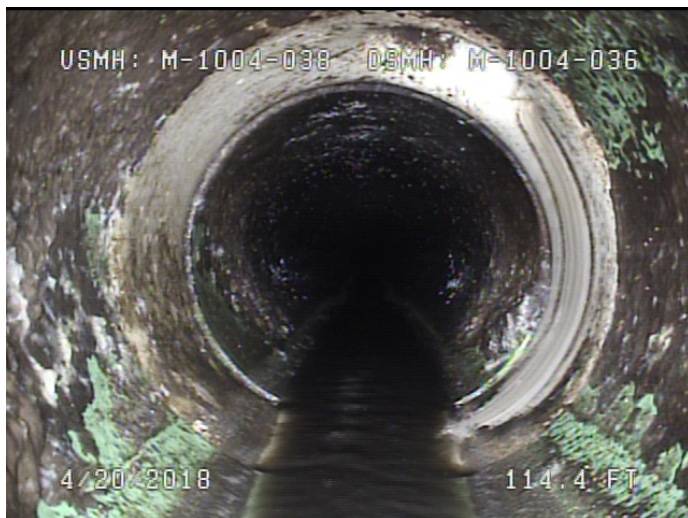
Code:	TF
Description:	Tap Factory
Distance (ft):	114.4
Structural Grade:	0
O&M Grade:	0
Clock Start/From:	1
Clock To:	
1st Value:	4.000
2nd Value:	
Value Percent:	
Continuous Index:	
Within 8" of Joint:	NO
Remarks:

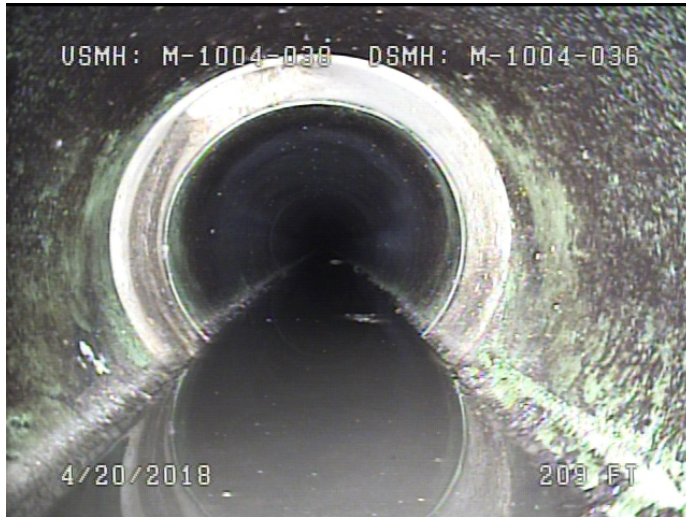
Code:	TF
Description:	Tap Factory
Distance (ft):	209.0
Structural Grade:	0
O&M Grade:	0
Clock Start/From:	11
Clock To:	
1st Value:	4.000
2nd Value:	
Value Percent:	
Continuous Index:	
Within 8" of Joint:	NO
Remarks:

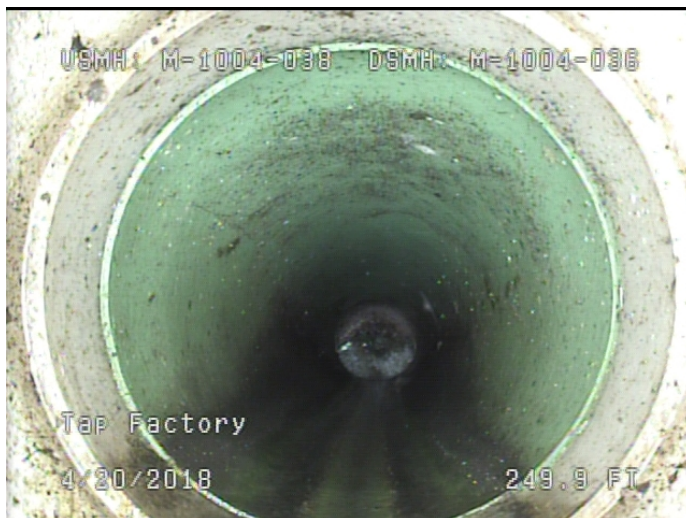
Code:	TF
Description:	Tap Factory
Distance (ft):	249.9
Structural Grade:	0
O&M Grade:	0
Clock Start/From:	1
Clock To:	
1st Value:	4.000
2nd Value:	
Value Percent:	
Continuous Index:	
Within 8" of Joint:	NO
Remarks:

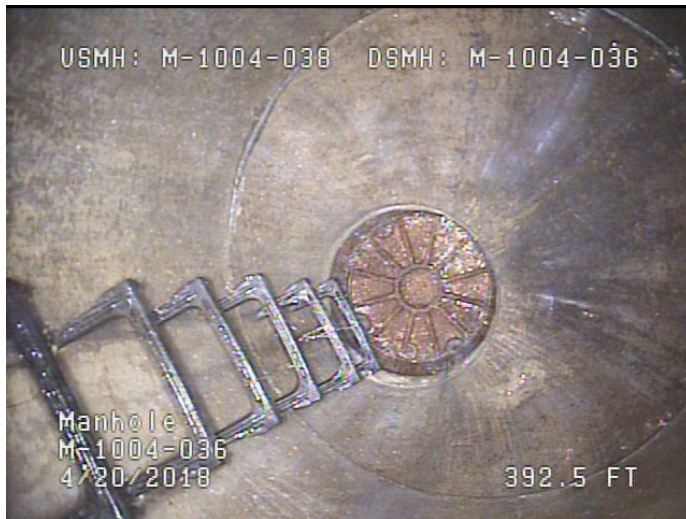
Code:	AMH
Description:	Manhole
Distance (ft):	392.5
Structural Grade:	0
O&M Grade:	0
Clock Start/From:	
Clock To:	
1st Value:	
2nd Value:	
Value Percent:	
Continuous Index:	
Within 8" of Joint:	NO
Remarks:	M-1004-036
