## Profile/Photo Observation Report

Date:	<b>04/19/2018</b>	Weather:		Coding:	<b>PACP 4.2</b>
Pipe Length (ft):	<b>381.2</b>	Owner:	<b>City of Hobart</b>	Pre Clean:	<b>No Pre-Cleaning</b>
P.O.#:	<b>2004</b>	Surveyor:	<b>SAN</b>	PSR:	<b>P-1004-040-039</b>
Customer:	<b>Red Zone</b>	Clean Date:		Shape:	<b>C</b>

Street:	<b>Coral Dr</b>	Flow Control:	<b>Not Controlled</b>
City:	<b>Hobart In</b>	Year Renewed:	
Location:	<b>Light Highway</b>	Tape/Media #:	<b>Deliverable 1</b>
Purpose:	<b>Routine Assessment</b>	Dia/Height:	<b>15"</b>
Use:	<b>Sanitary</b>	Material:	<b>PVC</b>
Drain Area:	<b>Northeast</b>	Lining:	
Category:	<b>NA</b>		
Comment:	<b>418-3</b>		
Location Details:	<b>Center of street</b>	Direction of Survey:	<b>Downstream</b>
US MH:	<b>M-1004-040</b>	DS MH:	<b>M-1004-039</b>
		Total Length Surveyed (ft):	<b>381.2</b>

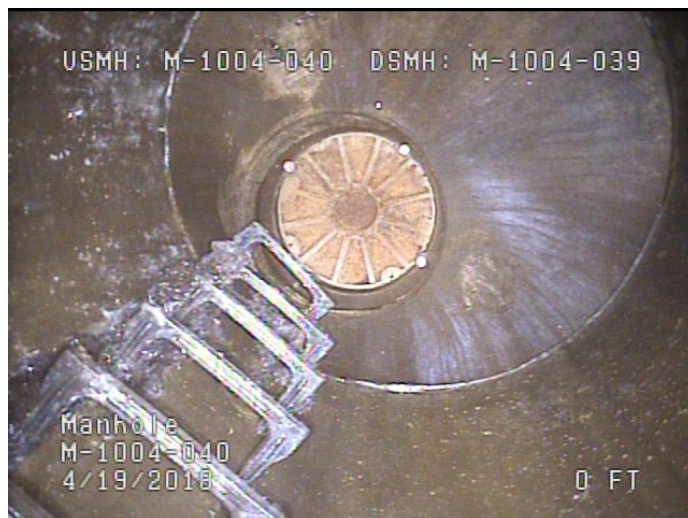
Code: **AMH**  
 Description: **Manhole**

Distance (ft): **.0**  
 Structural Grade: **0**  
 O&M Grade: **0**  
 Clock Start/From:  
 Clock To:  
 1st Value:  
 2nd Value:  
 Value Percent:  
 Continuous Index:  
 Within 8" of Joint: **NO**  
 Remarks: **M-1004-040**

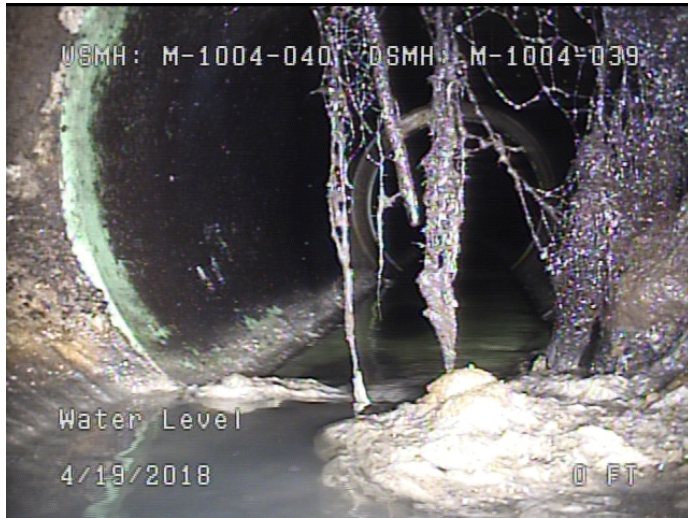
Code: **MWL**  
Description: **Water Level**

Distance (ft): **.0**  
Structural Grade: **0**  
O&M Grade: **0**  
Clock Start/From:  
Clock To:  
1st Value:  
2nd Value:  
Value Percent: **5.000**  
Continuous Index:  
Within 8" of Joint: **NO**  
Remarks:

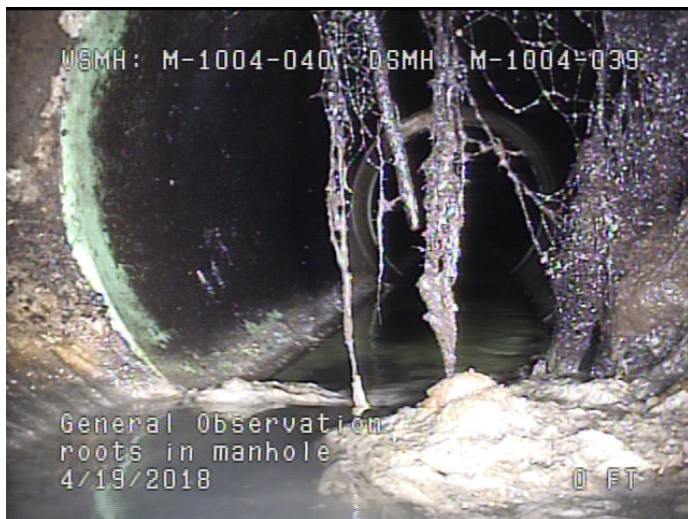
Code: **MGO**  
Description: **General Observation**

Distance (ft): **.0**  
Structural Grade: **0**  
O&M Grade: **0**  
Clock Start/From:  
Clock To:  
1st Value:  
2nd Value:  
Value Percent:  
Continuous Index:  
Within 8" of Joint: **NO**  
Remarks: **roots in manhole**

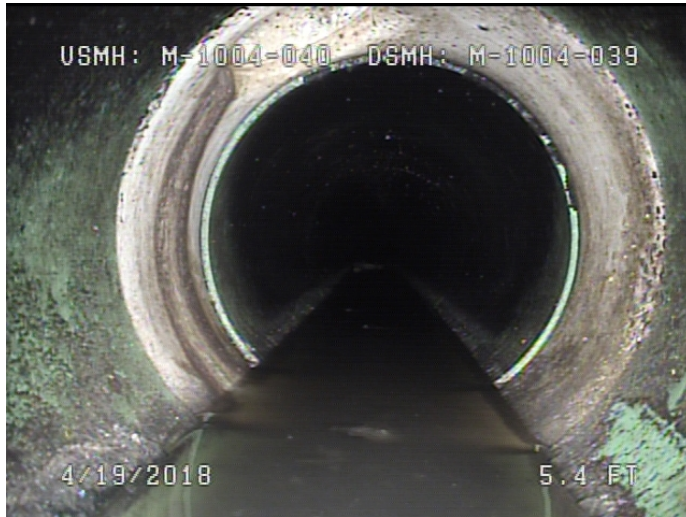
Code:	<b>TF</b>
Description:	<b>Tap Factory</b>
Distance (ft):	<b>5.4</b>
Structural Grade:	<b>0</b>
O&M Grade:	<b>0</b>
Clock Start/From:	<b>11</b>
Clock To:	
1st Value:	<b>4.000</b>
2nd Value:	
Value Percent:	
Continuous Index:	
Within 8" of Joint:	<b>NO</b>
Remarks:

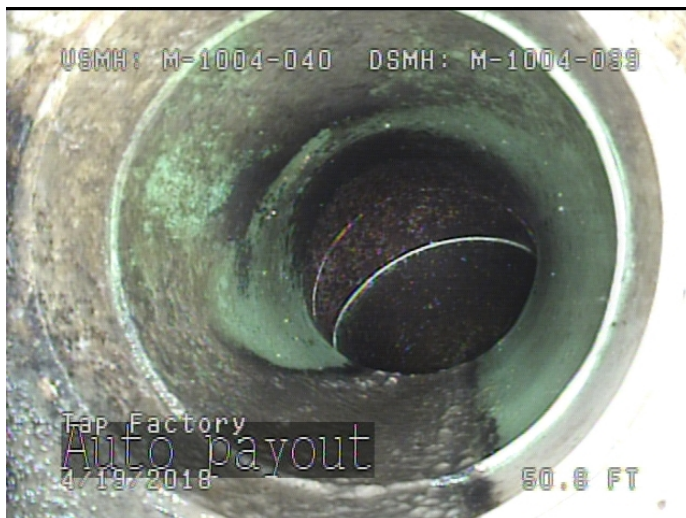
Code:	<b>TF</b>
Description:	<b>Tap Factory</b>
Distance (ft):	<b>50.8</b>
Structural Grade:	<b>0</b>
O&M Grade:	<b>0</b>
Clock Start/From:	<b>1</b>
Clock To:	
1st Value:	<b>4.000</b>
2nd Value:	
Value Percent:	
Continuous Index:	
Within 8" of Joint:	<b>NO</b>
Remarks:

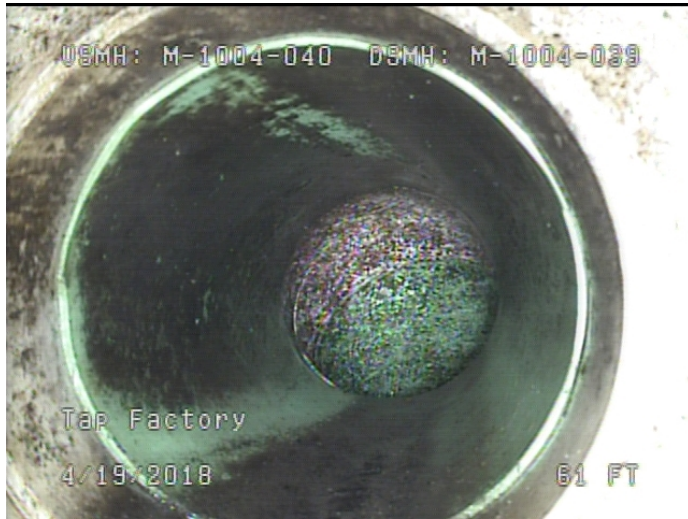
Code:	<b>TF</b>
Description:	<b>Tap Factory</b>
Distance (ft):	<b>61.0</b>
Structural Grade:	<b>0</b>
O&M Grade:	<b>0</b>
Clock Start/From:	<b>1</b>
Clock To:	
1st Value:	<b>4.000</b>
2nd Value:	
Value Percent:	
Continuous Index:	
Within 8" of Joint:	<b>NO</b>
Remarks:

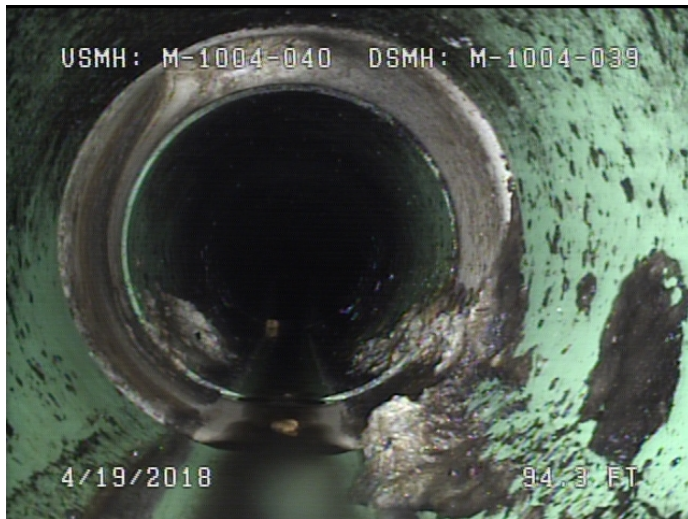
Code:	<b>TF</b>
Description:	<b>Tap Factory</b>
Distance (ft):	<b>94.3</b>
Structural Grade:	<b>0</b>
O&M Grade:	<b>0</b>
Clock Start/From:	<b>11</b>
Clock To:	
1st Value:	<b>4.000</b>
2nd Value:	
Value Percent:	
Continuous Index:	
Within 8" of Joint:	<b>NO</b>
Remarks:

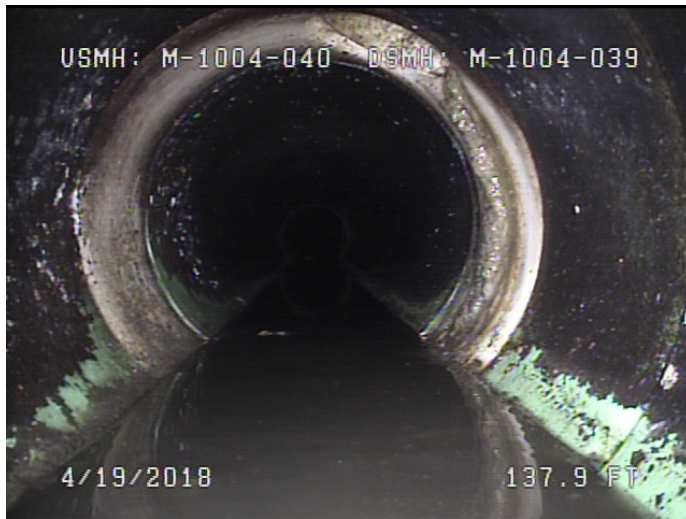
Code:	<b>TFD</b>
Description:	<b>Tap Factory Defective</b>
Distance (ft):	<b>137.9</b>
Structural Grade:	<b>0</b>
O&M Grade:	<b>2</b>
Clock Start/From:	<b>1</b>
Clock To:	
1st Value:	<b>4.000</b>
2nd Value:	
Value Percent:	
Continuous Index:	
Within 8" of Joint:	<b>NO</b>
Remarks:	<b>infil in tap</b>

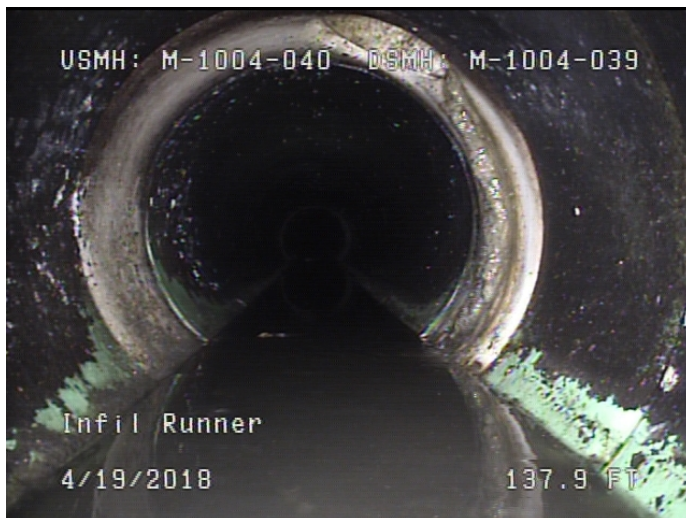
Code:	<b>IR</b>
Description:	<b>Infil Runner</b>
Distance (ft):	<b>137.9</b>
Structural Grade:	<b>0</b>
O&M Grade:	<b>4</b>
Clock Start/From:	<b>1</b>
Clock To:	
1st Value:	
2nd Value:	
Value Percent:	
Continuous Index:	
Within 8" of Joint:	<b>NO</b>
Remarks:

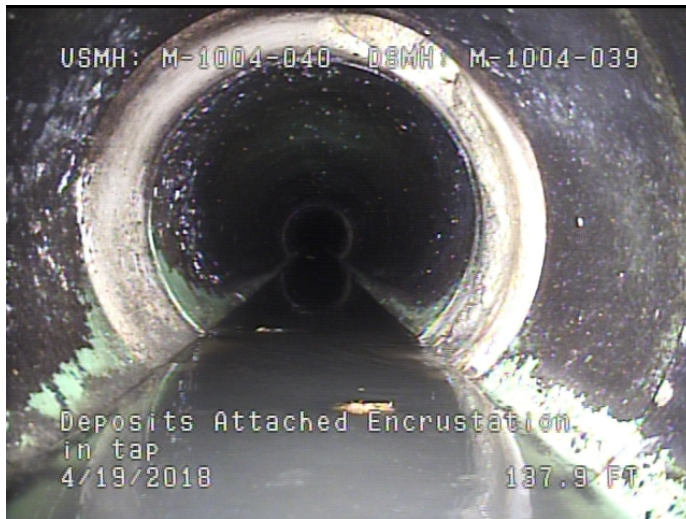
Code:	<b>DAE</b>
Description:	<b>Deposits Attached Encrustation</b>
Distance (ft):	<b>137.9</b>
Structural Grade:	<b>0</b>
O&M Grade:	<b>2</b>
Clock Start/From:	<b>2</b>
Clock To:	<b>5</b>
1st Value:	
2nd Value:	
Value Percent:	<b>10.000</b>
Continuous Index:	
Within 8" of Joint:	<b>NO</b>
Remarks:	<b>in tap</b>

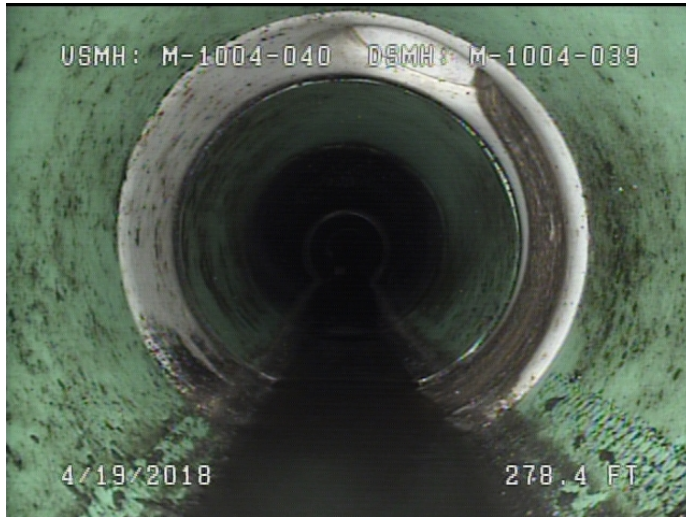
Code:	<b>TF</b>
Description:	<b>Tap Factory</b>
Distance (ft):	<b>278.4</b>
Structural Grade:	<b>0</b>
O&M Grade:	<b>0</b>
Clock Start/From:	<b>1</b>
Clock To:	
1st Value:	<b>4.000</b>
2nd Value:	
Value Percent:	
Continuous Index:	
Within 8" of Joint:	<b>NO</b>
Remarks:

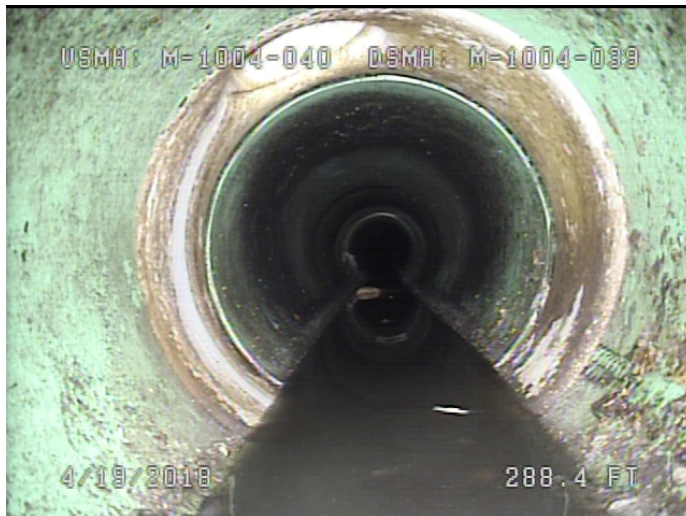
Code:	<b>TF</b>
Description:	<b>Tap Factory</b>
Distance (ft):	<b>288.4</b>
Structural Grade:	<b>0</b>
O&M Grade:	<b>0</b>
Clock Start/From:	<b>11</b>
Clock To:	
1st Value:	<b>4.000</b>
2nd Value:	
Value Percent:	
Continuous Index:	
Within 8" of Joint:	<b>NO</b>
Remarks:

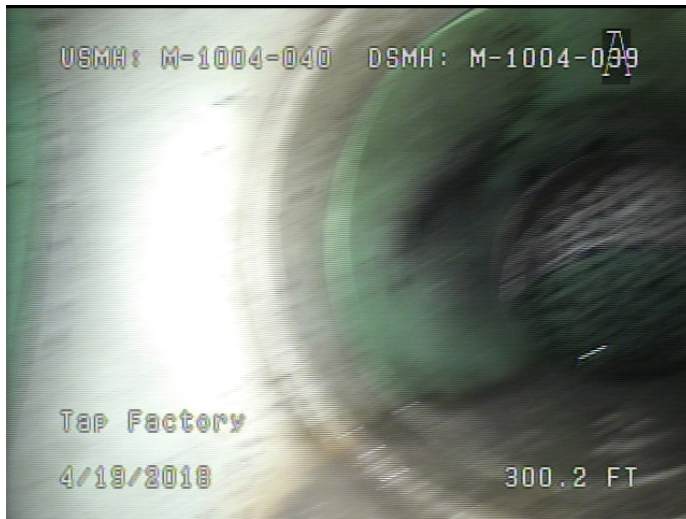
Code: **TF**  
 Description: **Tap Factory**

Distance (ft): **300.2**  
 Structural Grade: **0**  
 O&M Grade: **0**  
 Clock Start/From: **2**  
 Clock To:  
 1st Value: **4.000**  
 2nd Value:  
 Value Percent:  
 Continuous Index:  
 Within 8" of Joint: **NO**  
 Remarks:

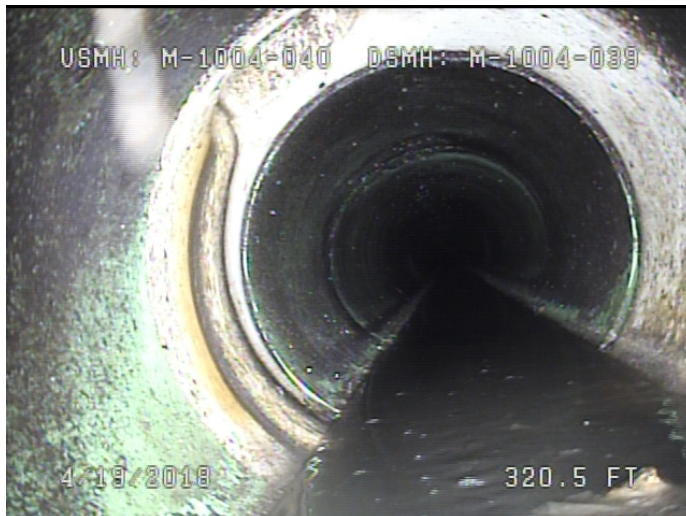
Code: **TF**  
 Description: **Tap Factory**

Distance (ft): **320.5**  
 Structural Grade: **0**  
 O&M Grade: **0**  
 Clock Start/From: **11**  
 Clock To:  
 1st Value: **4.000**  
 2nd Value:  
 Value Percent:  
 Continuous Index:  
 Within 8" of Joint: **NO**  
 Remarks:

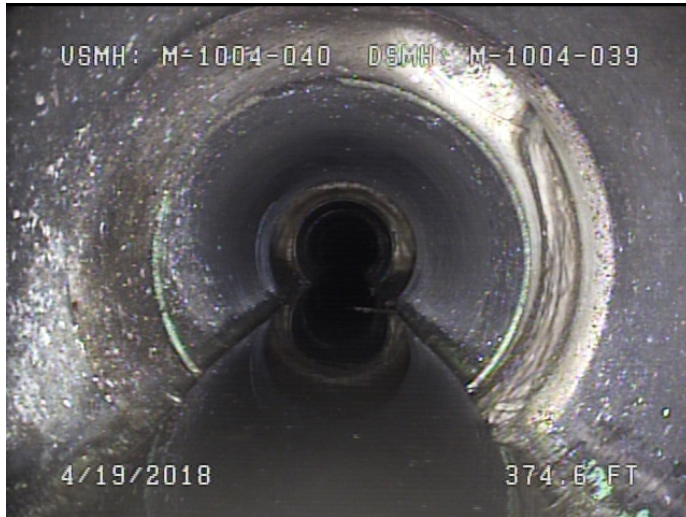
Code: **TF**  
 Description: **Tap Factory**

Distance (ft): **374.6**  
 Structural Grade: **0**  
 O&M Grade: **0**  
 Clock Start/From: **2**  
 Clock To:  
 1st Value: **4.000**  
 2nd Value:  
 Value Percent:  
 Continuous Index:  
 Within 8" of Joint: **NO**  
 Remarks:

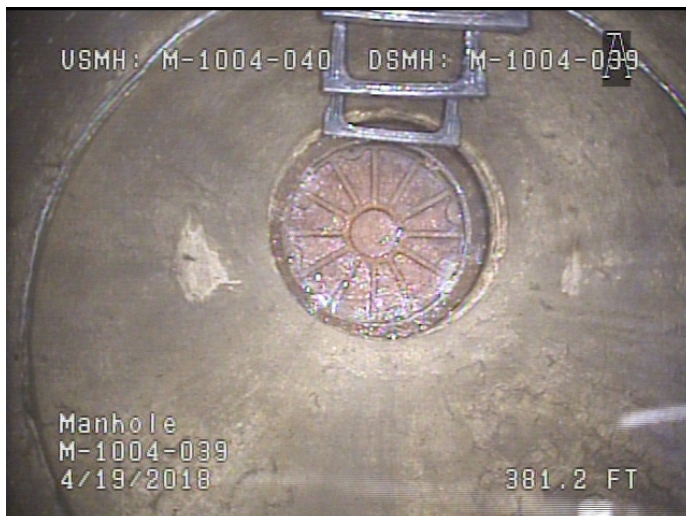
Code: **AMH**  
 Description: **Manhole**

Distance (ft): **381.2**  
 Structural Grade: **0**  
 O&M Grade: **0**  
 Clock Start/From:  
 Clock To:  
 1st Value:  
 2nd Value:  
 Value Percent:  
 Continuous Index:  
 Within 8" of Joint: **NO**  
 Remarks: **M-1004-039**
