Profile/Photo Observation Report

Date:	04/13/2018	Weather:		Coding:	PACP 6.0
Pipe Length (ft):	80.7	Owner:	NA	Pre Clean:	Not Known
P.O.#:		Surveyor:	Jen Costello	PSR:	P-1004-041-042
Customer:		Clean Date:	01/01/1900	Shape:	C

Street:	Ryan Ct.	Flow Control:	Not Controlled
City:	Hobart, IN	Year Renewed:	
Location:	Other	Tape/Media #:	
Purpose:	Not Known	Dia/Height:	8"
Use:	Sanitary	Material:	PVC
Drain Area:	NA	Lining:	
Category:	NA		
Comment:

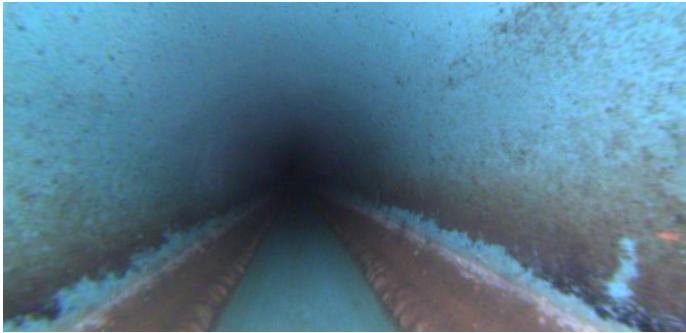
Code:	MWL
Description:	Water Level

Distance (ft):	.0
Structural Grade:	0
O&M Grade:	0
Clock Start/From:	
Clock To:	
1st Value:	
2nd Value:	
Value Percent:	5.000
Continuous Index:	
Within 8" of Joint:	NO
Remarks:

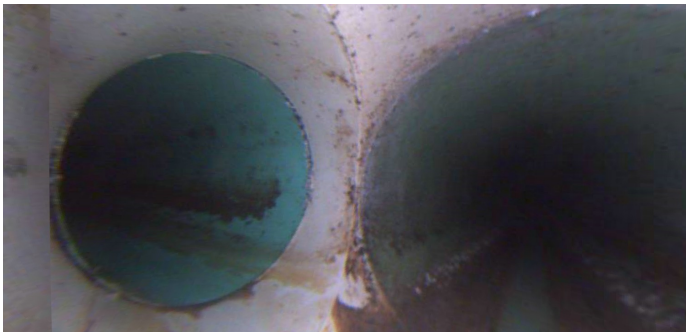
Code:	TF
Description:	Tap Factory

Distance (ft):	50.8
Structural Grade:	0
O&M Grade:	0
Clock Start/From:	9
Clock To:	
1st Value:	4.000
2nd Value:	
Value Percent:	
Continuous Index:	
Within 8" of Joint:	
Remarks:

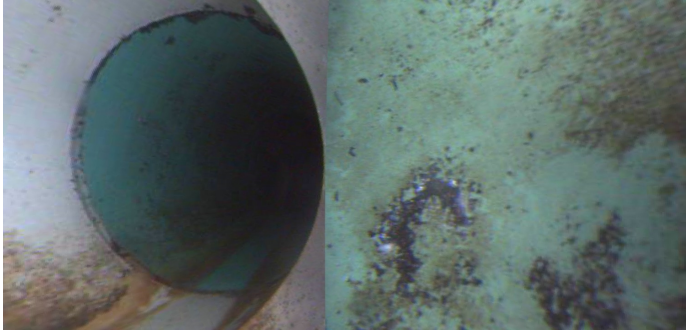
Code: **TF**
Description: **Tap Factory**

Distance (ft): **69.3**
Structural Grade: **0**
O&M Grade: **0**
Clock Start/From: **9**
Clock To:
1st Value: **4.000**
2nd Value:
Value Percent:
Continuous Index:
Within 8" of Joint:
Remarks:

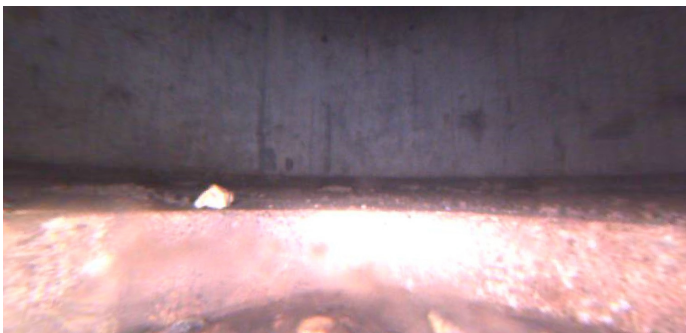
Code: **AMH**
Description: **Manhole**

Distance (ft): **77.2**
Structural Grade: **0**
O&M Grade: **0**
Clock Start/From:
Clock To:
1st Value:
2nd Value:
Value Percent:
Continuous Index:
Within 8" of Joint: **NO**
Remarks: **M-1004-041**
