## Profile/Photo Observation Report

Street:	<b>Ryan Ct.</b>	Flow Control:	<b>Not Controlled</b>
City:	<b>Hobart, IN</b>	Year Renewed:	
Location:	<b>Other</b>	Tape/Media #:	
Purpose:	<b>Not Known</b>	Dia/Height:	<b>8"</b>
Use:	<b>Sanitary</b>	Material:	<b>PVC</b>
Drain Area:	<b>NA</b>	Lining:	
Category:	<b>NA</b>		
Comment:

Location Details:		Direction of Survey:	<b>Upstream</b>
US MH:	<b>M-1004-043</b>	DS MH:	<b>M-1004-042</b>
		Total Length Surveyed (ft):	<b>332.8</b>

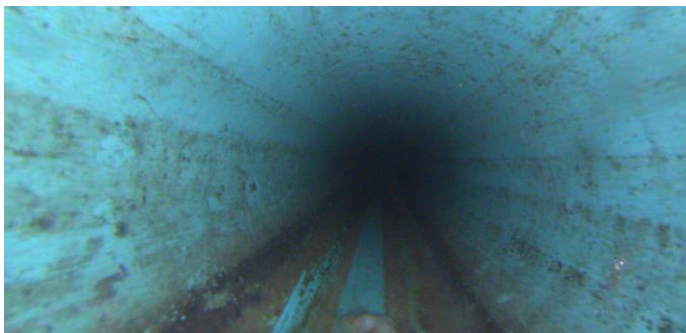
Code: **AMH**  
Description: **Manhole**

Distance (ft): **.0**  
Structural Grade: **0**  
O&M Grade: **0**  
Clock Start/From:  
Clock To:  
1st Value:  
2nd Value:  
Value Percent:  
Continuous Index:  
Within 8" of Joint: **NO**  
Remarks: **M-1004-042**

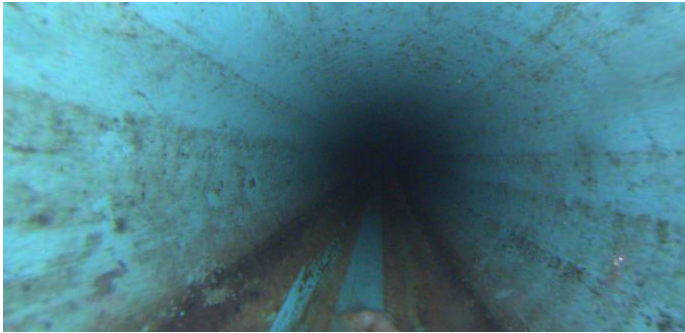
Code:	<b>MWL</b>
Description:	<b>Water Level</b>

Distance (ft):	<b>.0</b>
Structural Grade:	<b>0</b>
O&M Grade:	<b>0</b>
Clock Start/From:	
Clock To:	
1st Value:	
2nd Value:	
Value Percent:	<b>5.000</b>
Continuous Index:	
Within 8" of Joint:	<b>NO</b>
Remarks:

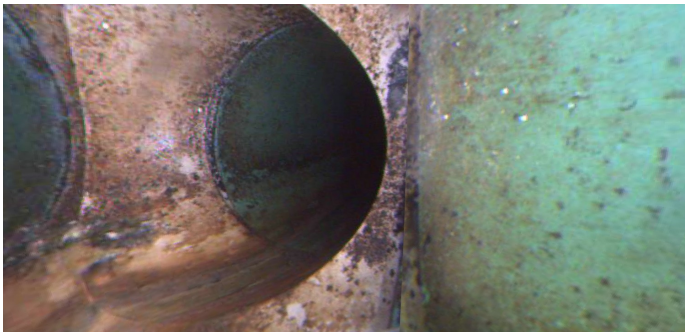
Code:	<b>TF</b>
Description:	<b>Tap Factory</b>

Distance (ft):	<b>10.1</b>
Structural Grade:	<b>0</b>
O&M Grade:	<b>0</b>
Clock Start/From:	<b>3</b>
Clock To:	
1st Value:	<b>4.000</b>
2nd Value:	
Value Percent:	
Continuous Index:	
Within 8" of Joint:	
Remarks:

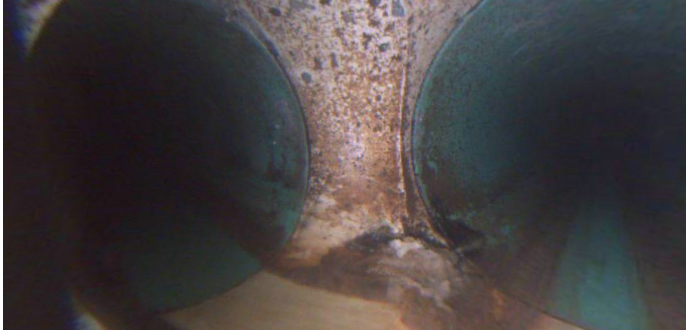
Code: **TFA**  
Description: **Tap Factory Active**

Distance (ft): **31.0**  
Structural Grade: **0**  
O&M Grade: **0**  
Clock Start/From: **9**  
Clock To:  
1st Value: **4.000**  
2nd Value:  
Value Percent:  
Continuous Index:  
Within 8" of Joint:  
Remarks:

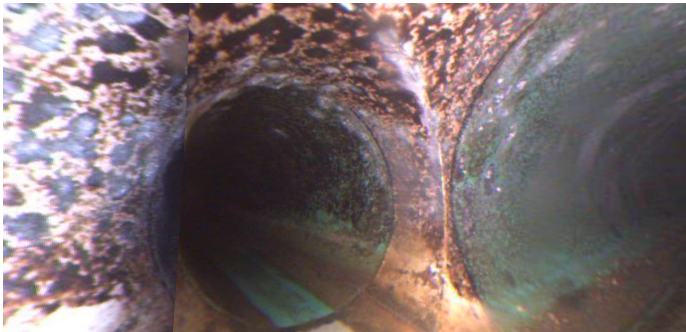
Code: **TFA**  
Description: **Tap Factory Active**

Distance (ft): **70.1**  
Structural Grade: **0**  
O&M Grade: **0**  
Clock Start/From: **3**  
Clock To:  
1st Value: **4.000**  
2nd Value:  
Value Percent:  
Continuous Index:  
Within 8" of Joint:  
Remarks:

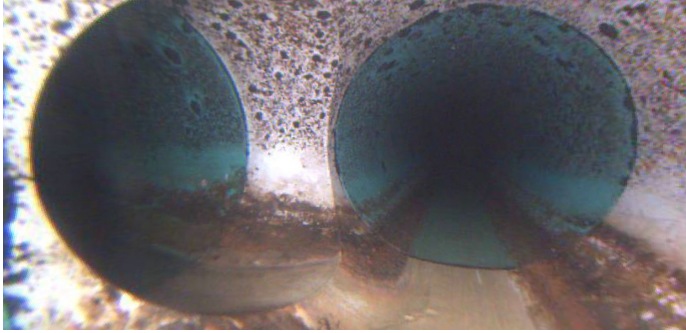
Code: **TFA**  
Description: **Tap Factory Active**

Distance (ft): **95.5**  
Structural Grade: **0**  
O&M Grade: **0**  
Clock Start/From: **9**  
Clock To:  
1st Value: **4.000**  
2nd Value:  
Value Percent:  
Continuous Index:  
Within 8" of Joint:  
Remarks:

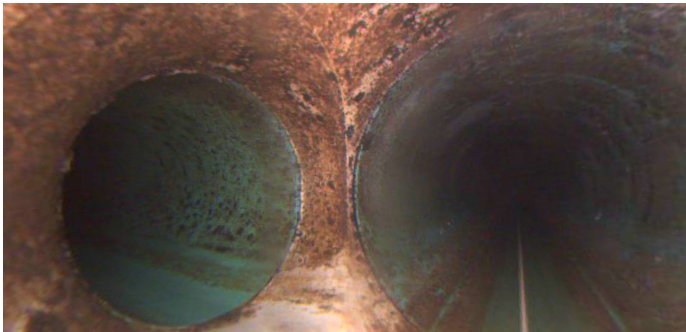
Code: **TF**  
Description: **Tap Factory**

Distance (ft): **151.2**  
Structural Grade: **0**  
O&M Grade: **0**  
Clock Start/From: **3**  
Clock To:  
1st Value: **4.000**  
2nd Value:  
Value Percent:  
Continuous Index:  
Within 8" of Joint:  
Remarks:

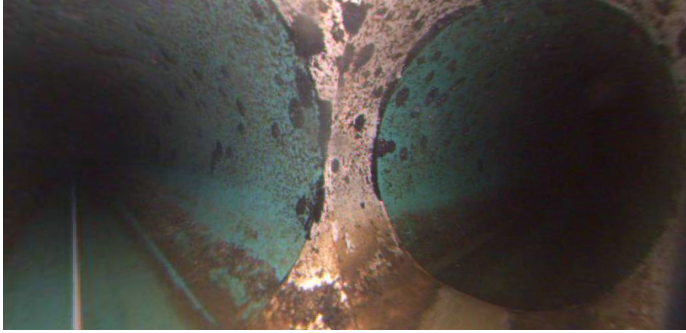
Code: **TF**  
Description: **Tap Factory**

Distance (ft): **169.9**  
Structural Grade: **0**  
O&M Grade: **0**  
Clock Start/From: **9**  
Clock To:  
1st Value: **4.000**  
2nd Value:  
Value Percent:  
Continuous Index:  
Within 8" of Joint:  
Remarks:

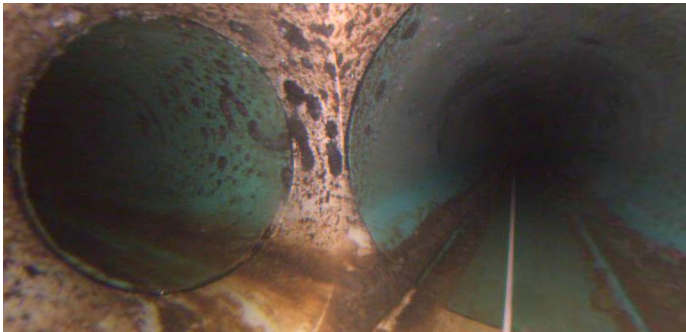
Code: **TF**  
Description: **Tap Factory**

Distance (ft): **233.5**  
Structural Grade: **0**  
O&M Grade: **0**  
Clock Start/From: **3**  
Clock To:  
1st Value: **4.000**  
2nd Value:  
Value Percent:  
Continuous Index:  
Within 8" of Joint:  
Remarks:

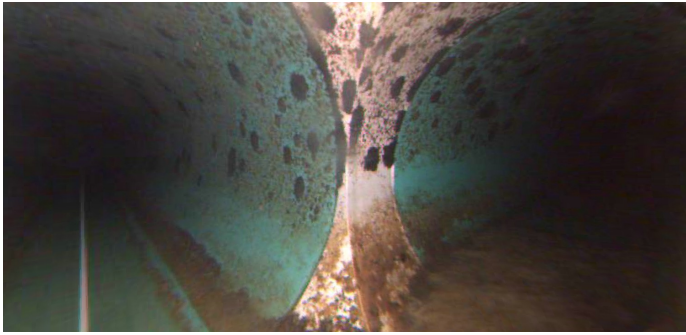
Code: **TF**  
Description: **Tap Factory**

Distance (ft): **241.6**  
Structural Grade: **0**  
O&M Grade: **0**  
Clock Start/From: **9**  
Clock To:  
1st Value: **4.000**  
2nd Value:  
Value Percent:  
Continuous Index:  
Within 8" of Joint:  
Remarks:

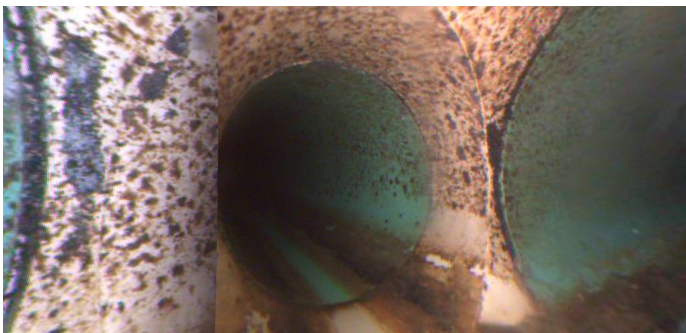
Code: **TF**  
Description: **Tap Factory**

Distance (ft): **291.9**  
Structural Grade: **0**  
O&M Grade: **0**  
Clock Start/From: **3**  
Clock To:  
1st Value: **4.000**  
2nd Value:  
Value Percent:  
Continuous Index:  
Within 8" of Joint:  
Remarks:

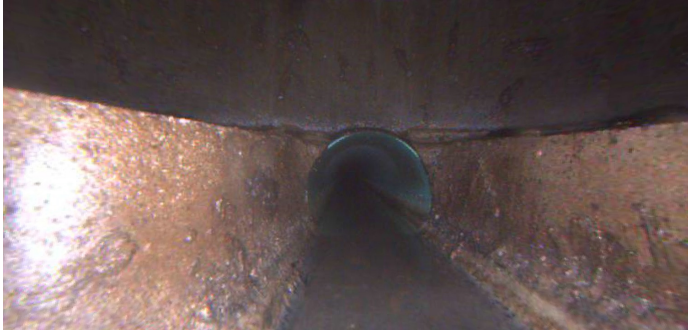
Code:	AMH
Description:	Manhole
Distance (ft):	332.8
Structural Grade:	0
O&M Grade:	0
Clock Start/From:	
Clock To:	
1st Value:	
2nd Value:	
Value Percent:	
Continuous Index:	
Within 8" of Joint:	NO
Remarks:	M-1004-043
