Profile/Photo Observation Report

| Street: | RYAN CT | Flow Control: | Not Controlled |

| US MH: | M-1004-043 | DS MH: | M-1004-044 |

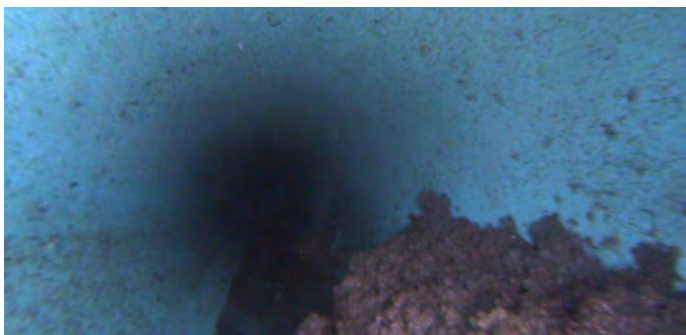
Code: **AMH**
Description: **Manhole**

Distance (ft): **.0**
Structural Grade: **0**
O&M Grade: **0**
Clock Start/From:
Clock To:
1st Value:
2nd Value:
Value Percent:
Continuous Index:
Within 8" of Joint: **NO**
Remarks: **M-1004-044**

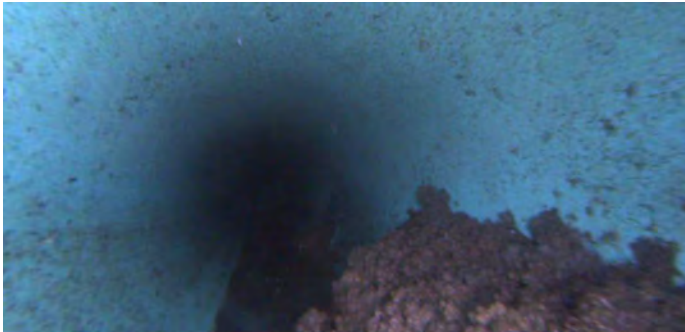
| Code: | MWL |
| Description: | Water Level |

| Value Percent: | 5.000 |

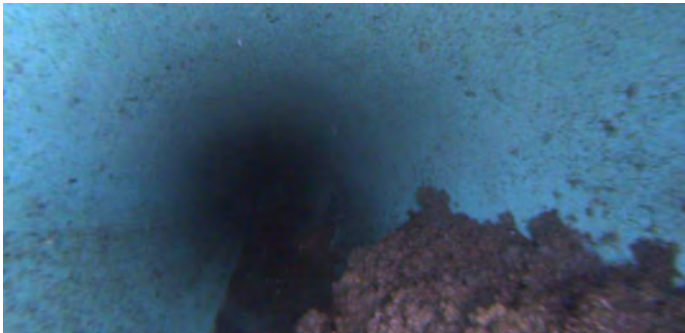
| Code: | DAZ |
| Description: | Deposits Attached Other |

| O&M Grade: | 2 |
| Clock Start/From: | 3 |
| Clock To: | 5 |
| Value Percent: | 10.000 |

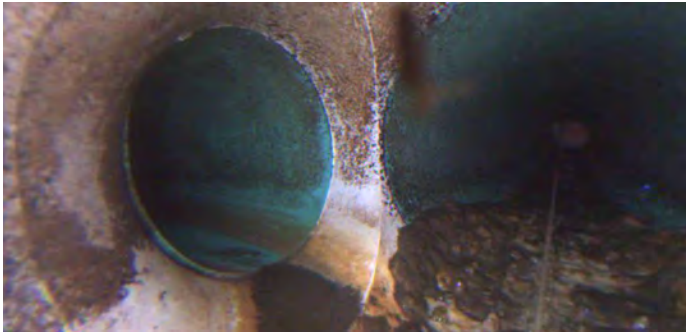
Code: **TF**
Description: **Tap Factory**

Distance (ft): **7.2**
Structural Grade: **0**
O&M Grade: **0**
Clock Start/From: **3**
Clock To:
1st Value: **4.000**
2nd Value:
Value Percent:
Continuous Index:
Within 8" of Joint:
Remarks:

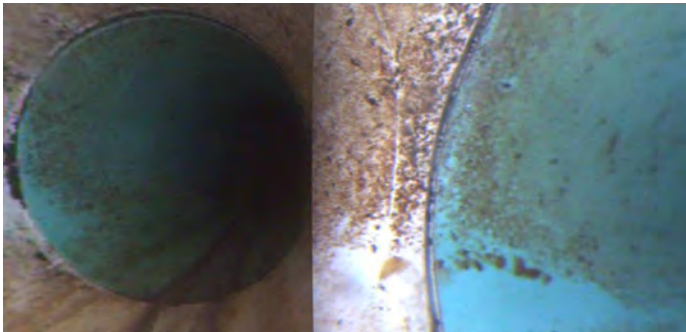
Code: **TF**
Description: **Tap Factory**

Distance (ft): **47.6**
Structural Grade: **0**
O&M Grade: **0**
Clock Start/From: **9**
Clock To:
1st Value: **4.000**
2nd Value:
Value Percent:
Continuous Index:
Within 8" of Joint:
Remarks:

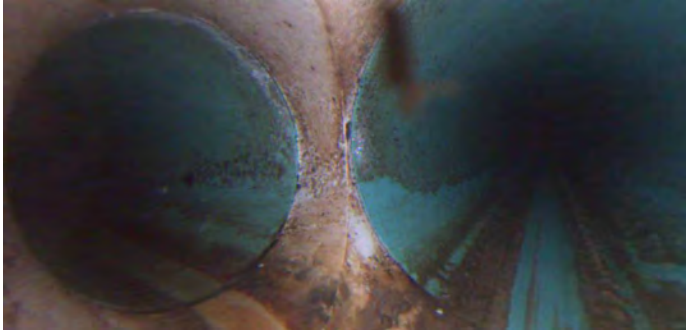
Code: **TF**
Description: **Tap Factory**

Distance (ft): **60.2**
Structural Grade: **0**
O&M Grade: **0**
Clock Start/From: **3**
Clock To:
1st Value: **4.000**
2nd Value:
Value Percent:
Continuous Index:
Within 8" of Joint:
Remarks:

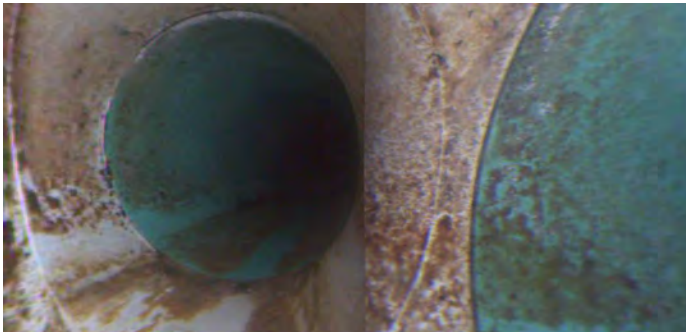
Code: **TF**
Description: **Tap Factory**

Distance (ft): **63.7**
Structural Grade: **0**
O&M Grade: **0**
Clock Start/From: **9**
Clock To:
1st Value: **4.000**
2nd Value:
Value Percent:
Continuous Index:
Within 8" of Joint:
Remarks:

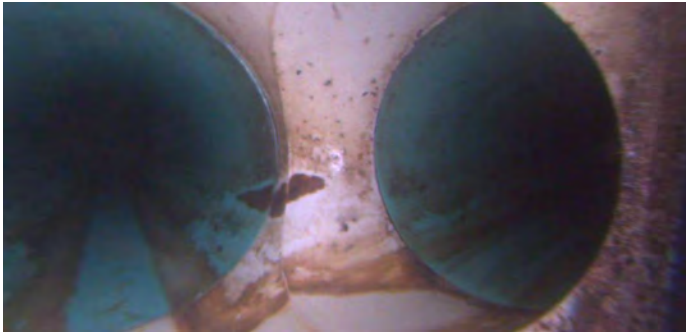
Code: **TF**
Description: **Tap Factory**

Distance (ft): **76.4**
Structural Grade: **0**
O&M Grade: **0**
Clock Start/From: **3**
Clock To:
1st Value: **4.000**
2nd Value:
Value Percent:
Continuous Index:
Within 8" of Joint:
Remarks:

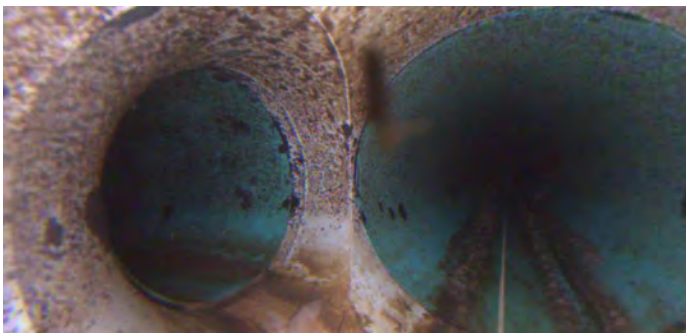
Code: **TF**
Description: **Tap Factory**

Distance (ft): **140.9**
Structural Grade: **0**
O&M Grade: **0**
Clock Start/From: **3**
Clock To:
1st Value: **4.000**
2nd Value:
Value Percent:
Continuous Index:
Within 8" of Joint:
Remarks:

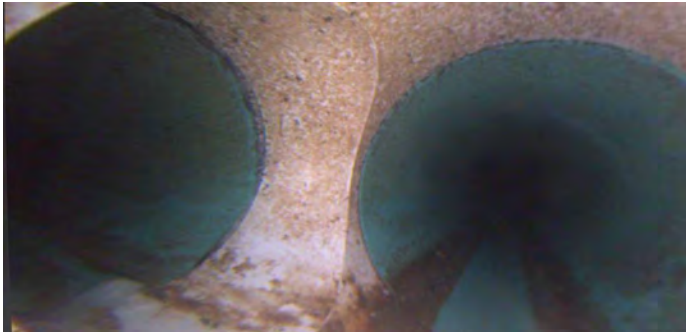
Code: **TF**
Description: **Tap Factory**

Distance (ft): **153.4**
Structural Grade: **0**
O&M Grade: **0**
Clock Start/From: **9**
Clock To:
1st Value: **4.000**
2nd Value:
Value Percent:
Continuous Index:
Within 8" of Joint:
Remarks:

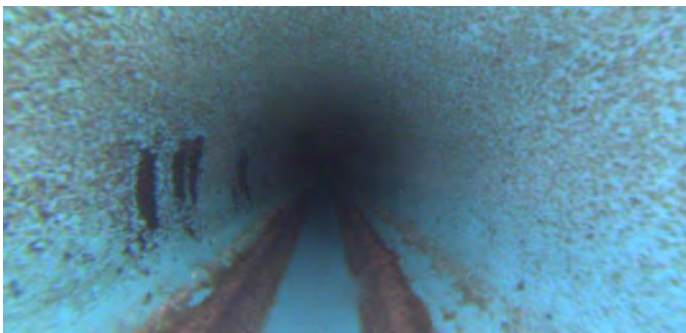
Code: **DAGS**
Description: **Deposits Attached Grease**

Distance (ft): **207.6**
Structural Grade: **0**
O&M Grade: **2**
Clock Start/From: **5**
Clock To: **7**
1st Value:
2nd Value:
Value Percent: **5.000**
Continuous Index: **S01**
Within 8" of Joint: **NO**
Remarks:

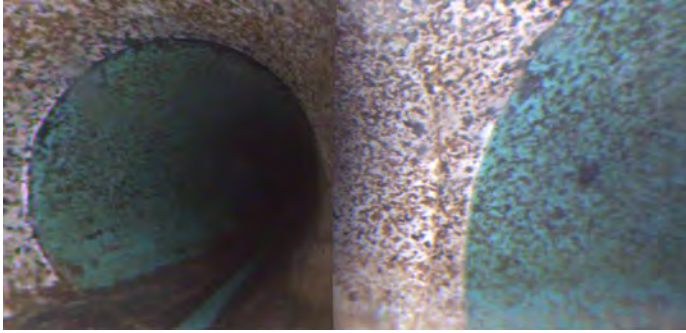
Code: **TF**
Description: **Tap Factory**

Distance (ft): **217.6**
Structural Grade: **0**
O&M Grade: **0**
Clock Start/From: **9**
Clock To:
1st Value: **4.000**
2nd Value:
Value Percent:
Continuous Index:
Within 8" of Joint:
Remarks:

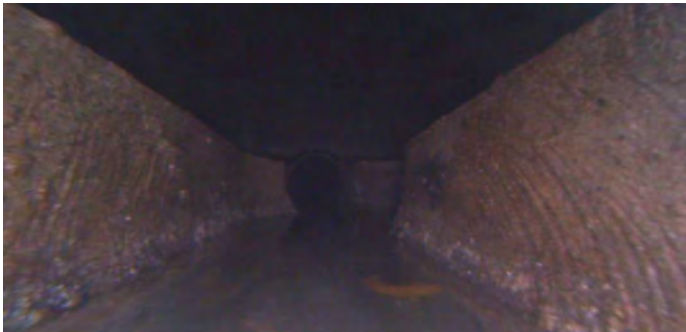
Code: **DAGS**
Description: **Deposits Attached Grease**

Distance (ft): **236.8**
Structural Grade: **0**
O&M Grade: **2**
Clock Start/From: **5**
Clock To: **7**
1st Value:
2nd Value:
Value Percent: **5.000**
Continuous Index: **F01**
Within 8" of Joint: **NO**
Remarks:

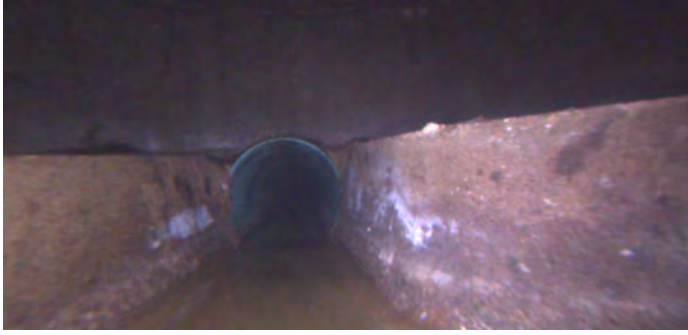
| Code: | AMH |
| Description: | Manhole |
| Distance (ft): | 238.3 |
| Remarks: | M-1004-043 |
