Profile/Photo Observation Report

Street:	McAfee Dr.	Flow Control:	Not Controlled
City:	Hobart, IN	Year Renewed:	
Location:	Other	Tape/Media #:	
Purpose:	Not Known	Dia/Height:	8"
Use:	Sanitary	Material:	PVC
Drain Area:	NA	Lining:	
Category:	NA		
Comment:

Location Details:		Direction of Survey:	Upstream
US MH:	M-1004-043	DS MH:	M-1004-044
		Total Length Surveyed (ft):	238.3

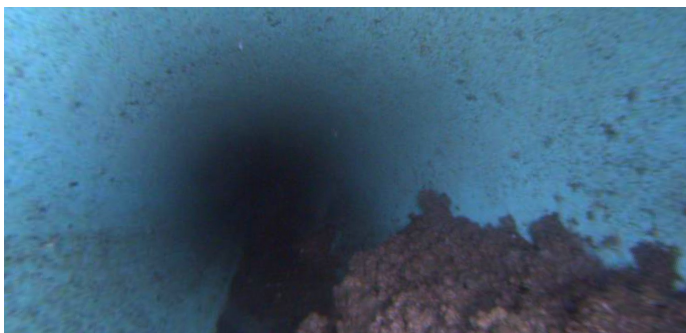
Code: **AMH**
Description: **Manhole**

Distance (ft): **.0**
Structural Grade: **0**
O&M Grade: **0**
Clock Start/From:
Clock To:
1st Value:
2nd Value:
Value Percent:
Continuous Index:
Within 8" of Joint: **NO**
Remarks: **M-1004-044**

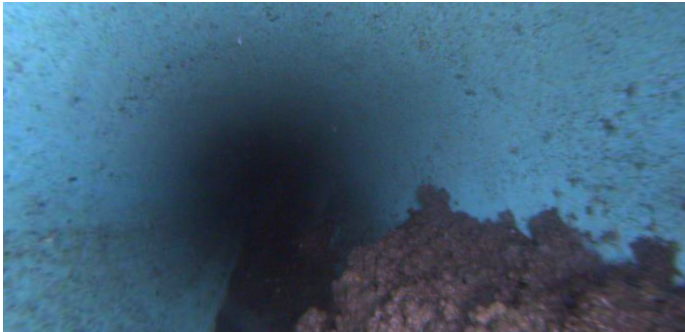
Code:	MWL
Description:	Water Level

Distance (ft):	.0
Structural Grade:	0
O&M Grade:	0
Clock Start/From:	
Clock To:	
1st Value:	
2nd Value:	
Value Percent:	5.000
Continuous Index:	
Within 8" of Joint:	NO
Remarks:

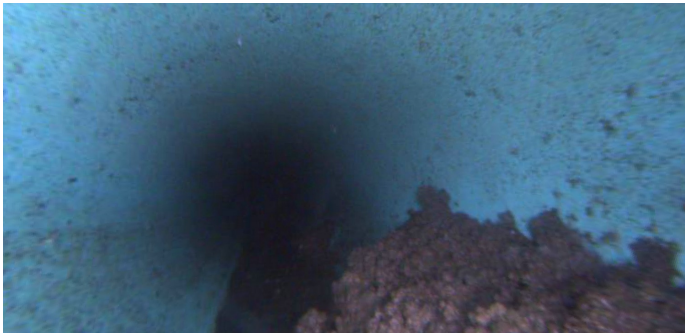
Code:	DAZ
Description:	Deposits Attached Other

Distance (ft):	.0
Structural Grade:	0
O&M Grade:	2
Clock Start/From:	3
Clock To:	5
1st Value:	
2nd Value:	
Value Percent:	10.000
Continuous Index:	
Within 8" of Joint:	NO
Remarks:

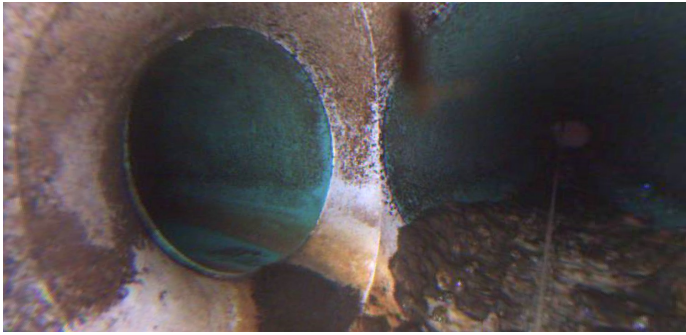
Code: **TF**
Description: **Tap Factory**

Distance (ft): **7.2**
Structural Grade: **0**
O&M Grade: **0**
Clock Start/From: **3**
Clock To:
1st Value: **4.000**
2nd Value:
Value Percent:
Continuous Index:
Within 8" of Joint:
Remarks:

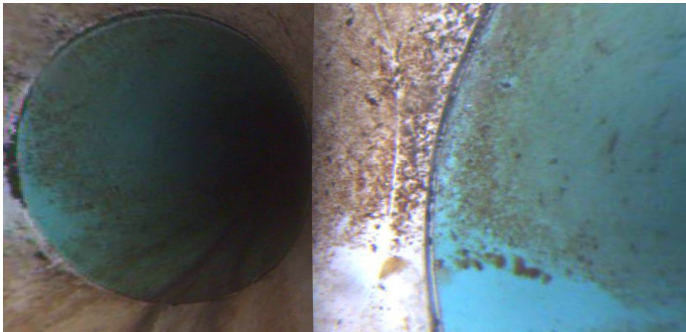
Code: **TF**
Description: **Tap Factory**

Distance (ft): **47.6**
Structural Grade: **0**
O&M Grade: **0**
Clock Start/From: **9**
Clock To:
1st Value: **4.000**
2nd Value:
Value Percent:
Continuous Index:
Within 8" of Joint:
Remarks:

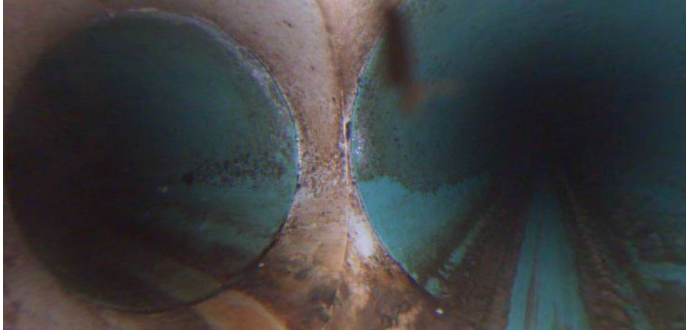
Code: **TF**
Description: **Tap Factory**

Distance (ft): **60.2**
Structural Grade: **0**
O&M Grade: **0**
Clock Start/From: **3**
Clock To:
1st Value: **4.000**
2nd Value:
Value Percent:
Continuous Index:
Within 8" of Joint:
Remarks:

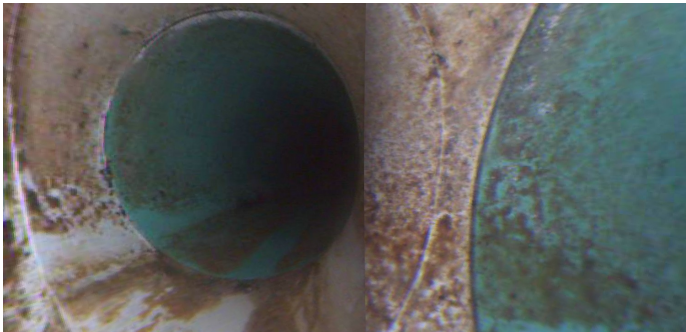
Code: **TF**
Description: **Tap Factory**

Distance (ft): **63.7**
Structural Grade: **0**
O&M Grade: **0**
Clock Start/From: **9**
Clock To:
1st Value: **4.000**
2nd Value:
Value Percent:
Continuous Index:
Within 8" of Joint:
Remarks:

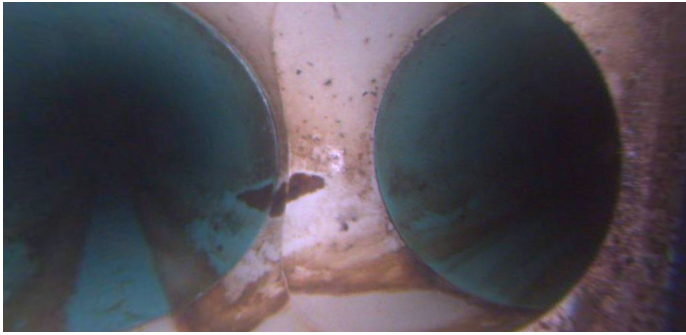
Code: **TF**
Description: **Tap Factory**

Distance (ft): **76.4**
Structural Grade: **0**
O&M Grade: **0**
Clock Start/From: **3**
Clock To:
1st Value: **4.000**
2nd Value:
Value Percent:
Continuous Index:
Within 8" of Joint:
Remarks:

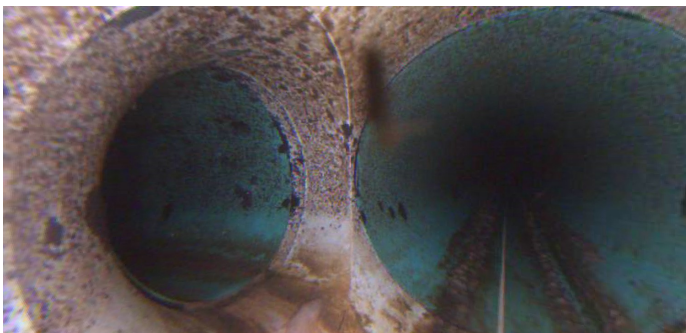
Code: **TF**
Description: **Tap Factory**

Distance (ft): **140.9**
Structural Grade: **0**
O&M Grade: **0**
Clock Start/From: **3**
Clock To:
1st Value: **4.000**
2nd Value:
Value Percent:
Continuous Index:
Within 8" of Joint:
Remarks:

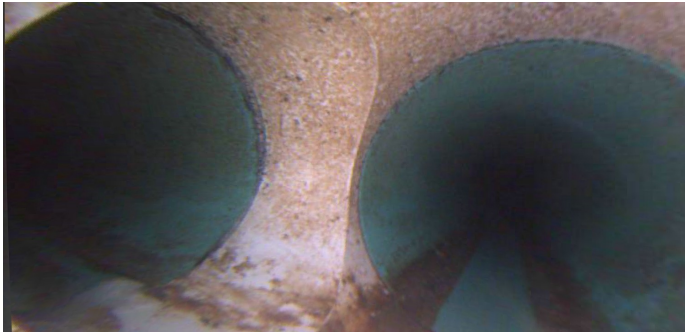
Code: **TF**
Description: **Tap Factory**

Distance (ft): **153.4**
Structural Grade: **0**
O&M Grade: **0**
Clock Start/From: **9**
Clock To:
1st Value: **4.000**
2nd Value:
Value Percent:
Continuous Index:
Within 8" of Joint:
Remarks:

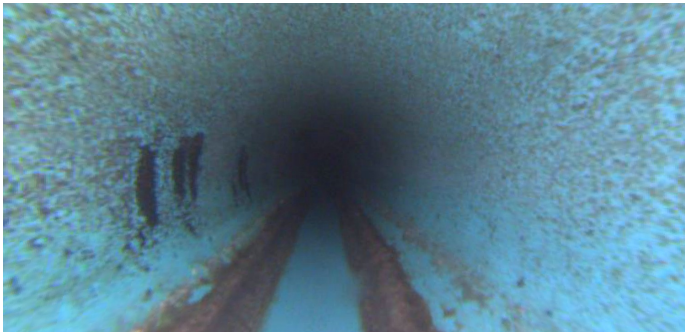
Code: **DAGS**
Description: **Deposits Attached Grease**

Distance (ft): **207.6**
Structural Grade: **0**
O&M Grade: **2**
Clock Start/From: **5**
Clock To: **7**
1st Value:
2nd Value:
Value Percent: **5.000**
Continuous Index: **S01**
Within 8" of Joint: **NO**
Remarks:

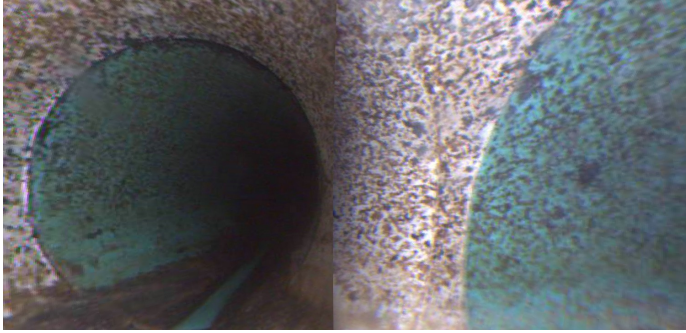
Code: **TF**
Description: **Tap Factory**

Distance (ft): **217.6**
Structural Grade: **0**
O&M Grade: **0**
Clock Start/From: **9**
Clock To:
1st Value: **4.000**
2nd Value:
Value Percent:
Continuous Index:
Within 8" of Joint:
Remarks:

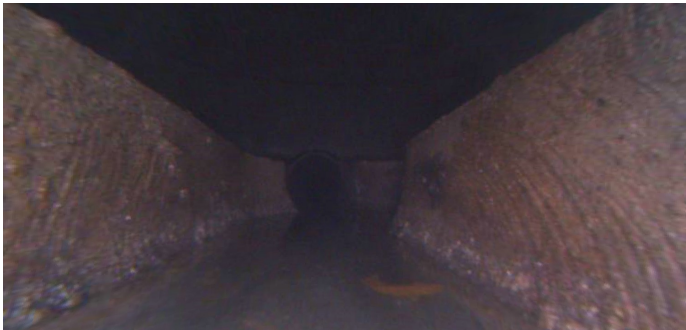
Code: **DAGS**
Description: **Deposits Attached Grease**

Distance (ft): **236.8**
Structural Grade: **0**
O&M Grade: **2**
Clock Start/From: **5**
Clock To: **7**
1st Value:
2nd Value:
Value Percent: **5.000**
Continuous Index: **F01**
Within 8" of Joint: **NO**
Remarks:

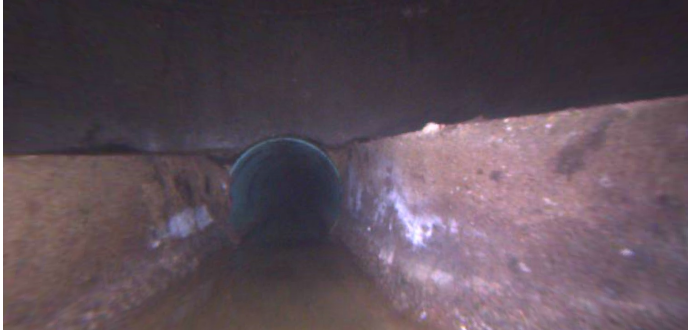
Code:	AMH
Description:	Manhole
Distance (ft):	238.3
Structural Grade:	0
O&M Grade:	0
Clock Start/From:	
Clock To:	
1st Value:	
2nd Value:	
Value Percent:	
Continuous Index:	
Within 8" of Joint:	NO
Remarks:	M-1004-043
