Profile/Photo Observation Report

Street:	Ryan Court	Flow Control:	Not Controlled
City:	Hobart, IN	Year Renewed:	
Location:	Yard	Tape/Media #:	
Purpose:	Routine Assessment	Dia/Height:	8"
Use:	Sanitary Sewage Pipe	Material:	PVC
Drain Area:		Lining:	None
Category:	NA		
Comment:			
Location Details:		Direction of Survey:	Upstream
US MH:	M-1004-045	DS MH:	M-1004-043
		Total Length Surveyed (ft):	165.3

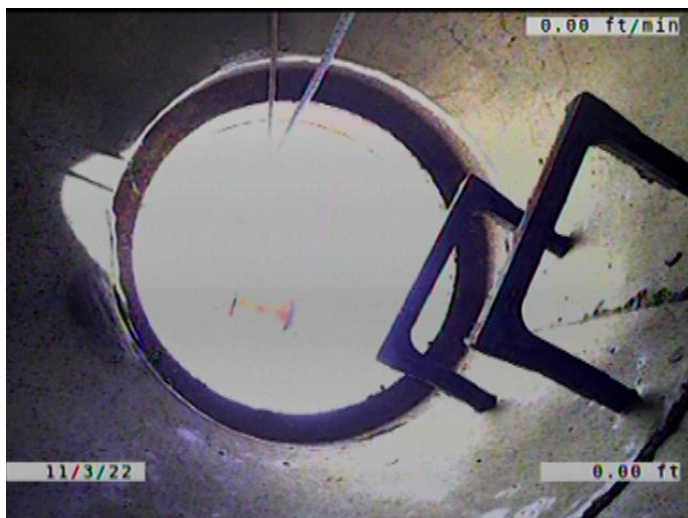
Code: **AMH**
Description: **Manhole**

Distance (ft): **.0**
Structural Grade: **0**
O&M Grade: **0**
Clock Start/From:
Clock To:
1st Value:
2nd Value:
Value Percent:
Continuous Index:
Within 8" of Joint: **NO**
Remarks: **M-1004-043**

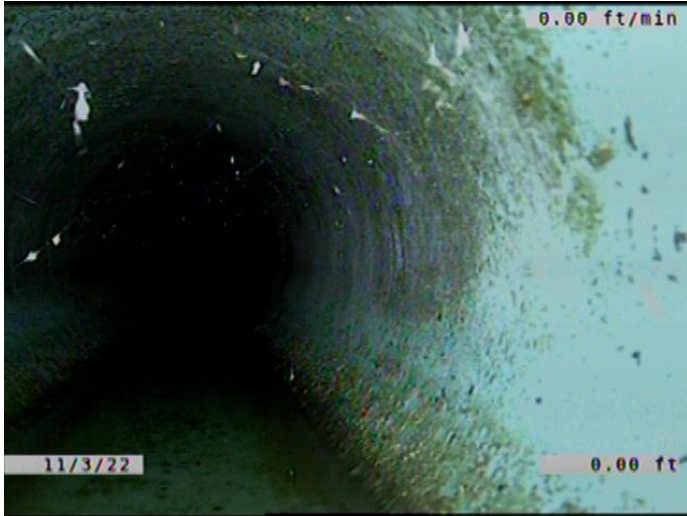
Code: **MWL**
Description: **Miscellaneous Water Level**

Distance (ft): **.0**
Structural Grade: **0**
O&M Grade: **0**
Clock Start/From:
Clock To:
1st Value:
2nd Value:
Value Percent: **5.000**
Continuous Index:
Within 8" of Joint: **NO**
Remarks:

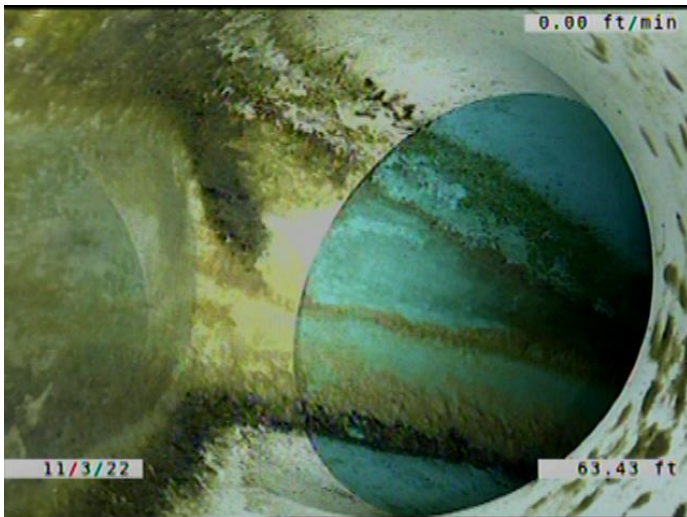
Code: **TF**
Description: **Tap Factory**

Distance (ft): **63.4**
Structural Grade: **0**
O&M Grade: **0**
Clock Start/From: **9**
Clock To:
1st Value: **4.000**
2nd Value:
Value Percent:
Continuous Index:
Within 8" of Joint: **YES**
Remarks:

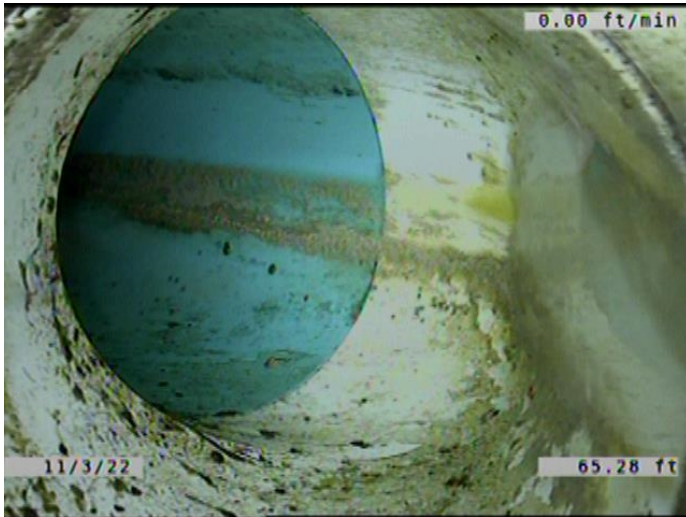
Code: **TFA**
 Description: **Tap Factory Activity**

Distance (ft): **65.3**
 Structural Grade: **0**
 O&M Grade: **0**
 Clock Start/From: **3**
 Clock To:
 1st Value: **4.000**
 2nd Value:
 Value Percent:
 Continuous Index:
 Within 8" of Joint: **YES**
 Remarks:

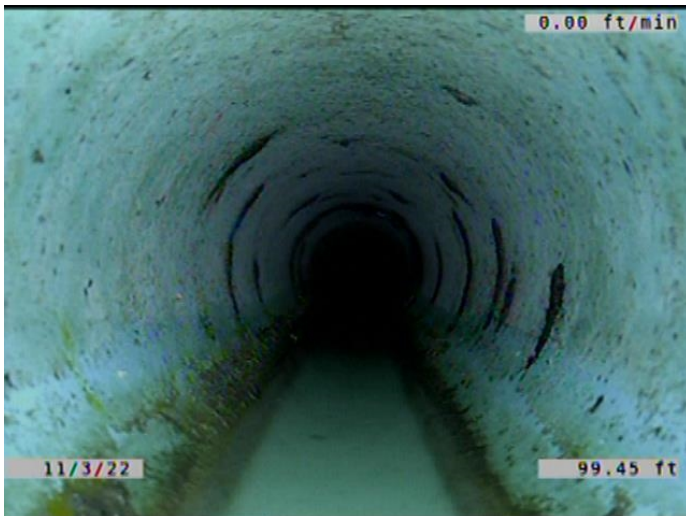
Code: **MWLS**
 Description: **Miscellaneous Water Level Sag**

Distance (ft): **99.4**
 Structural Grade: **2**
 O&M Grade: **0**
 Clock Start/From:
 Clock To:
 1st Value:
 2nd Value:
 Value Percent: **5.000**
 Continuous Index: **S01**
 Within 8" of Joint: **NO**
 Remarks:

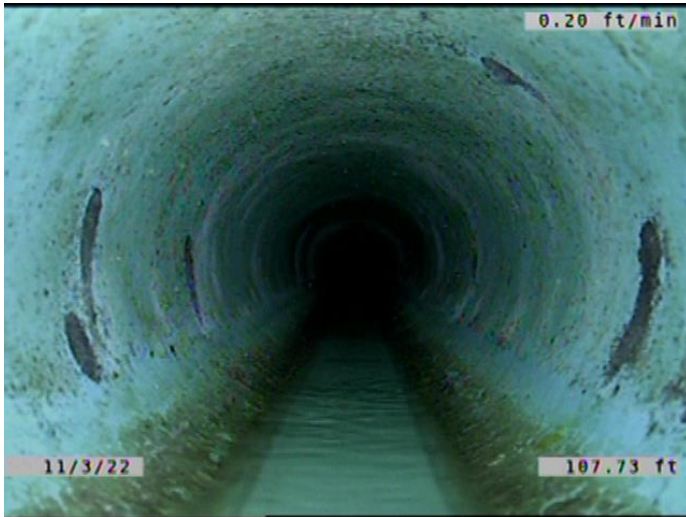
Code: **MWLS**
Description: **Miscellaneous Water Level Sag**

Distance (ft): **107.7**
Structural Grade: **2**
O&M Grade: **0**
Clock Start/From:
Clock To:
1st Value:
2nd Value:
Value Percent: **5.000**
Continuous Index: **F01**
Within 8" of Joint: **NO**
Remarks:

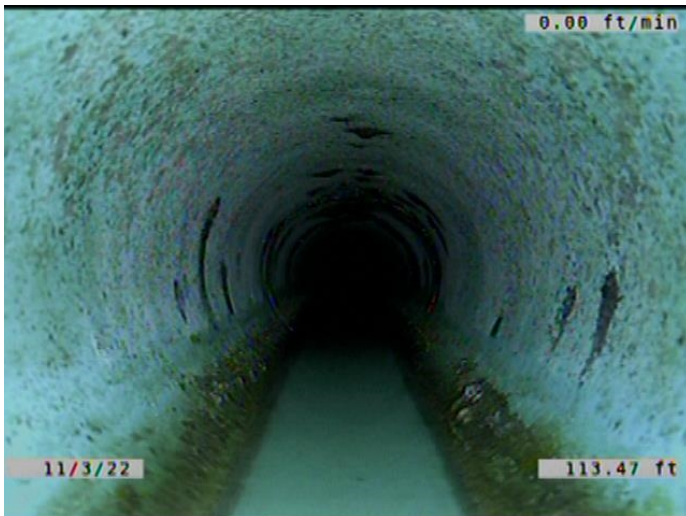
Code: **MWLS**
Description: **Miscellaneous Water Level Sag**

Distance (ft): **113.4**
Structural Grade: **2**
O&M Grade: **0**
Clock Start/From:
Clock To:
1st Value:
2nd Value:
Value Percent: **10.000**
Continuous Index: **S02**
Within 8" of Joint: **NO**
Remarks:

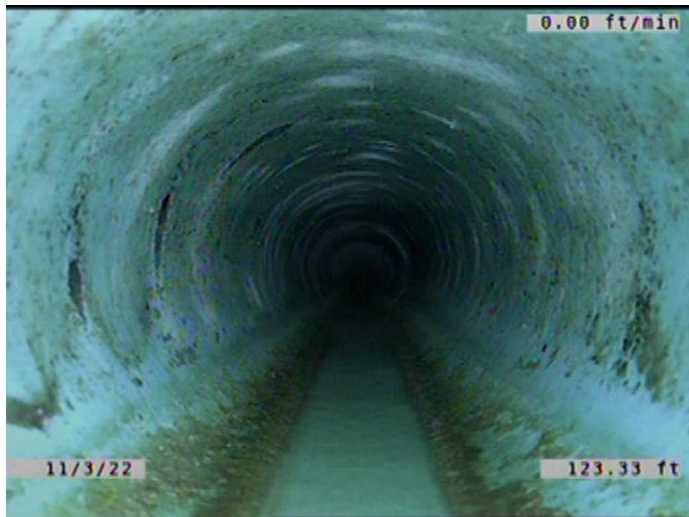
Code: **MWLS**
Description: **Miscellaneous Water Level Sag**

Distance (ft): **123.3**
Structural Grade: **2**
O&M Grade: **0**
Clock Start/From:
Clock To:
1st Value:
2nd Value:
Value Percent: **10.000**
Continuous Index: **F02**
Within 8" of Joint: **NO**
Remarks:

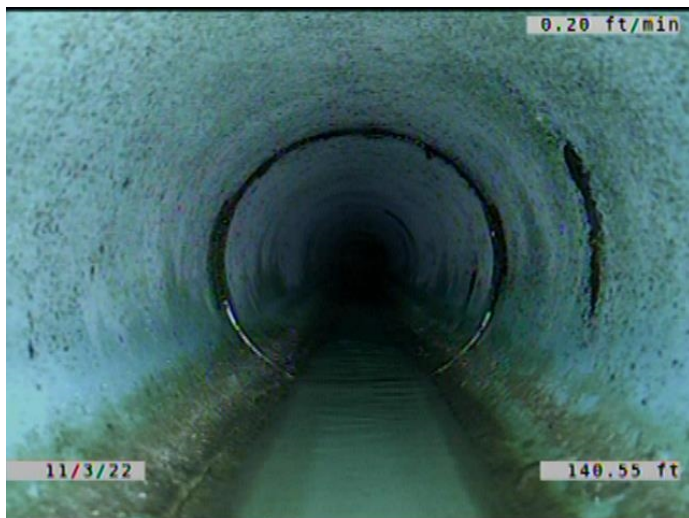
Code: **MWLS**
Description: **Miscellaneous Water Level Sag**

Distance (ft): **140.5**
Structural Grade: **2**
O&M Grade: **0**
Clock Start/From:
Clock To:
1st Value:
2nd Value:
Value Percent: **5.000**
Continuous Index:
Within 8" of Joint: **NO**
Remarks:

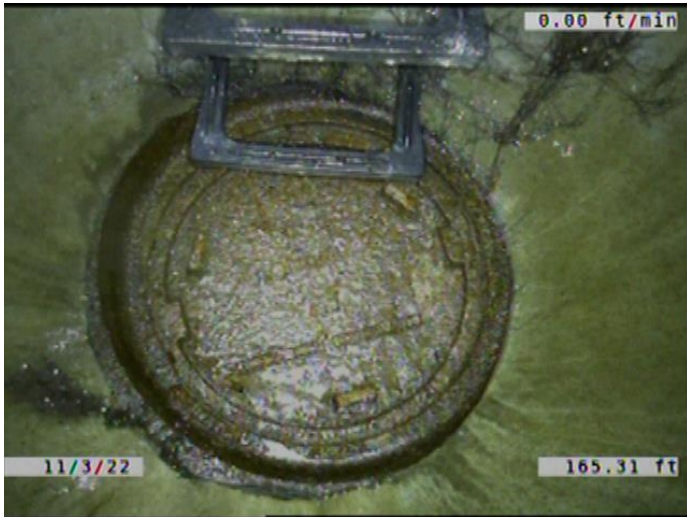
Code:	AMH
Description:	Manhole
Distance (ft):	165.3
Structural Grade:	0
O&M Grade:	0
Clock Start/From:	
Clock To:	
1st Value:	
2nd Value:	
Value Percent:	
Continuous Index:	
Within 8" of Joint:	NO
Remarks:	M-1004-045
