Profile/Photo Observation Report

Date:	11/03/2022	Weather:		Coding:	PACP 7.0
Pipe Length (ft):	133.0	Owner:	City of Hobart	Pre Clean:	No Pre-Cleaning
P.O.#:	YES502259	Surveyor:	S. Bucklin	PSR:	P-1004-046-047
Customer:	City of Hobart, IN (Red	Clean Date:		Shape:	C

Street:	McAfee Drive	Flow Control:	Not Controlled
City:	Hobart, IN	Year Renewed:	
Location:	Easement/Right of Way	Tape/Media #:	
Purpose:	Routine Assessment	Dia/Height:	8"
Use:	Sanitary Sewage Pipe	Material:	PVC
Drain Area:		Lining:	None
Category:	NA		
Comment:

Location Details:		Direction of Survey:	Upstream
US MH:	M-1004-047	DS MH:	M-1004-046
		Total Length Surveyed (ft):	120.3

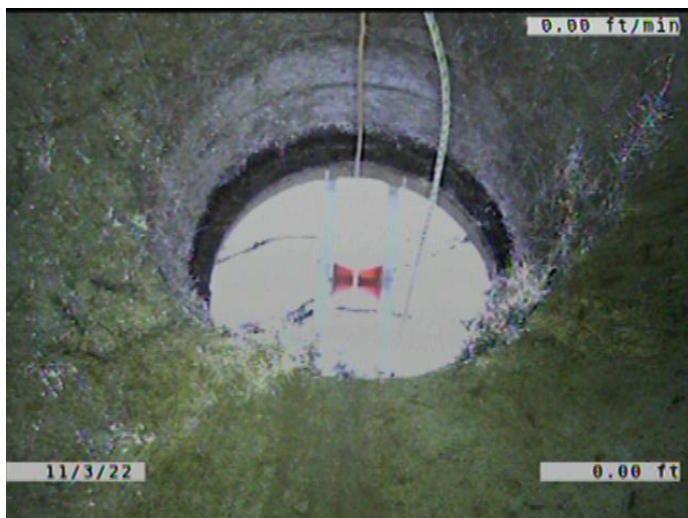
Code: **AMH**
Description: **Manhole**

Distance (ft): **.0**
Structural Grade: **0**
O&M Grade: **0**
Clock Start/From:
Clock To:
1st Value:
2nd Value:
Value Percent:
Continuous Index:
Within 8" of Joint: **NO**
Remarks: **M-1004-046**

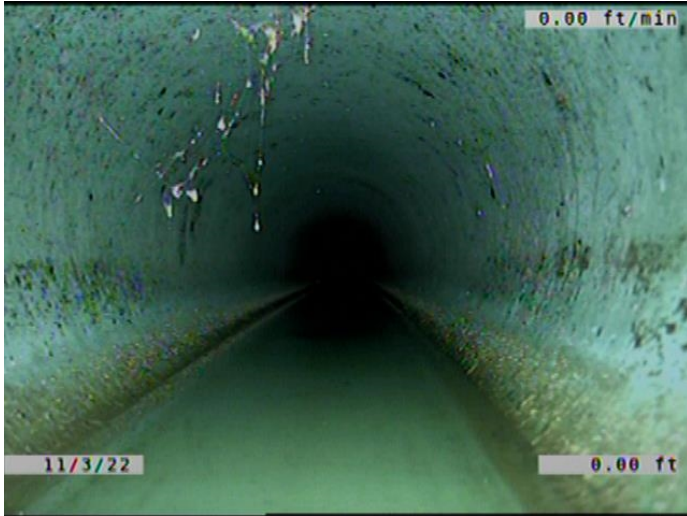
Code: **MWL**
Description: **Miscellaneous Water Level**

Distance (ft): **.0**
Structural Grade: **0**
O&M Grade: **0**
Clock Start/From:
Clock To:
1st Value:
2nd Value:
Value Percent: **10.000**
Continuous Index:
Within 8" of Joint: **NO**
Remarks:

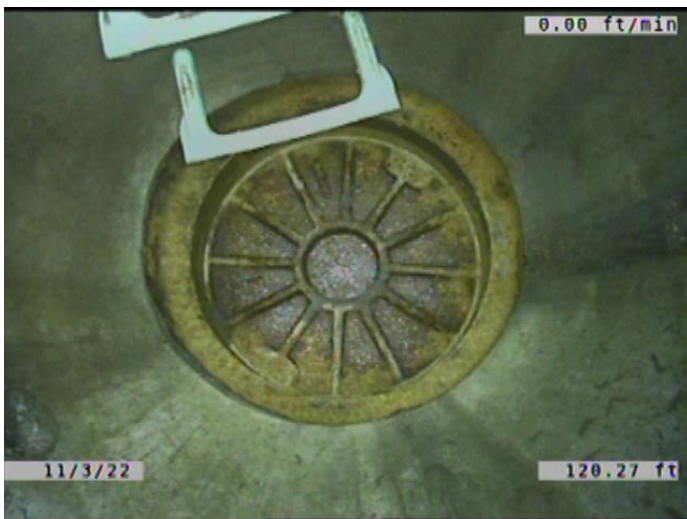
Code: **AMH**
Description: **Manhole**

Distance (ft): **120.3**
Structural Grade: **0**
O&M Grade: **0**
Clock Start/From:
Clock To:
1st Value:
2nd Value:
Value Percent:
Continuous Index:
Within 8" of Joint: **NO**
Remarks: **M-1004-047**
