## Profile/Photo Observation Report

Street:	<b>MCAFEE DR</b>	Flow Control:	<b>Not Controlled</b>
City:	<b>Hobart, IN</b>	Year Renewed:	
Location:	<b>Other</b>	Tape/Media #:	
Purpose:	<b>Not Known</b>	Dia/Height:	<b>10"</b>
Use:	<b>Sanitary</b>	Material:	<b>PVC</b>
Drain Area:	<b>NA</b>	Lining:	
Category:	<b>NA</b>		
Comment:

Location Details:		Direction of Survey:	<b>Upstream</b>
US MH:	<b>M-1004-047</b>	DS MH:	<b>M-1004-048</b>
		Total Length Surveyed (ft):	<b>295.9</b>

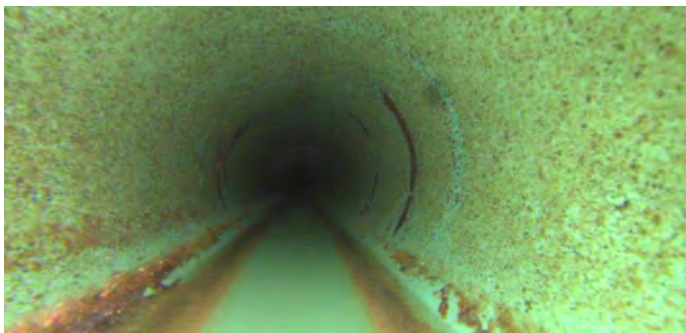
Code: **AMH**  
Description: **Manhole**

Distance (ft): **.0**  
Structural Grade: **0**  
O&M Grade: **0**  
Clock Start/From:  
Clock To:  
1st Value:  
2nd Value:  
Value Percent:  
Continuous Index:  
Within 8" of Joint: **NO**  
Remarks: **M-1004-048**

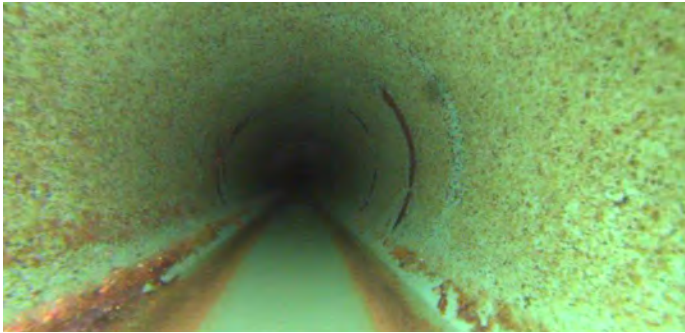
Code:	<b>MWL</b>
Description:	<b>Water Level</b>

Distance (ft):	<b>.0</b>
Structural Grade:	<b>0</b>
O&M Grade:	<b>0</b>
Clock Start/From:	
Clock To:	
1st Value:	
2nd Value:	
Value Percent:	<b>5.000</b>
Continuous Index:	
Within 8" of Joint:	<b>NO</b>
Remarks:

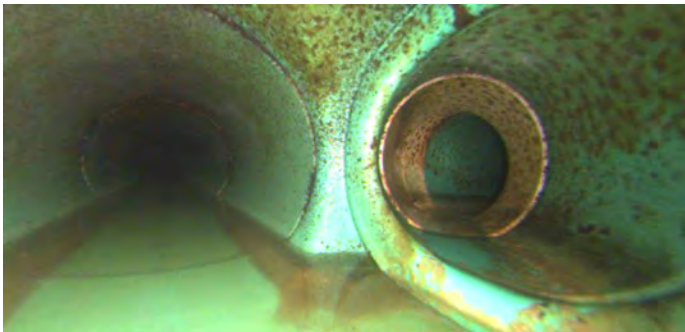
Code:	<b>TFA</b>
Description:	<b>Tap Factory Active</b>

Distance (ft):	<b>49.1</b>
Structural Grade:	<b>0</b>
O&M Grade:	<b>0</b>
Clock Start/From:	<b>3</b>
Clock To:	
1st Value:	<b>4.000</b>
2nd Value:	
Value Percent:	
Continuous Index:	
Within 8" of Joint:	
Remarks:

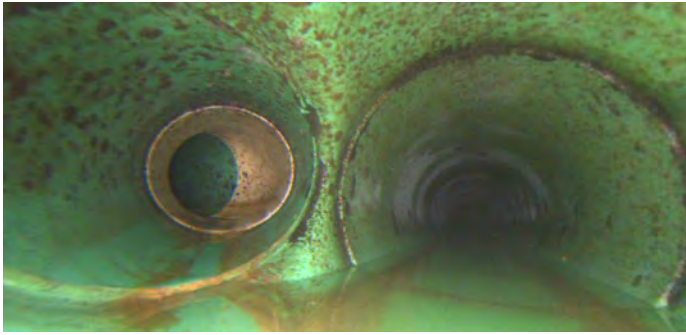
Code: **TF**  
Description: **Tap Factory**

Distance (ft): **93.6**  
Structural Grade: **0**  
O&M Grade: **0**  
Clock Start/From: **9**  
Clock To:  
1st Value: **4.000**  
2nd Value:  
Value Percent:  
Continuous Index:  
Within 8" of Joint:  
Remarks:

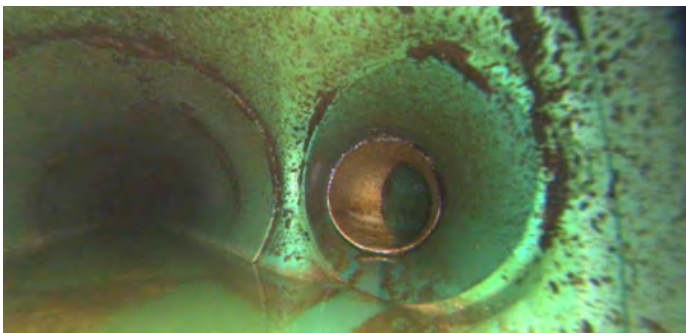
Code: **TFA**  
Description: **Tap Factory Active**

Distance (ft): **118.5**  
Structural Grade: **0**  
O&M Grade: **0**  
Clock Start/From: **3**  
Clock To:  
1st Value: **4.000**  
2nd Value:  
Value Percent:  
Continuous Index:  
Within 8" of Joint:  
Remarks:

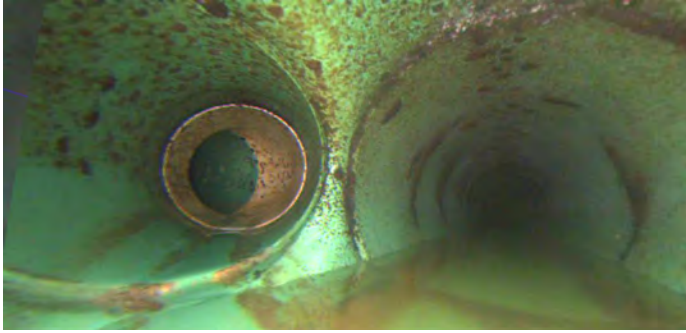
Code: **TF**  
Description: **Tap Factory**

Distance (ft): **168.3**  
Structural Grade: **0**  
O&M Grade: **0**  
Clock Start/From: **9**  
Clock To:  
1st Value: **4.000**  
2nd Value:  
Value Percent:  
Continuous Index:  
Within 8" of Joint:  
Remarks:

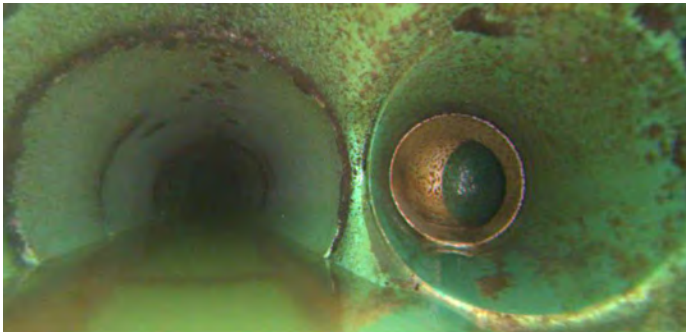
Code: **TF**  
Description: **Tap Factory**

Distance (ft): **187.7**  
Structural Grade: **0**  
O&M Grade: **0**  
Clock Start/From: **3**  
Clock To:  
1st Value: **4.000**  
2nd Value:  
Value Percent:  
Continuous Index:  
Within 8" of Joint:  
Remarks:

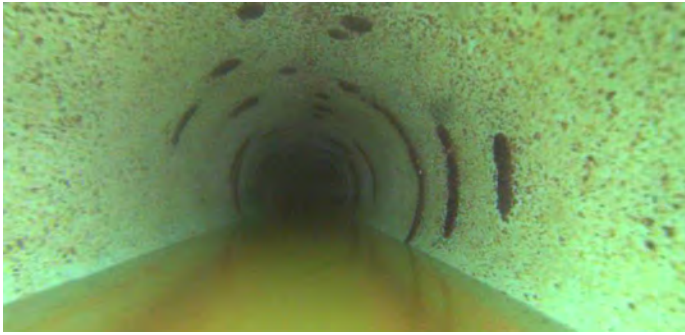
Code: **MWL**  
Description: **Water Level**

Distance (ft): **216.6**  
Structural Grade: **0**  
O&M Grade: **0**  
Clock Start/From:  
Clock To:  
1st Value:  
2nd Value:  
Value Percent: **20.000**  
Continuous Index:  
Within 8" of Joint: **NO**  
Remarks:

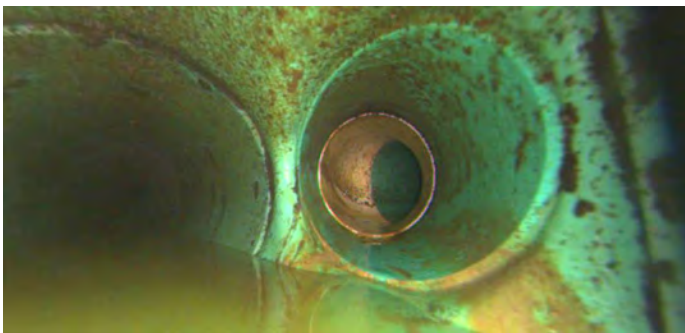
Code: **TF**  
Description: **Tap Factory**

Distance (ft): **257.9**  
Structural Grade: **0**  
O&M Grade: **0**  
Clock Start/From: **3**  
Clock To:  
1st Value: **4.000**  
2nd Value:  
Value Percent:  
Continuous Index:  
Within 8" of Joint:  
Remarks:

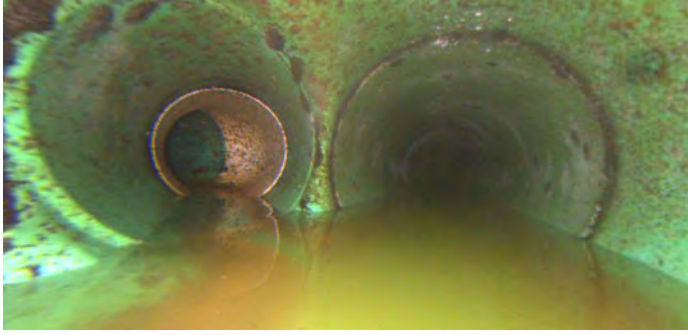
Code: **TFA**  
Description: **Tap Factory Active**

Distance (ft): **266.6**  
Structural Grade: **0**  
O&M Grade: **0**  
Clock Start/From: **9**  
Clock To:  
1st Value: **4.000**  
2nd Value:  
Value Percent:  
Continuous Index:  
Within 8" of Joint:  
Remarks:

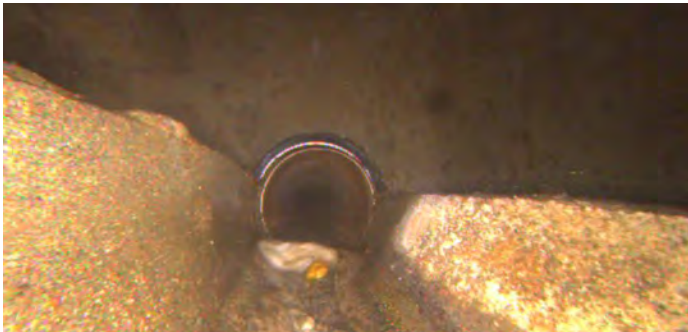
Code: **AMH**  
Description: **Manhole**

Distance (ft): **295.9**  
Structural Grade: **0**  
O&M Grade: **0**  
Clock Start/From:  
Clock To:  
1st Value:  
2nd Value:  
Value Percent:  
Continuous Index:  
Within 8" of Joint: **NO**  
Remarks: **M-1004-047**
