## Profile/Photo Observation Report

Date:	<b>04/12/2018</b>	Weather:		Coding:	<b>PACP 6.0</b>
Pipe Length (ft):	<b>299.6</b>	Owner:	<b>NA</b>	Pre Clean:	<b>Not Known</b>
P.O.#:		Surveyor:	<b>Jen Costello</b>	PSR:	<b>P-1004-047-048</b>
Customer:		Clean Date:	<b>01/01/1900</b>	Shape:	<b>C</b>

Street:	<b>McAfee Dr.</b>	Flow Control:	<b>Not Controlled</b>
City:	<b>Hobart, IN</b>	Year Renewed:	
Location:	<b>Other</b>	Tape/Media #:	
Purpose:	<b>Not Known</b>	Dia/Height:	<b>10"</b>
Use:	<b>Sanitary</b>	Material:	<b>PVC</b>
Drain Area:	<b>NA</b>	Lining:	
Category:	<b>NA</b>		
Comment:

Location Details:		Direction of Survey:	<b>Upstream</b>
US MH:	<b>M-1004-047</b>	DS MH:	<b>M-1004-048</b>
		Total Length Surveyed (ft):	<b>295.9</b>

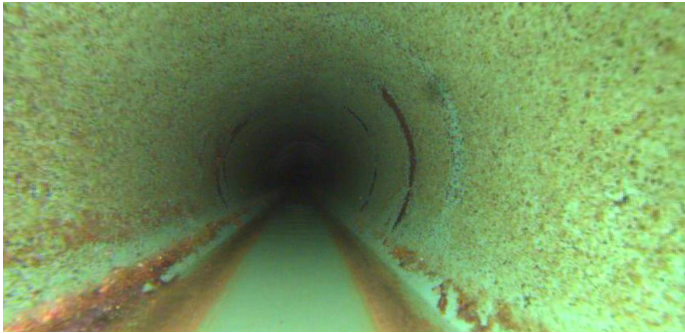
Code:	<b>MWL</b>
Description:	<b>Water Level</b>

Distance (ft):	<b>.0</b>
Structural Grade:	<b>0</b>
O&M Grade:	<b>0</b>
Clock Start/From:	
Clock To:	
1st Value:	
2nd Value:	
Value Percent:	<b>5.000</b>
Continuous Index:	
Within 8" of Joint:	<b>NO</b>
Remarks:

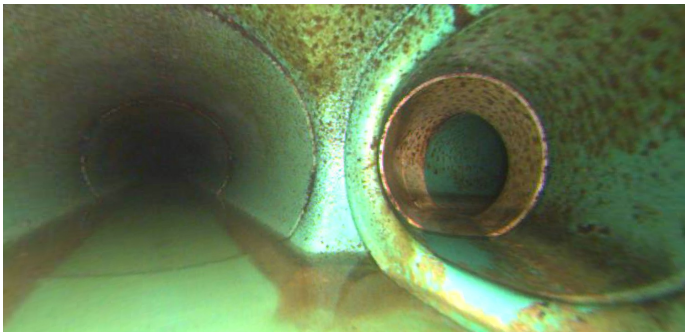
Code:	<b>TFA</b>
Description:	<b>Tap Factory Active</b>

Distance (ft):	<b>49.1</b>
Structural Grade:	<b>0</b>
O&M Grade:	<b>0</b>
Clock Start/From:	<b>3</b>
Clock To:	
1st Value:	<b>4.000</b>
2nd Value:	
Value Percent:	
Continuous Index:	
Within 8" of Joint:	
Remarks:

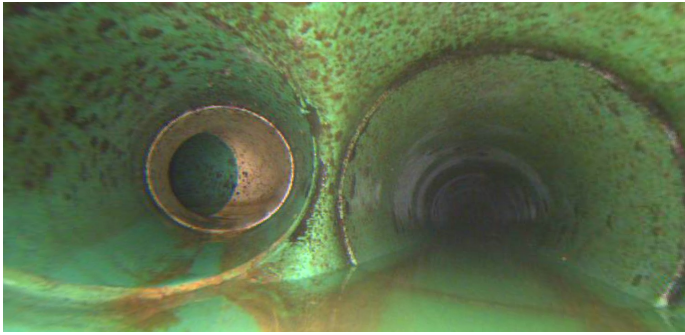
Code: **TF**  
Description: **Tap Factory**

Distance (ft): **93.6**  
Structural Grade: **0**  
O&M Grade: **0**  
Clock Start/From: **9**  
Clock To:  
1st Value: **4.000**  
2nd Value:  
Value Percent:  
Continuous Index:  
Within 8" of Joint:  
Remarks:

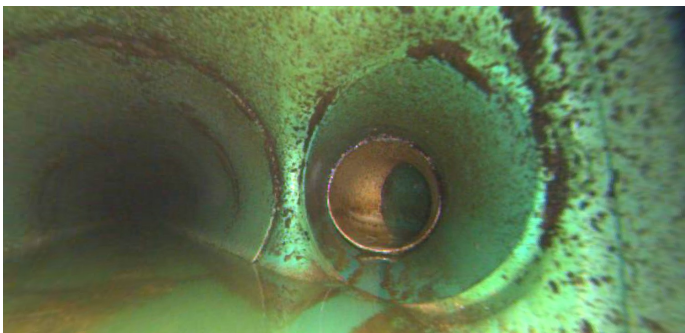
Code: **TFA**  
Description: **Tap Factory Active**

Distance (ft): **118.5**  
Structural Grade: **0**  
O&M Grade: **0**  
Clock Start/From: **3**  
Clock To:  
1st Value: **4.000**  
2nd Value:  
Value Percent:  
Continuous Index:  
Within 8" of Joint:  
Remarks:

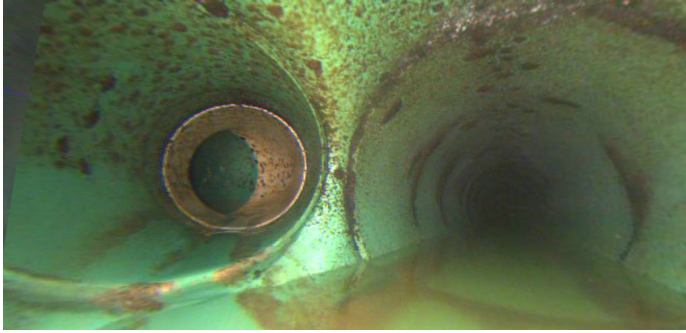
Code: **TF**  
Description: **Tap Factory**

Distance (ft): **168.3**  
Structural Grade: **0**  
O&M Grade: **0**  
Clock Start/From: **9**  
Clock To:  
1st Value: **4.000**  
2nd Value:  
Value Percent:  
Continuous Index:  
Within 8" of Joint:  
Remarks:

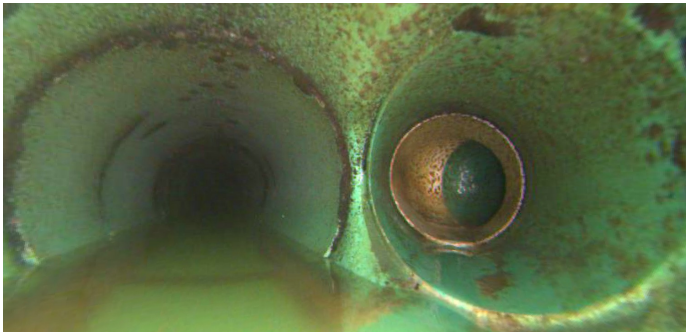
Code: **TF**  
Description: **Tap Factory**

Distance (ft): **187.7**  
Structural Grade: **0**  
O&M Grade: **0**  
Clock Start/From: **3**  
Clock To:  
1st Value: **4.000**  
2nd Value:  
Value Percent:  
Continuous Index:  
Within 8" of Joint:  
Remarks:

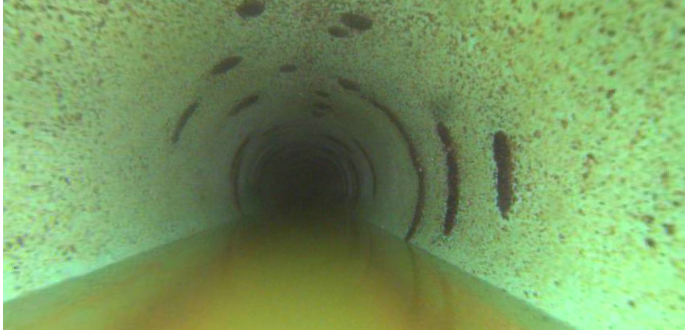
Code: **MWL**  
Description: **Water Level**

Distance (ft): **216.6**  
Structural Grade: **0**  
O&M Grade: **0**  
Clock Start/From:  
Clock To:  
1st Value:  
2nd Value:  
Value Percent: **20.000**  
Continuous Index:  
Within 8" of Joint: **NO**  
Remarks:

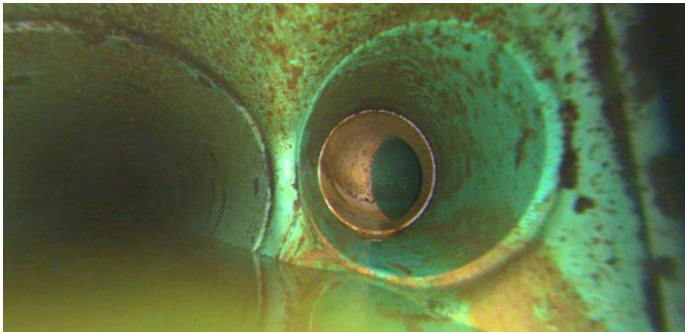
Code: **TF**  
Description: **Tap Factory**

Distance (ft): **257.9**  
Structural Grade: **0**  
O&M Grade: **0**  
Clock Start/From: **3**  
Clock To:  
1st Value: **4.000**  
2nd Value:  
Value Percent:  
Continuous Index:  
Within 8" of Joint:  
Remarks:

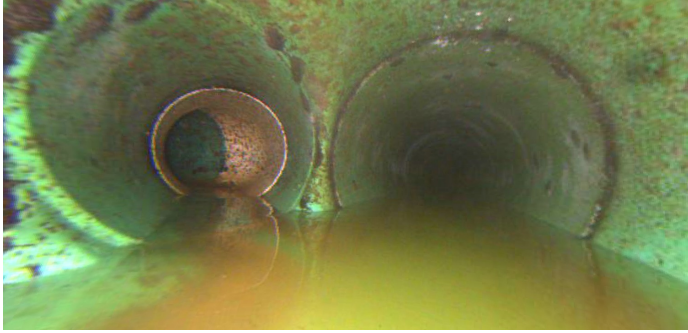
Code: **TFA**  
Description: **Tap Factory Active**

Distance (ft): **266.6**  
Structural Grade: **0**  
O&M Grade: **0**  
Clock Start/From: **9**  
Clock To:  
1st Value: **4.000**  
2nd Value:  
Value Percent:  
Continuous Index:  
Within 8" of Joint:  
Remarks:

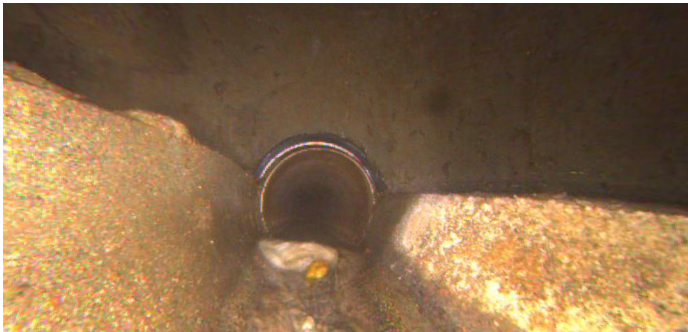
Code: **AMH**  
Description: **Manhole**

Distance (ft): **295.9**  
Structural Grade: **0**  
O&M Grade: **0**  
Clock Start/From:  
Clock To:  
1st Value:  
2nd Value:  
Value Percent:  
Continuous Index:  
Within 8" of Joint: **NO**  
Remarks: **M-1004-047**
