Profile/Photo Observation Report

Street:	MCAFEE DR	Flow Control:	Not Controlled
City:	Hobart, IN	Year Renewed:	
Location:	Other	Tape/Media #:	
Purpose:	Not Known	Dia/Height:	8"
Use:	Sanitary	Material:	PVC
Drain Area:	NA	Lining:	
Category:	NA		
Comment:

Location Details:		Direction of Survey:	Downstream
US MH:	M-1004-048	DS MH:	M-1004-049
		Total Length Surveyed (ft):	142.3

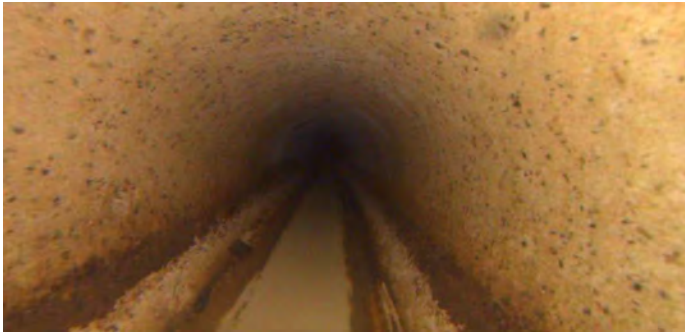
Distance (ft):	.0
Structural Grade:	0
O&M Grade:	0
Clock Start/From:	
Clock To:	
1st Value:	
2nd Value:	
Value Percent:	
Continuous Index:	
Within 8" of Joint:	NO
Remarks:	M-1004-048

Code:	MWL
Description:	Water Level

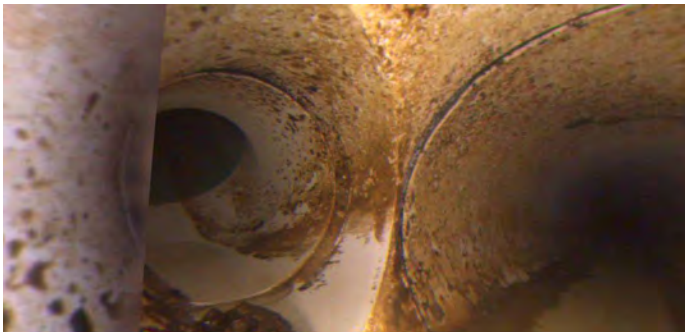
Distance (ft):	.0
Structural Grade:	0
O&M Grade:	0
Clock Start/From:	
Clock To:	
1st Value:	
2nd Value:	
Value Percent:	5.000
Continuous Index:	
Within 8" of Joint:	NO
Remarks:

Code:	TF
Description:	Tap Factory

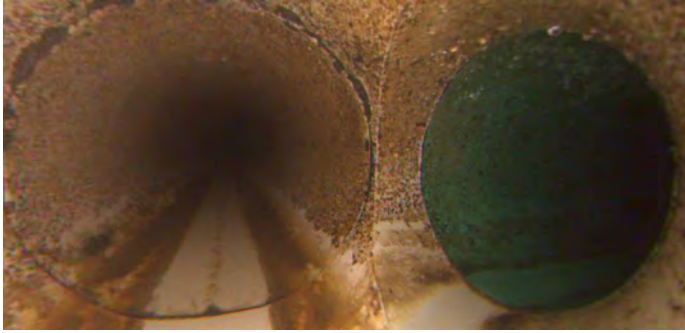
Distance (ft):	27.2
Structural Grade:	0
O&M Grade:	0
Clock Start/From:	9
Clock To:	
1st Value:	4.000
2nd Value:	
Value Percent:	
Continuous Index:	
Within 8" of Joint:	
Remarks:

Code: **TF**
Description: **Tap Factory**

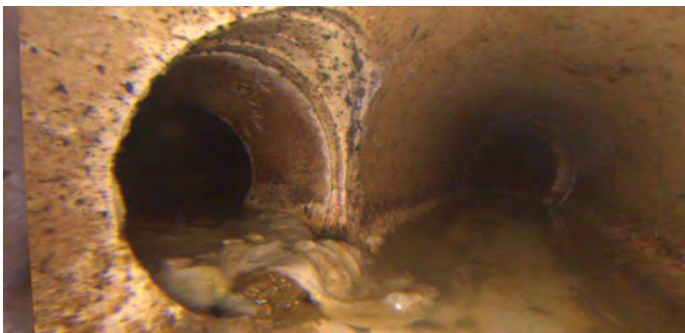
Distance (ft): **119.6**
Structural Grade: **0**
O&M Grade: **0**
Clock Start/From: **3**
Clock To:
1st Value: **4.000**
2nd Value:
Value Percent:
Continuous Index:
Within 8" of Joint:
Remarks:

Code: **TFA**
Description: **Tap Factory Active**

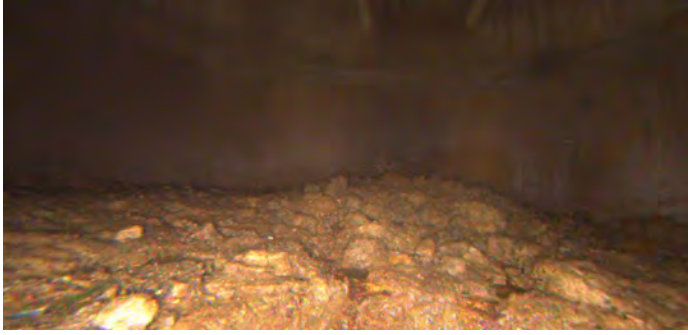
Distance (ft): **134.8**
Structural Grade: **0**
O&M Grade: **0**
Clock Start/From: **9**
Clock To:
1st Value: **4.000**
2nd Value:
Value Percent:
Continuous Index:
Within 8" of Joint:
Remarks:

Code:	AMH
Description:	Manhole
Distance (ft):	142.3
Structural Grade:	0
O&M Grade:	0
Clock Start/From:	
Clock To:	
1st Value:	
2nd Value:	
Value Percent:	
Continuous Index:	
Within 8" of Joint:	NO
Remarks:	M-1004-049
