Profile/Photo Observation Report

Street:	BARBERRY DR	Flow Control:	Not Controlled
City:	Hobart, IN	Year Renewed:	
Location:	Other	Tape/Media #:	
Purpose:	Not Known	Dia/Height:	10"
Use:	Sanitary	Material:	PVC
Drain Area:	NA	Lining:	
Category:	NA		
Comment:

Location Details:		Direction of Survey:	Downstream
US MH:	M-1004-051	DS MH:	M-1004-048
		Total Length Surveyed (ft):	313.7

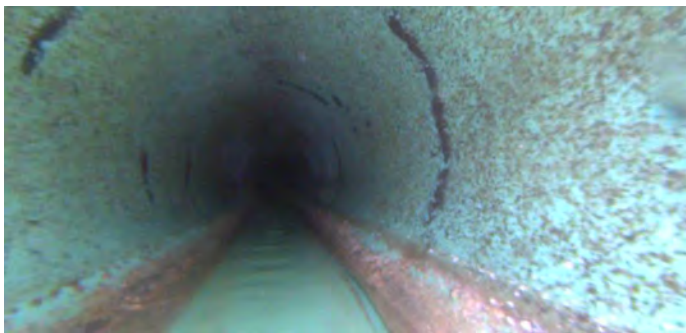
Code: **AMH**
Description: **Manhole**

Distance (ft): **.0**
Structural Grade: **0**
O&M Grade: **0**
Clock Start/From:
Clock To:
1st Value:
2nd Value:
Value Percent:
Continuous Index:
Within 8" of Joint: **NO**
Remarks: **M-1004-051**

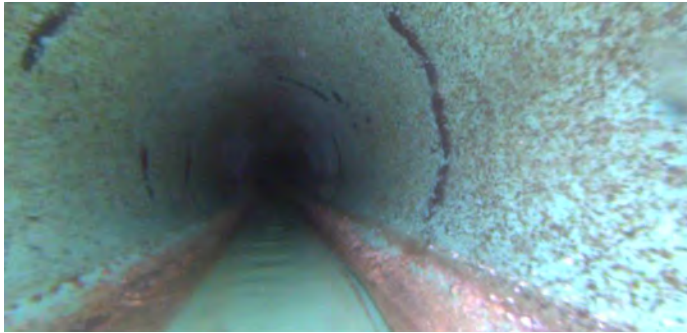
Code: **MWL**
Description: **Water Level**

Distance (ft): **.0**
Structural Grade: **0**
O&M Grade: **0**
Clock Start/From:
Clock To:
1st Value:
2nd Value:
Value Percent: **5.000**
Continuous Index:
Within 8" of Joint: **NO**
Remarks:

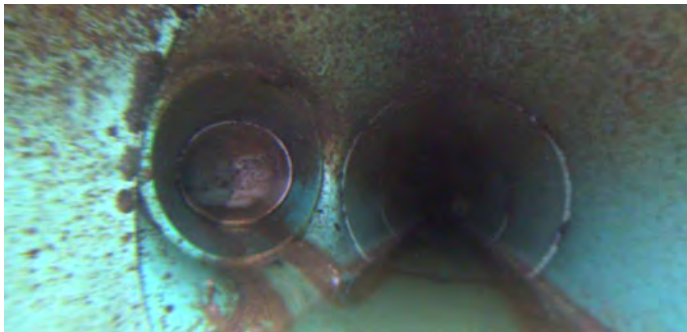
Code: **TF**
Description: **Tap Factory**

Distance (ft): **29.8**
Structural Grade: **0**
O&M Grade: **0**
Clock Start/From: **9**
Clock To:
1st Value: **4.000**
2nd Value:
Value Percent:
Continuous Index:
Within 8" of Joint:
Remarks:

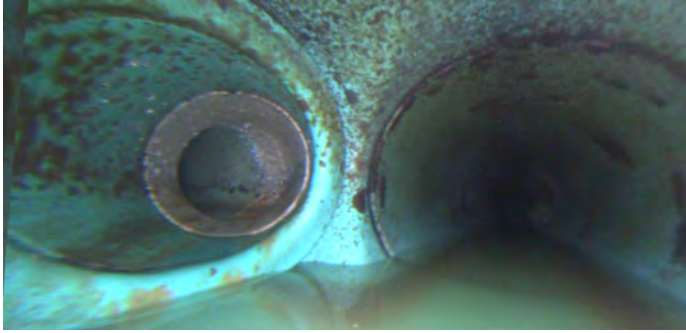
Code: **TF**
Description: **Tap Factory**

Distance (ft): **103.9**
Structural Grade: **0**
O&M Grade: **0**
Clock Start/From: **9**
Clock To:
1st Value: **4.000**
2nd Value:
Value Percent:
Continuous Index:
Within 8" of Joint:
Remarks:

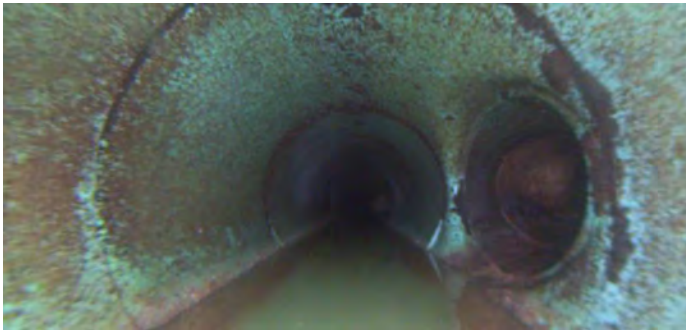
Code: **TF**
Description: **Tap Factory**

Distance (ft): **123.8**
Structural Grade: **0**
O&M Grade: **0**
Clock Start/From: **3**
Clock To:
1st Value: **4.000**
2nd Value:
Value Percent:
Continuous Index:
Within 8" of Joint:
Remarks:

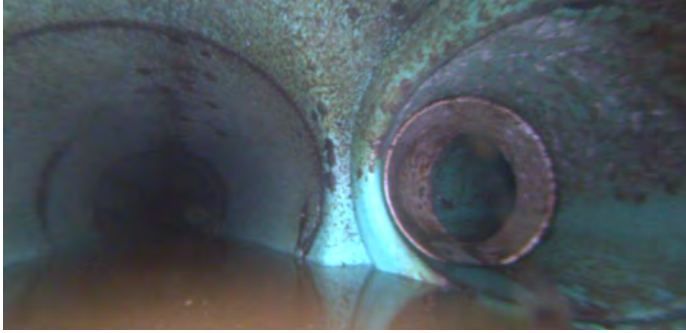
Code: **TFA**
Description: **Tap Factory Active**

Distance (ft): **221.8**
Structural Grade: **0**
O&M Grade: **0**
Clock Start/From: **3**
Clock To:
1st Value: **4.000**
2nd Value:
Value Percent:
Continuous Index:
Within 8" of Joint:
Remarks:

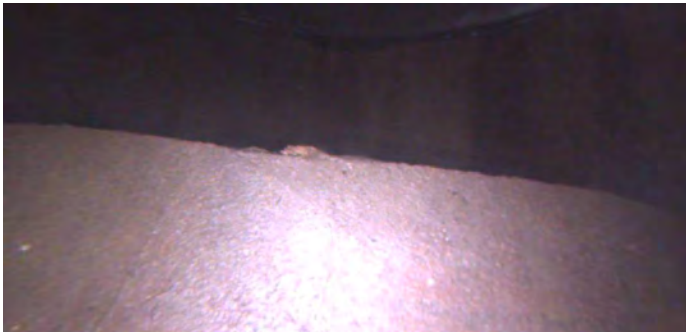
Code: **AMH**
Description: **Manhole**

Distance (ft): **313.7**
Structural Grade: **0**
O&M Grade: **0**
Clock Start/From:
Clock To:
1st Value:
2nd Value:
Value Percent:
Continuous Index:
Within 8" of Joint: **NO**
Remarks: **M-1004-048**
