## Profile/Photo Observation Report

Street:	<b>Barberry Dr.</b>	Flow Control:	<b>Not Controlled</b>
City:	<b>Hobart, IN</b>	Year Renewed:	
Location:	<b>Other</b>	Tape/Media #:	
Purpose:	<b>Not Known</b>	Dia/Height:	<b>10"</b>
Use:	<b>Sanitary</b>	Material:	<b>PVC</b>
Drain Area:	<b>NA</b>	Lining:	
Category:	<b>NA</b>		
Comment:

Location Details:		Direction of Survey:	<b>Downstream</b>
US MH:	<b>M-1004-051</b>	DS MH:	<b>M-1004-048</b>
		Total Length Surveyed (ft):	<b>313.7</b>

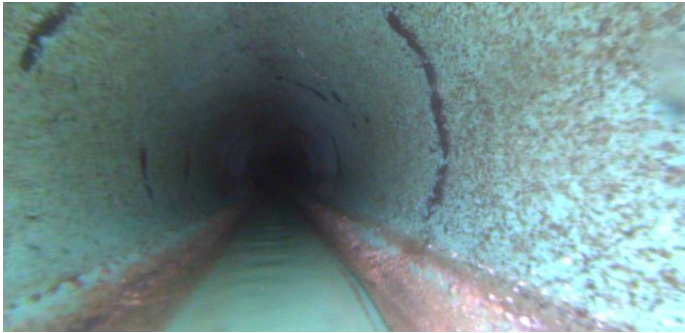
Code:	<b>MWL</b>
Description:	<b>Water Level</b>

Distance (ft):	<b>.0</b>
Structural Grade:	<b>0</b>
O&M Grade:	<b>0</b>
Clock Start/From:	
Clock To:	
1st Value:	
2nd Value:	
Value Percent:	<b>5.000</b>
Continuous Index:	
Within 8" of Joint:	<b>NO</b>
Remarks:

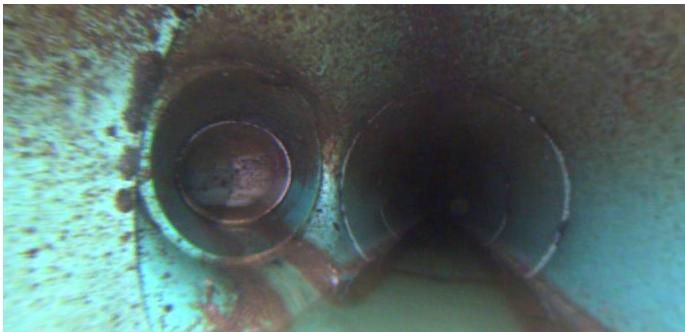
Code:	<b>TF</b>
Description:	<b>Tap Factory</b>

Distance (ft):	<b>29.8</b>
Structural Grade:	<b>0</b>
O&M Grade:	<b>0</b>
Clock Start/From:	<b>9</b>
Clock To:	
1st Value:	<b>4.000</b>
2nd Value:	
Value Percent:	
Continuous Index:	
Within 8" of Joint:	
Remarks:

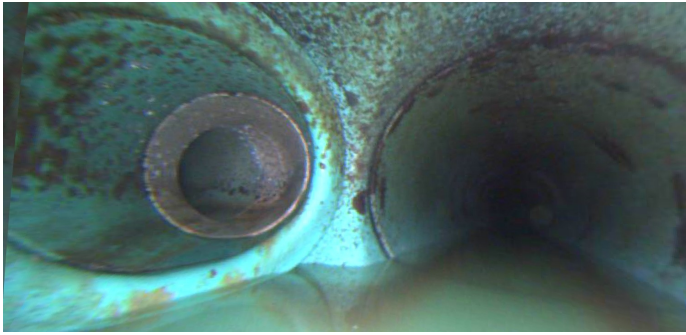
Code: **TF**  
Description: **Tap Factory**

Distance (ft): **103.9**  
Structural Grade: **0**  
O&M Grade: **0**  
Clock Start/From: **9**  
Clock To:  
1st Value: **4.000**  
2nd Value:  
Value Percent:  
Continuous Index:  
Within 8" of Joint:  
Remarks:

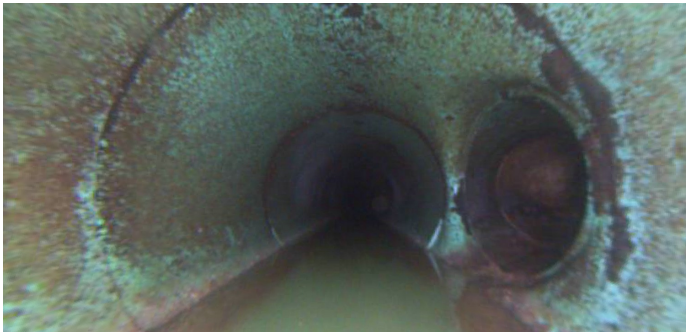
Code: **TF**  
Description: **Tap Factory**

Distance (ft): **123.8**  
Structural Grade: **0**  
O&M Grade: **0**  
Clock Start/From: **3**  
Clock To:  
1st Value: **4.000**  
2nd Value:  
Value Percent:  
Continuous Index:  
Within 8" of Joint:  
Remarks:

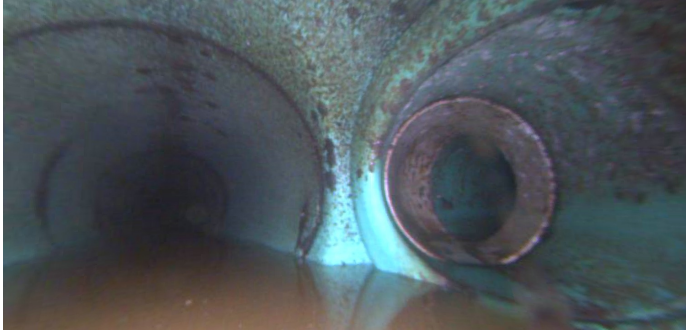
Code: **TFA**  
Description: **Tap Factory Active**

Distance (ft): **221.8**  
Structural Grade: **0**  
O&M Grade: **0**  
Clock Start/From: **3**  
Clock To:  
1st Value: **4.000**  
2nd Value:  
Value Percent:  
Continuous Index:  
Within 8" of Joint:  
Remarks:

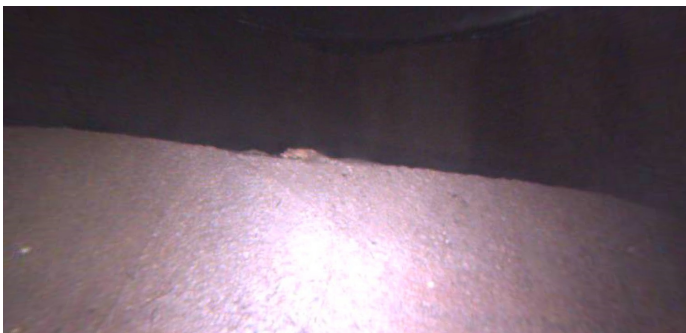
Code: **AMH**  
Description: **Manhole**

Distance (ft): **313.7**  
Structural Grade: **0**  
O&M Grade: **0**  
Clock Start/From:  
Clock To:  
1st Value:  
2nd Value:  
Value Percent:  
Continuous Index:  
Within 8" of Joint: **NO**  
Remarks: **M-1004-048**
