Profile/Photo Observation Report

Date:	04/12/2018	Weather:		Coding:	PACP 6.0
Pipe Length (ft):	135.9	Owner:	NA	Pre Clean:	Not Known
P.O.#:		Surveyor:	Jen Costello	PSR:	P-1004-050-051
Customer:		Clean Date:	01/01/1900	Shape:	C

Location Details:		Direction of Survey:	Downstream
US MH:	M-1004-051	DS MH:	M-1004-050
		Total Length Surveyed (ft):	131.6

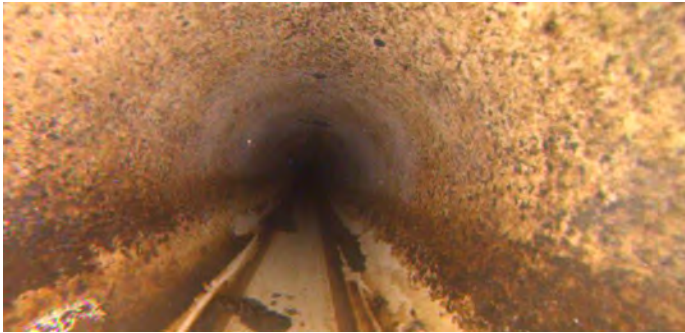
Code:	MWL
Description:	Water Level

Distance (ft):	.0
Structural Grade:	0
O&M Grade:	0
Clock Start/From:	
Clock To:	
1st Value:	
2nd Value:	
Value Percent:	5.000
Continuous Index:	
Within 8" of Joint:	NO
Remarks:

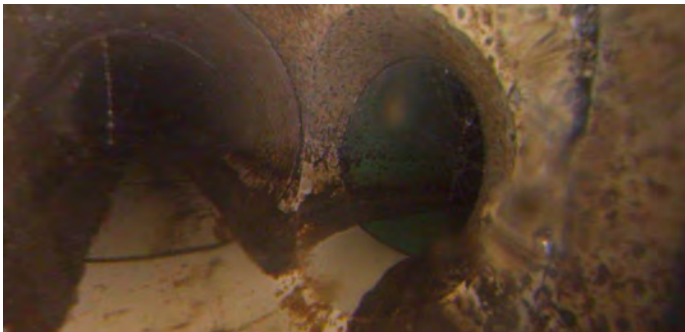
Code:	TFA
Description:	Tap Factory Active

Distance (ft):	100.4
Structural Grade:	0
O&M Grade:	0
Clock Start/From:	3
Clock To:	
1st Value:	4.000
2nd Value:	
Value Percent:	
Continuous Index:	
Within 8" of Joint:	
Remarks:

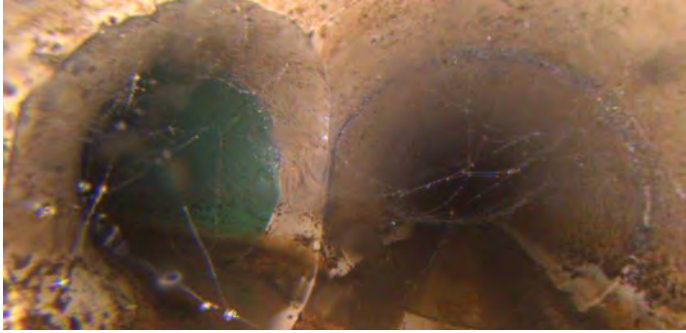
Code: **TFA**
Description: **Tap Factory Active**

Distance (ft): **101.9**
Structural Grade: **0**
O&M Grade: **0**
Clock Start/From: **9**
Clock To:
1st Value: **4.000**
2nd Value:
Value Percent:
Continuous Index:
Within 8" of Joint:
Remarks:

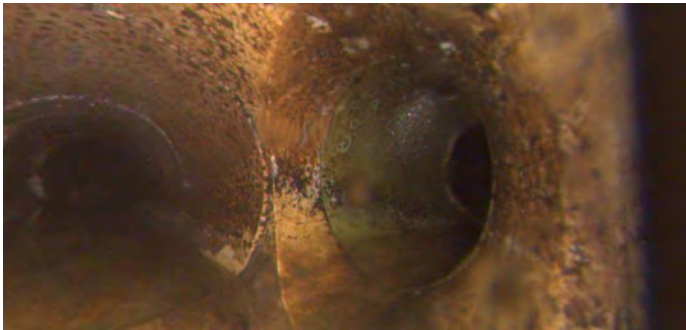
Code: **TFA**
Description: **Tap Factory Active**

Distance (ft): **123.7**
Structural Grade: **0**
O&M Grade: **0**
Clock Start/From: **3**
Clock To:
1st Value: **4.000**
2nd Value:
Value Percent:
Continuous Index:
Within 8" of Joint:
Remarks:

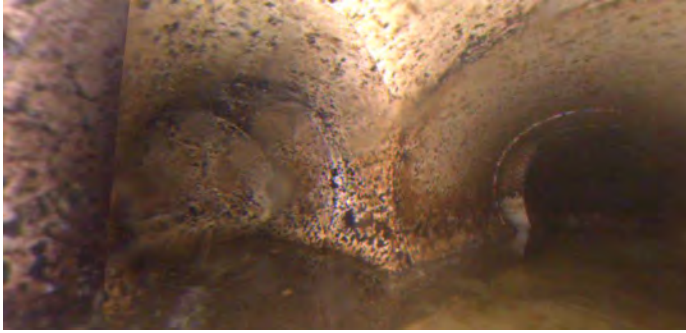
Code: **TFA**
Description: **Tap Factory Active**

Distance (ft): **125.3**
Structural Grade: **0**
O&M Grade: **0**
Clock Start/From: **9**
Clock To:
1st Value: **4.000**
2nd Value:
Value Percent:
Continuous Index:
Within 8" of Joint:
Remarks:

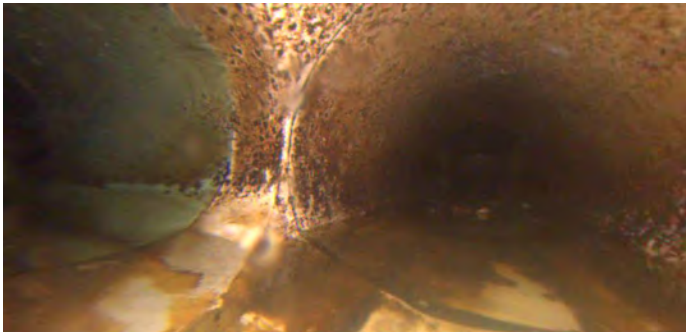
Code: **TFA**
Description: **Tap Factory Active**

Distance (ft): **126.8**
Structural Grade: **0**
O&M Grade: **0**
Clock Start/From: **9**
Clock To:
1st Value: **4.000**
2nd Value:
Value Percent:
Continuous Index:
Within 8" of Joint:
Remarks:

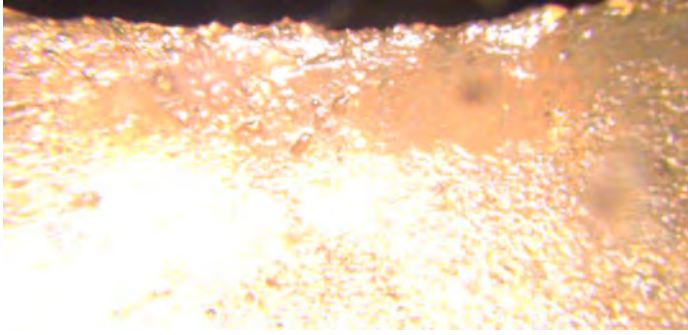
Code:	AMH
Description:	Manhole
Distance (ft):	131.6
Structural Grade:	0
O&M Grade:	0
Clock Start/From:	
Clock To:	
1st Value:	
2nd Value:	
Value Percent:	
Continuous Index:	
Within 8" of Joint:	NO
Remarks:	M-1004-050
