## Profile/Photo Observation Report

Date:	<b>04/12/2018</b>	Weather:		Coding:	<b>PACP 6.0</b>
Pipe Length (ft):	<b>135.9</b>	Owner:	<b>NA</b>	Pre Clean:	<b>Not Known</b>
P.O.#:		Surveyor:	<b>Jen Costello</b>	PSR:	<b>P-1004-050-051</b>
Customer:		Clean Date:	<b>01/01/1900</b>	Shape:	<b>C</b>

Street:	<b>Hawthorne Ct.</b>	Flow Control:	<b>Not Controlled</b>
City:	<b>Hobart, IN</b>	Year Renewed:	
Location:	<b>Other</b>	Tape/Media #:	
Purpose:	<b>Not Known</b>	Dia/Height:	<b>8"</b>
Use:	<b>Sanitary</b>	Material:	<b>PVC</b>
Drain Area:	<b>NA</b>	Lining:	
Category:	<b>NA</b>		
Comment:

Location Details:		Direction of Survey:	<b>Downstream</b>
US MH:	<b>M-1004-051</b>	DS MH:	<b>M-1004-050</b>
		Total Length Surveyed (ft):	<b>131.6</b>

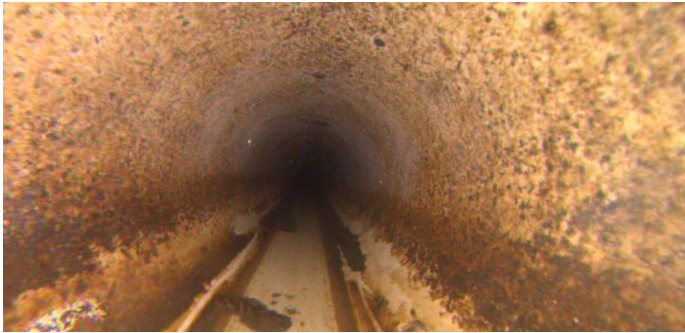
Code: **MWL**  
Description: **Water Level**

Distance (ft): **.0**  
Structural Grade: **0**  
O&M Grade: **0**  
Clock Start/From:  
Clock To:  
1st Value:  
2nd Value:  
Value Percent: **5.000**  
Continuous Index:  
Within 8" of Joint: **NO**  
Remarks:

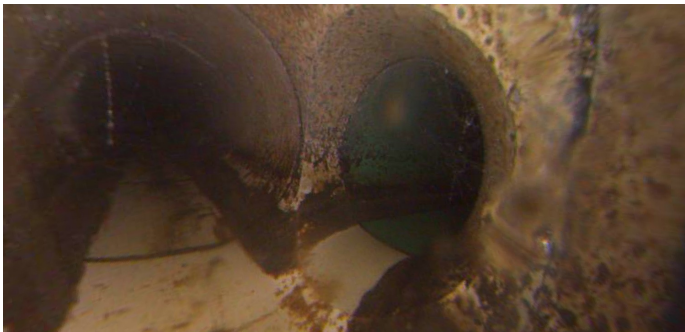
Code: **TFA**  
Description: **Tap Factory Active**

Distance (ft): **100.4**  
Structural Grade: **0**  
O&M Grade: **0**  
Clock Start/From: **3**  
Clock To:  
1st Value: **4.000**  
2nd Value:  
Value Percent:  
Continuous Index:  
Within 8" of Joint:  
Remarks:

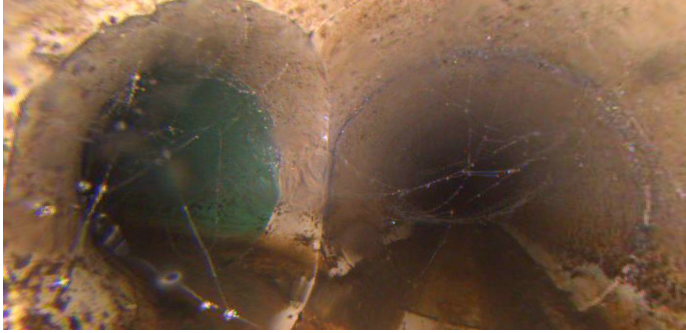
Code: **TFA**  
Description: **Tap Factory Active**

Distance (ft): **101.9**  
Structural Grade: **0**  
O&M Grade: **0**  
Clock Start/From: **9**  
Clock To:  
1st Value: **4.000**  
2nd Value:  
Value Percent:  
Continuous Index:  
Within 8" of Joint:  
Remarks:

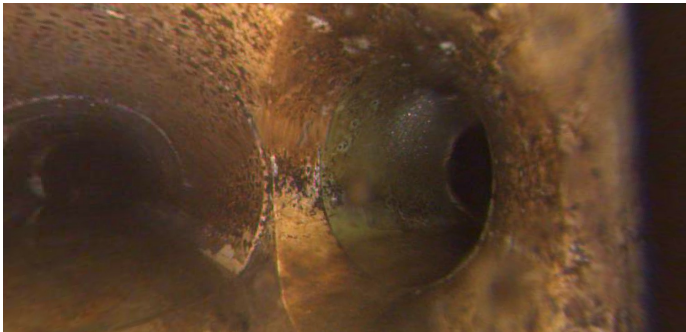
Code: **TFA**  
Description: **Tap Factory Active**

Distance (ft): **123.7**  
Structural Grade: **0**  
O&M Grade: **0**  
Clock Start/From: **3**  
Clock To:  
1st Value: **4.000**  
2nd Value:  
Value Percent:  
Continuous Index:  
Within 8" of Joint:  
Remarks:

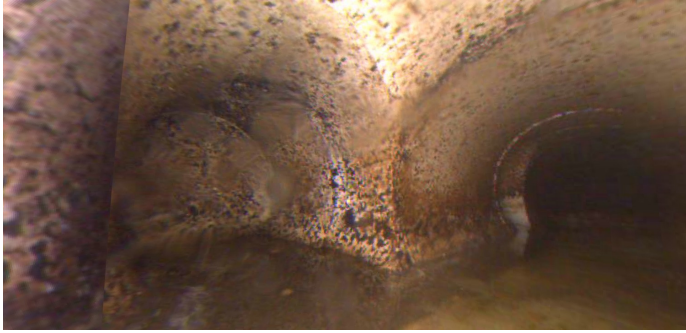
Code: **TFA**  
Description: **Tap Factory Active**

Distance (ft): **125.3**  
Structural Grade: **0**  
O&M Grade: **0**  
Clock Start/From: **9**  
Clock To:  
1st Value: **4.000**  
2nd Value:  
Value Percent:  
Continuous Index:  
Within 8" of Joint:  
Remarks:

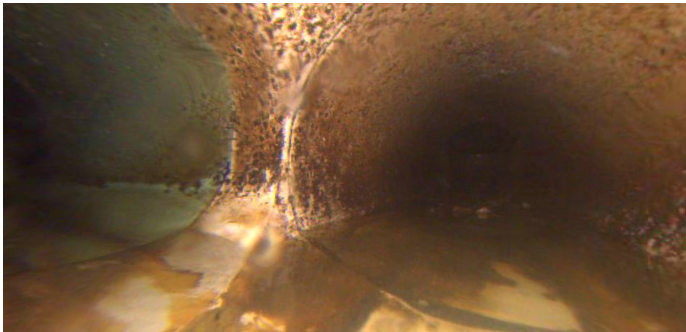
Code: **TFA**  
Description: **Tap Factory Active**

Distance (ft): **126.8**  
Structural Grade: **0**  
O&M Grade: **0**  
Clock Start/From: **9**  
Clock To:  
1st Value: **4.000**  
2nd Value:  
Value Percent:  
Continuous Index:  
Within 8" of Joint:  
Remarks:

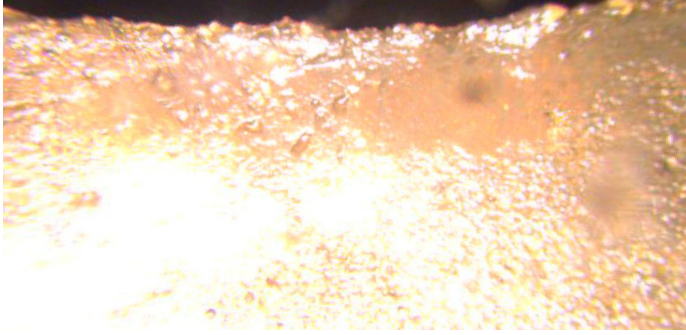
Code:	AMH
Description:	Manhole
Distance (ft):	131.6
Structural Grade:	0
O&M Grade:	0
Clock Start/From:	
Clock To:	
1st Value:	
2nd Value:	
Value Percent:	
Continuous Index:	
Within 8" of Joint:	NO
Remarks:	M-1004-050
