Profile/Photo Observation Report

Date:	04/12/2018	Weather:		Coding:	PACP 6.0
Pipe Length (ft):	315.3	Owner:	NA	Pre Clean:	Not Known
P.O.#:		Surveyor:	Jen Costello	PSR:	P-1004-051-052
Customer:		Clean Date:	01/01/1900	Shape:	C

Street:	BARBERRY DR	Flow Control:	Not Controlled
City:	Hobart, IN	Year Renewed:	
Location:	Other	Tape/Media #:	
Purpose:	Not Known	Dia/Height:	10"
Use:	Sanitary	Material:	PVC
Drain Area:	NA	Lining:	
Category:	NA		
Comment:

Location Details:		Direction of Survey:	Upstream
US MH:	M-1004-051	DS MH:	M-1004-052
		Total Length Surveyed (ft):	223.6

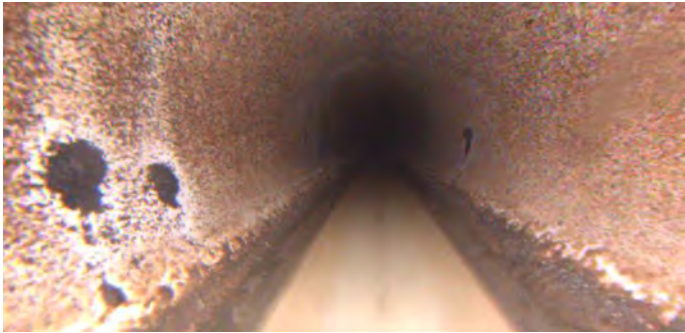
Code:	MWL
Description:	Water Level

Distance (ft):	.0
Structural Grade:	0
O&M Grade:	0
Clock Start/From:	
Clock To:	
1st Value:	
2nd Value:	
Value Percent:	5.000
Continuous Index:	
Within 8" of Joint:	NO
Remarks:

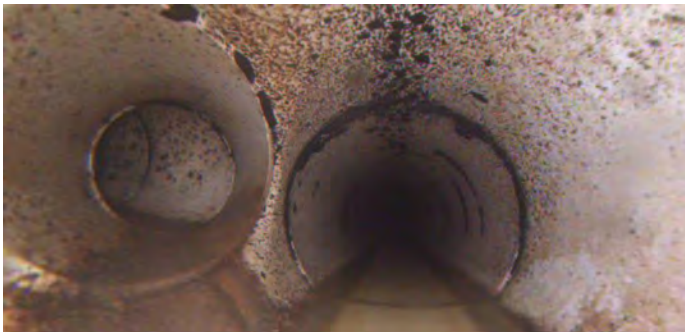
Code:	TFA
Description:	Tap Factory Active

Distance (ft):	33.2
Structural Grade:	0
O&M Grade:	0
Clock Start/From:	9
Clock To:	
1st Value:	4.000
2nd Value:	
Value Percent:	
Continuous Index:	
Within 8" of Joint:	
Remarks:

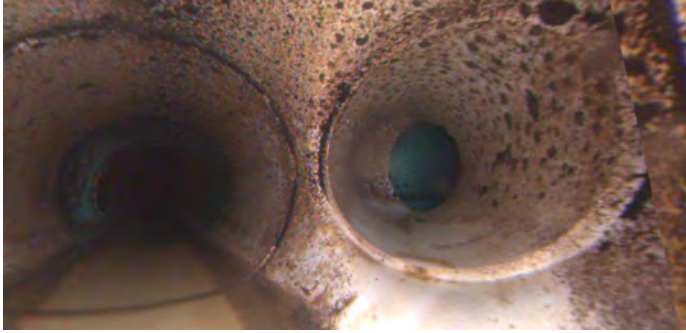
Code: **TF**
Description: **Tap Factory**

Distance (ft): **103.6**
Structural Grade: **0**
O&M Grade: **0**
Clock Start/From: **3**
Clock To:
1st Value: **4.000**
2nd Value:
Value Percent:
Continuous Index:
Within 8" of Joint:
Remarks:

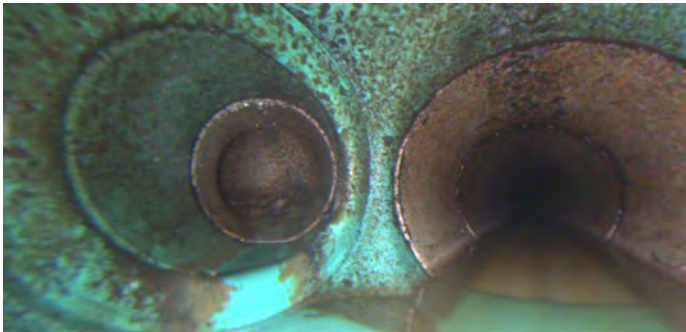
Code: **TF**
Description: **Tap Factory**

Distance (ft): **105.7**
Structural Grade: **0**
O&M Grade: **0**
Clock Start/From: **9**
Clock To:
1st Value: **4.000**
2nd Value:
Value Percent:
Continuous Index:
Within 8" of Joint:
Remarks:

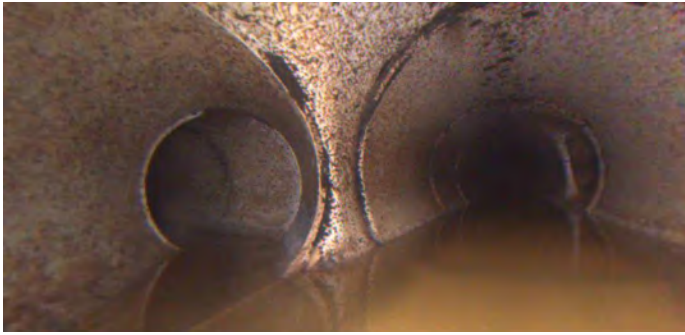
Code: **TFA**
Description: **Tap Factory Active**

Distance (ft): **202.1**
Structural Grade: **0**
O&M Grade: **0**
Clock Start/From: **9**
Clock To:
1st Value: **4.000**
2nd Value:
Value Percent:
Continuous Index:
Within 8" of Joint:
Remarks:

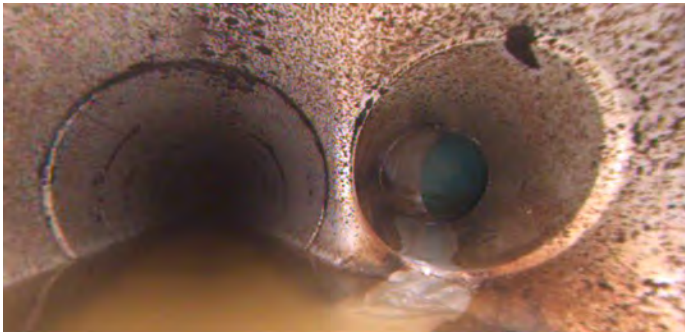
Code: **TFA**
Description: **Tap Factory Active**

Distance (ft): **203.9**
Structural Grade: **0**
O&M Grade: **0**
Clock Start/From: **3**
Clock To:
1st Value: **4.000**
2nd Value:
Value Percent:
Continuous Index:
Within 8" of Joint:
Remarks:

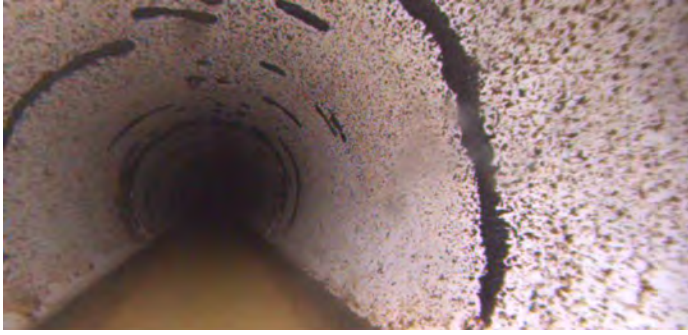
Code:	MSA
Description:	Abandoned Survey
Distance (ft):	223.6
Structural Grade:	0
O&M Grade:	0
Clock Start/From:	
Clock To:	
1st Value:	
2nd Value:	
Value Percent:	
Continuous Index:	
Within 8" of Joint:	NO
Remarks:	debris under water
