## Profile/Photo Observation Report

Street:	<b>BARBERRY DR</b>	Flow Control:	<b>Not Controlled</b>
City:	<b>Hobart, IN</b>	Year Renewed:	
Location:	<b>Other</b>	Tape/Media #:	
Purpose:	<b>Not Known</b>	Dia/Height:	<b>10"</b>
Use:	<b>Sanitary</b>	Material:	<b>PVC</b>
Drain Area:	<b>NA</b>	Lining:	
Category:	<b>NA</b>		
Comment:

Location Details:		Direction of Survey:	<b>Downstream</b>
US MH:	<b>M-1004-051</b>	DS MH:	<b>M-1004-052</b>
		Total Length Surveyed (ft):	<b>310.4</b>

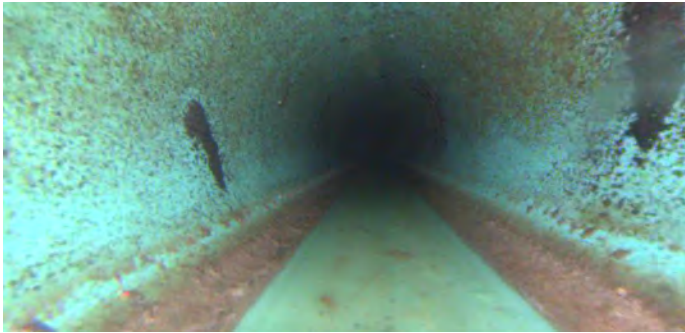
Code: **MWL**  
Description: **Water Level**

Distance (ft): **.0**  
Structural Grade: **0**  
O&M Grade: **0**  
Clock Start/From:  
Clock To:  
1st Value:  
2nd Value:  
Value Percent: **5.000**  
Continuous Index:  
Within 8" of Joint: **NO**  
Remarks:

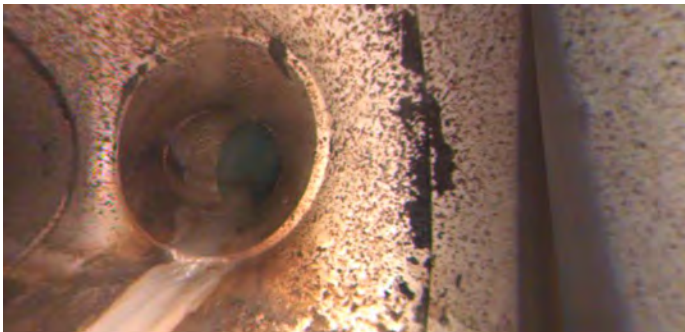
Code: **TFA**  
Description: **Tap Factory Active**

Distance (ft): **104.2**  
Structural Grade: **0**  
O&M Grade: **0**  
Clock Start/From: **9**  
Clock To:  
1st Value: **4.000**  
2nd Value:  
Value Percent:  
Continuous Index:  
Within 8" of Joint:  
Remarks:

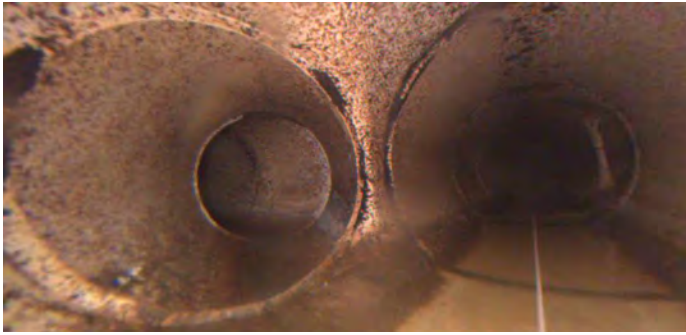
Code: **TFA**  
Description: **Tap Factory Active**

Distance (ft): **106.0**  
Structural Grade: **0**  
O&M Grade: **0**  
Clock Start/From: **3**  
Clock To:  
1st Value: **4.000**  
2nd Value:  
Value Percent:  
Continuous Index:  
Within 8" of Joint:  
Remarks:

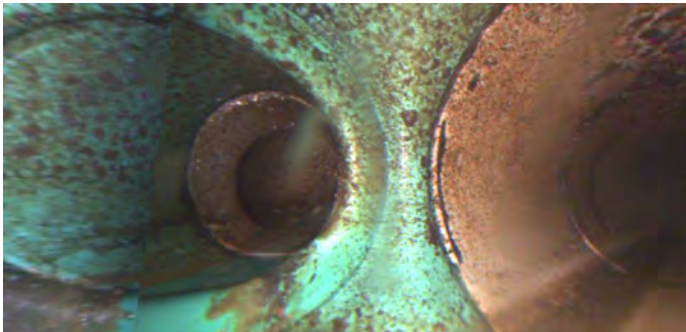
Code: **TF**  
Description: **Tap Factory**

Distance (ft): **201.9**  
Structural Grade: **0**  
O&M Grade: **0**  
Clock Start/From: **3**  
Clock To:  
1st Value: **4.000**  
2nd Value:  
Value Percent:  
Continuous Index:  
Within 8" of Joint:  
Remarks:

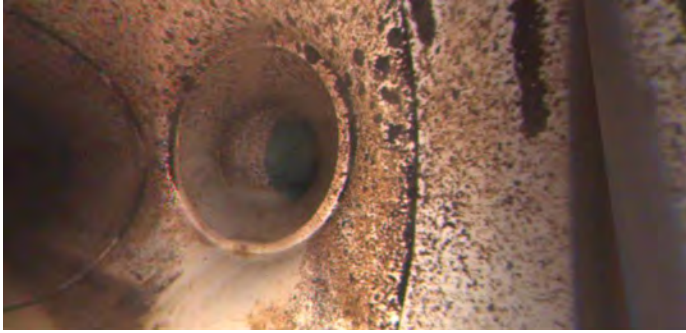
Code: **TF**  
Description: **Tap Factory**

Distance (ft): **204.6**  
Structural Grade: **0**  
O&M Grade: **0**  
Clock Start/From: **9**  
Clock To:  
1st Value: **4.000**  
2nd Value:  
Value Percent:  
Continuous Index:  
Within 8" of Joint:  
Remarks:

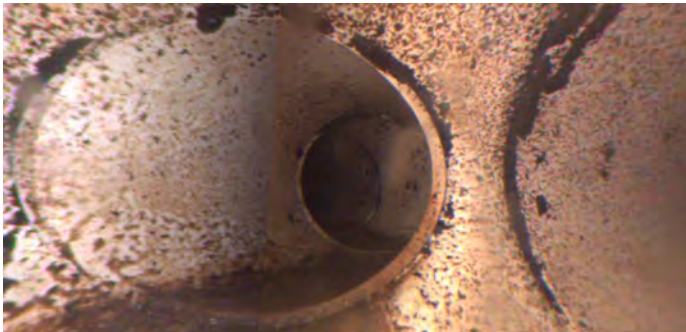
Code: **TF**  
Description: **Tap Factory**

Distance (ft): **274.2**  
Structural Grade: **0**  
O&M Grade: **0**  
Clock Start/From: **3**  
Clock To:  
1st Value: **4.000**  
2nd Value:  
Value Percent:  
Continuous Index:  
Within 8" of Joint:  
Remarks:

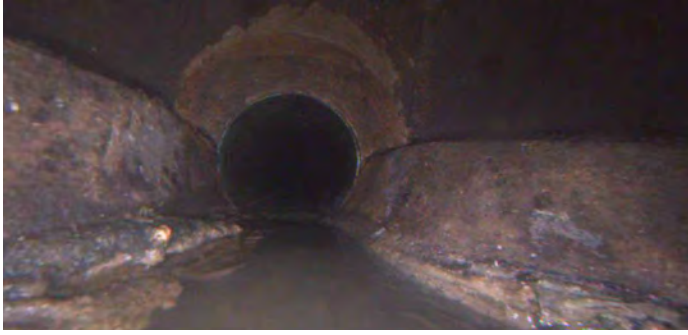
Code:	AMH
Description:	Manhole
Distance (ft):	310.4
Structural Grade:	0
O&M Grade:	0
Clock Start/From:	
Clock To:	
1st Value:	
2nd Value:	
Value Percent:	
Continuous Index:	
Within 8" of Joint:	NO
Remarks:	M-1004-052
