Profile/Photo Observation Report

Street:	Barberry Dr.	Flow Control:	Not Controlled
City:	Hobart, IN	Year Renewed:	
Location:	Other	Tape/Media #:	
Purpose:	Not Known	Dia/Height:	10"
Use:	Sanitary	Material:	PVC
Drain Area:	NA	Lining:	
Category:	NA		
Comment:

Location Details:		Direction of Survey:	Downstream
US MH:	M-1004-051	DS MH:	M-1004-052
		Total Length Surveyed (ft):	310.4

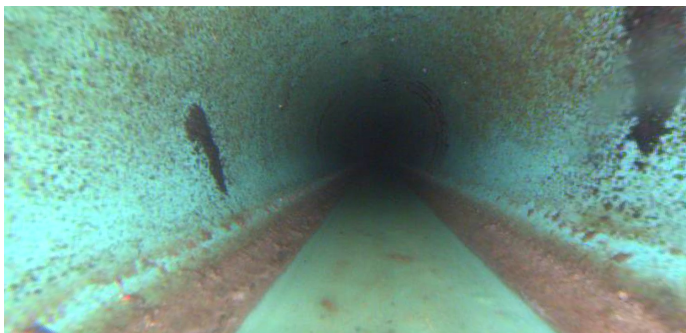
Code: **AMH**
Description: **Manhole**

Distance (ft): **.0**
Structural Grade: **0**
O&M Grade: **0**
Clock Start/From:
Clock To:
1st Value:
2nd Value:
Value Percent:
Continuous Index:
Within 8" of Joint: **NO**
Remarks: **M-1004-051**

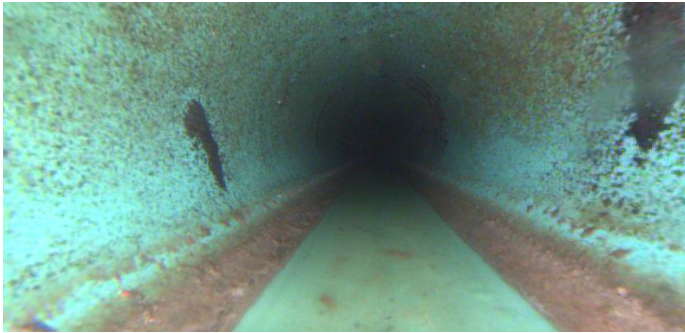
Code: **MWL**
Description: **Water Level**

Distance (ft): **.0**
Structural Grade: **0**
O&M Grade: **0**
Clock Start/From:
Clock To:
1st Value:
2nd Value:
Value Percent: **5.000**
Continuous Index:
Within 8" of Joint: **NO**
Remarks:

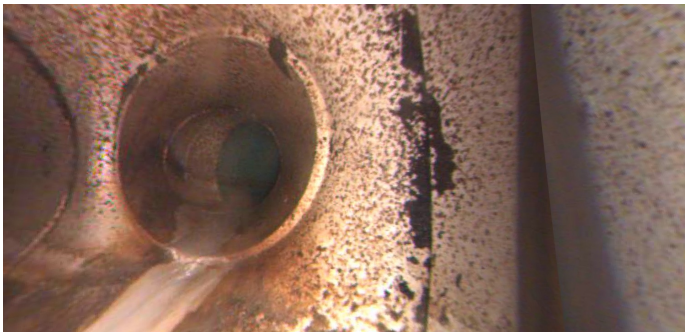
Code: **TFA**
Description: **Tap Factory Active**

Distance (ft): **104.2**
Structural Grade: **0**
O&M Grade: **0**
Clock Start/From: **9**
Clock To:
1st Value: **4.000**
2nd Value:
Value Percent:
Continuous Index:
Within 8" of Joint:
Remarks:

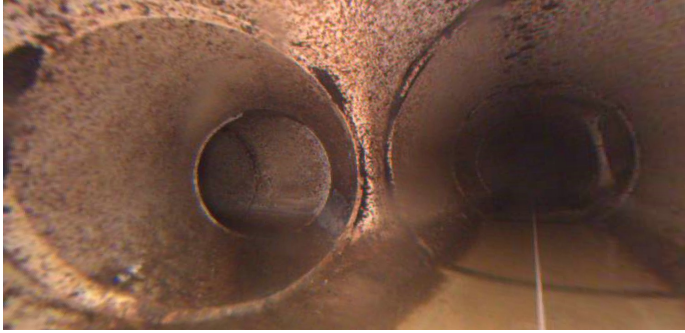
Code: **TFA**
Description: **Tap Factory Active**

Distance (ft): **106.0**
Structural Grade: **0**
O&M Grade: **0**
Clock Start/From: **3**
Clock To:
1st Value: **4.000**
2nd Value:
Value Percent:
Continuous Index:
Within 8" of Joint:
Remarks:

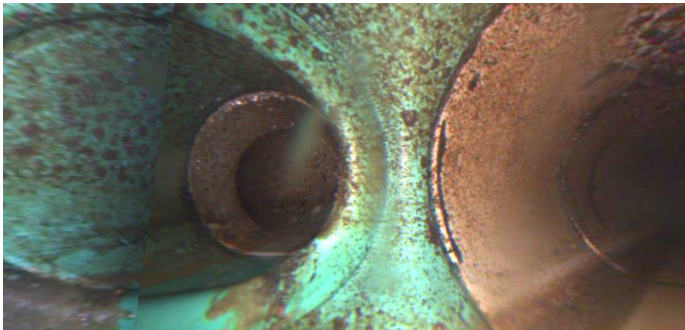
Code: **TF**
Description: **Tap Factory**

Distance (ft): **201.9**
Structural Grade: **0**
O&M Grade: **0**
Clock Start/From: **3**
Clock To:
1st Value: **4.000**
2nd Value:
Value Percent:
Continuous Index:
Within 8" of Joint:
Remarks:

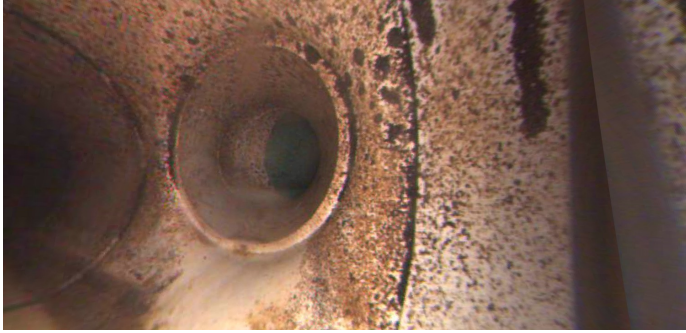
Code: **TF**
Description: **Tap Factory**

Distance (ft): **204.6**
Structural Grade: **0**
O&M Grade: **0**
Clock Start/From: **9**
Clock To:
1st Value: **4.000**
2nd Value:
Value Percent:
Continuous Index:
Within 8" of Joint:
Remarks:

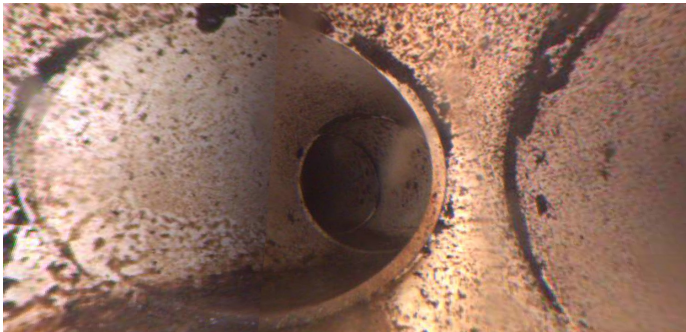
Code: **TF**
Description: **Tap Factory**

Distance (ft): **274.2**
Structural Grade: **0**
O&M Grade: **0**
Clock Start/From: **3**
Clock To:
1st Value: **4.000**
2nd Value:
Value Percent:
Continuous Index:
Within 8" of Joint:
Remarks:

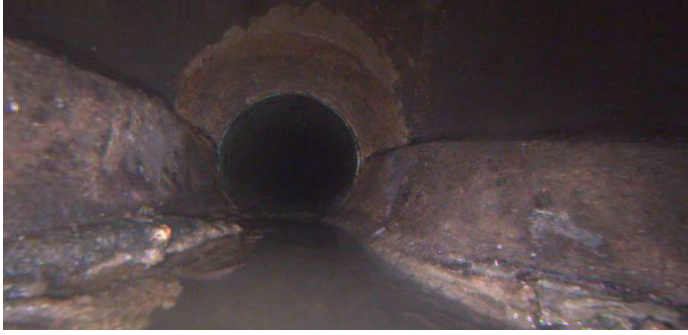
Code:	AMH
Description:	Manhole
Distance (ft):	310.4
Structural Grade:	0
O&M Grade:	0
Clock Start/From:	
Clock To:	
1st Value:	
2nd Value:	
Value Percent:	
Continuous Index:	
Within 8" of Joint:	NO
Remarks:	M-1004-052
