Profile/Photo Observation Report

Street:	BARBERRY DR	Flow Control:	Not Controlled
City:	Hobart, IN	Year Renewed:	
Location:	Other	Tape/Media #:	
Purpose:	Not Known	Dia/Height:	10"
Use:	Sanitary	Material:	PVC
Drain Area:	NA	Lining:	
Category:	NA		
Comment:

Location Details:		Direction of Survey:	Upstream
US MH:	M-1004-052	DS MH:	M-1004-054
		Total Length Surveyed (ft):	195.7

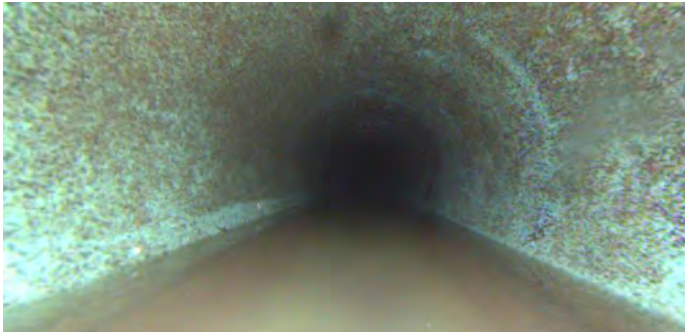
Code:	MWL
Description:	Water Level

Distance (ft):	.0
Structural Grade:	0
O&M Grade:	0
Clock Start/From:	
Clock To:	
1st Value:	
2nd Value:	
Value Percent:	20.000
Continuous Index:	
Within 8" of Joint:	NO
Remarks:

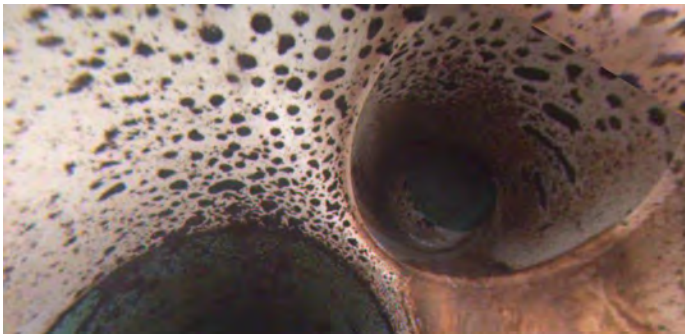
Code:	TF
Description:	Tap Factory

Distance (ft):	35.8
Structural Grade:	0
O&M Grade:	0
Clock Start/From:	1
Clock To:	
1st Value:	4.000
2nd Value:	
Value Percent:	
Continuous Index:	
Within 8" of Joint:	
Remarks:

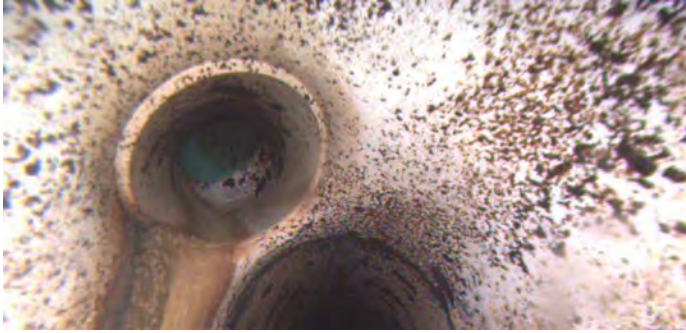
Code: **TF**
Description: **Tap Factory**

Distance (ft): **44.6**
Structural Grade: **0**
O&M Grade: **0**
Clock Start/From: **11**
Clock To:
1st Value: **4.000**
2nd Value:
Value Percent:
Continuous Index:
Within 8" of Joint:
Remarks:

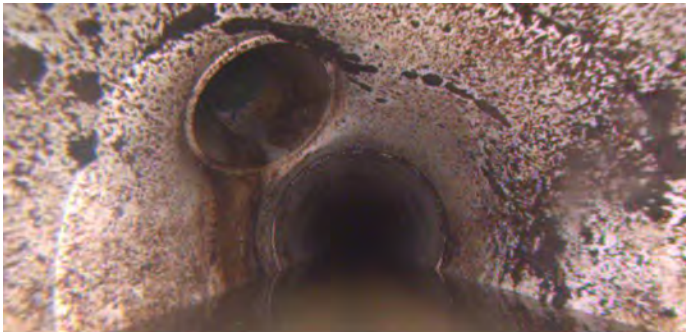
Code: **TF**
Description: **Tap Factory**

Distance (ft): **107.9**
Structural Grade: **0**
O&M Grade: **0**
Clock Start/From: **10**
Clock To:
1st Value: **4.000**
2nd Value:
Value Percent:
Continuous Index:
Within 8" of Joint:
Remarks:

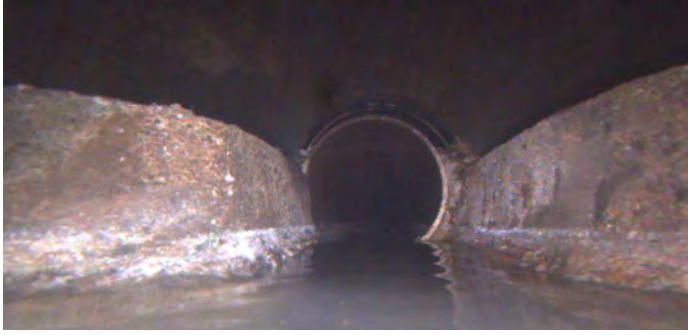
Code:	AMH
Description:	Manhole
Distance (ft):	195.7
Structural Grade:	0
O&M Grade:	0
Clock Start/From:	
Clock To:	
1st Value:	
2nd Value:	
Value Percent:	
Continuous Index:	
Within 8" of Joint:	NO
Remarks:	M-1004-052
