Profile/Photo Observation Report

Street:	Barberry Dr.	Flow Control:	Not Controlled
City:	Hobart, IN	Year Renewed:	
Location:	Other	Tape/Media #:	
Purpose:	Not Known	Dia/Height:	10"
Use:	Sanitary	Material:	PVC
Drain Area:	NA	Lining:	
Category:	NA		
Comment:

Location Details:		Direction of Survey:	Upstream
US MH:	M-1004-052	DS MH:	M-1004-054
		Total Length Surveyed (ft):	195.7

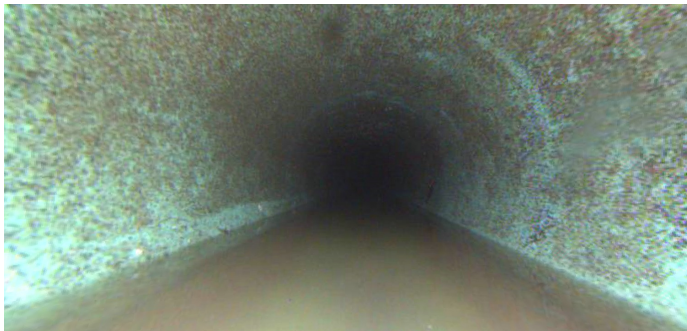
Code: **AMH**
 Description: **Manhole**

Distance (ft): **.0**
 Structural Grade: **0**
 O&M Grade: **0**
 Clock Start/From:
 Clock To:
 1st Value:
 2nd Value:
 Value Percent:
 Continuous Index:
 Within 8" of Joint: **NO**
 Remarks: **M-1004-054**

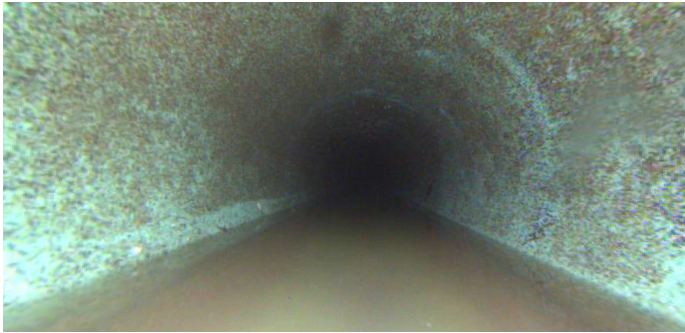
Code:	MWL
Description:	Water Level

Distance (ft):	.0
Structural Grade:	0
O&M Grade:	0
Clock Start/From:	
Clock To:	
1st Value:	
2nd Value:	
Value Percent:	20.000
Continuous Index:	
Within 8" of Joint:	NO
Remarks:

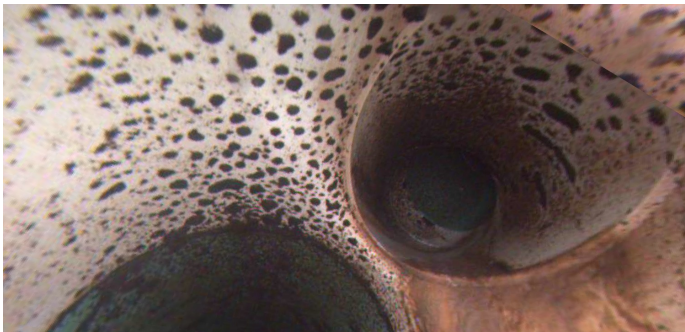
Code:	TF
Description:	Tap Factory

Distance (ft):	35.8
Structural Grade:	0
O&M Grade:	0
Clock Start/From:	1
Clock To:	
1st Value:	4.000
2nd Value:	
Value Percent:	
Continuous Index:	
Within 8" of Joint:	
Remarks:

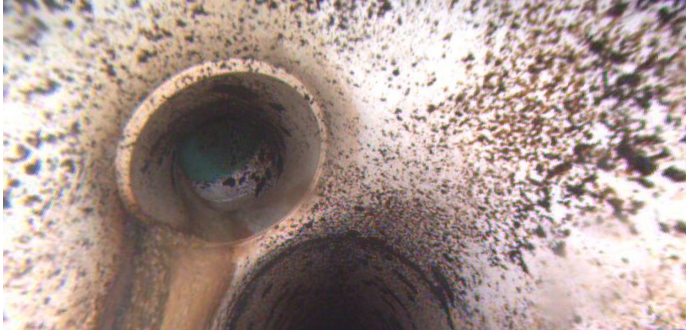
Code: **TF**
Description: **Tap Factory**

Distance (ft): **44.6**
Structural Grade: **0**
O&M Grade: **0**
Clock Start/From: **11**
Clock To:
1st Value: **4.000**
2nd Value:
Value Percent:
Continuous Index:
Within 8" of Joint:
Remarks:

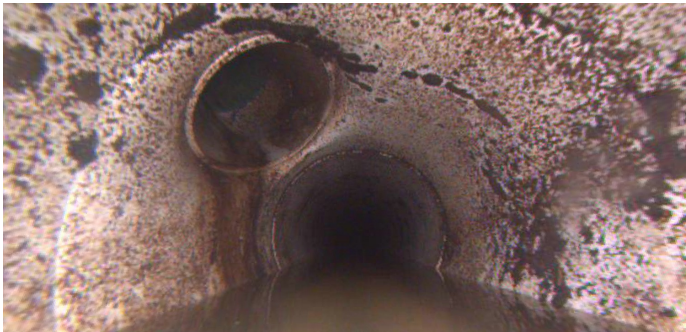
Code: **TF**
Description: **Tap Factory**

Distance (ft): **107.9**
Structural Grade: **0**
O&M Grade: **0**
Clock Start/From: **10**
Clock To:
1st Value: **4.000**
2nd Value:
Value Percent:
Continuous Index:
Within 8" of Joint:
Remarks:

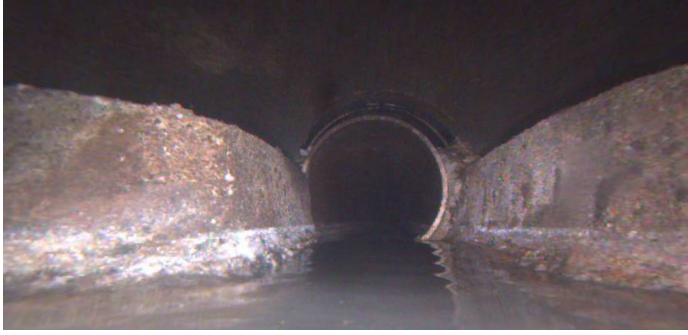
Code:	AMH
Description:	Manhole
Distance (ft):	195.7
Structural Grade:	0
O&M Grade:	0
Clock Start/From:	
Clock To:	
1st Value:	
2nd Value:	
Value Percent:	
Continuous Index:	
Within 8" of Joint:	NO
Remarks:	M-1004-052
