## Profile/Photo Observation Report

Street:	<b>HEMLOCK DR</b>	Flow Control:	<b>Not Controlled</b>
City:	<b>Hobart, IN</b>	Year Renewed:	
Location:	<b>Other</b>	Tape/Media #:	
Purpose:	<b>Not Known</b>	Dia/Height:	<b>10"</b>
Use:	<b>Sanitary</b>	Material:	<b>PVC</b>
Drain Area:	<b>NA</b>	Lining:	
Category:	<b>NA</b>		
Comment:

Location Details:		Direction of Survey:	<b>Downstream</b>
US MH:	<b>M-1004-052</b>	DS MH:	<b>M-1004-085</b>
		Total Length Surveyed (ft):	<b>336.5</b>

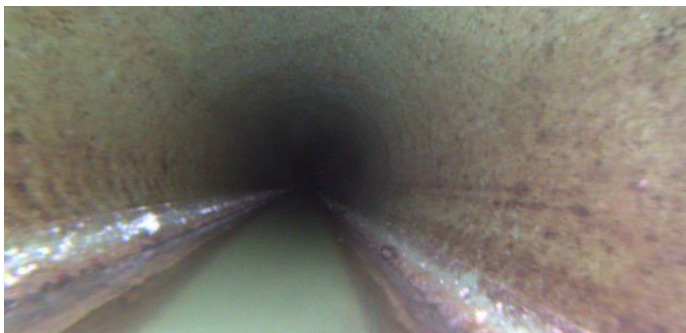
Code: **AMH**  
Description: **Manhole**

Distance (ft): **.0**  
Structural Grade: **0**  
O&M Grade: **0**  
Clock Start/From:  
Clock To:  
1st Value:  
2nd Value:  
Value Percent:  
Continuous Index:  
Within 8" of Joint: **NO**  
Remarks: **M-1004-052**

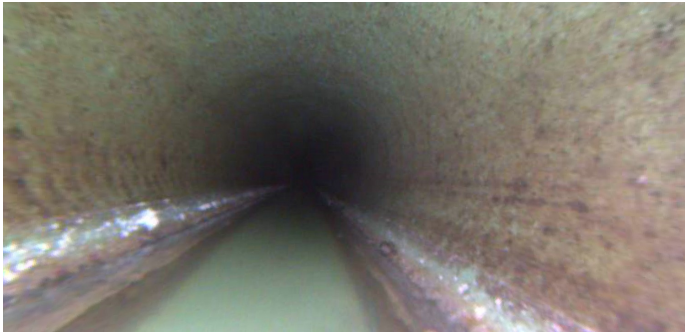
Code:	<b>MWL</b>
Description:	<b>Water Level</b>

Distance (ft):	<b>.0</b>
Structural Grade:	<b>0</b>
O&M Grade:	<b>0</b>
Clock Start/From:	
Clock To:	
1st Value:	
2nd Value:	
Value Percent:	<b>10.000</b>
Continuous Index:	
Within 8" of Joint:	<b>NO</b>
Remarks:

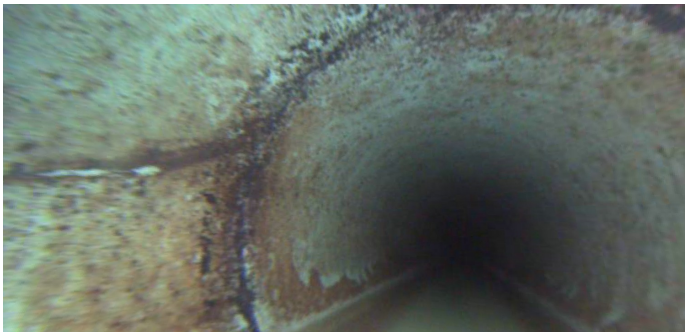
Code:	<b>RFJ</b>
Description:	<b>Roots Fine Joint</b>

Distance (ft):	<b>11.9</b>
Structural Grade:	<b>0</b>
O&M Grade:	<b>1</b>
Clock Start/From:	<b>10</b>
Clock To:	
1st Value:	
2nd Value:	
Value Percent:	
Continuous Index:	
Within 8" of Joint:	<b>YES</b>
Remarks:

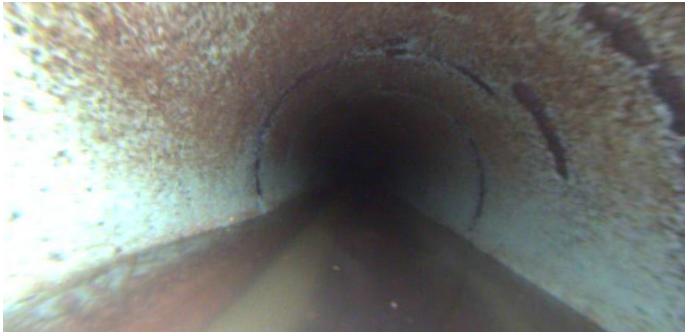
Code: **MWL**  
Description: **Water Level**

Distance (ft): **38.7**  
Structural Grade: **0**  
O&M Grade: **0**  
Clock Start/From:  
Clock To:  
1st Value:  
2nd Value:  
Value Percent: **20.000**  
Continuous Index:  
Within 8" of Joint: **NO**  
Remarks:

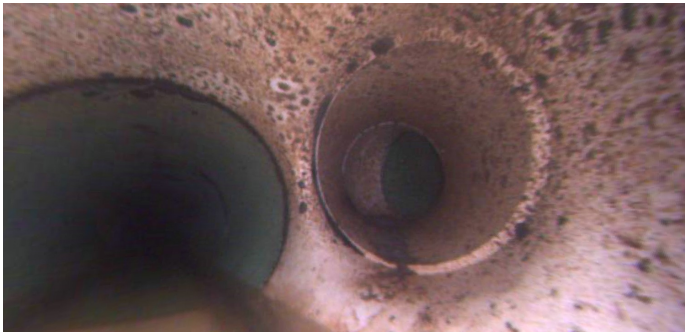
Code: **TF**  
Description: **Tap Factory**

Distance (ft): **99.9**  
Structural Grade: **0**  
O&M Grade: **0**  
Clock Start/From: **3**  
Clock To:  
1st Value: **4.000**  
2nd Value:  
Value Percent:  
Continuous Index:  
Within 8" of Joint:  
Remarks:

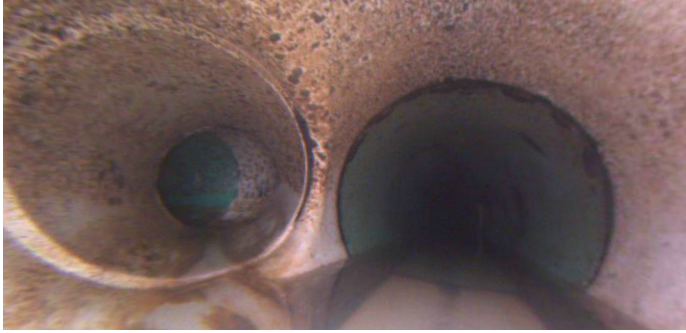
Code: **TFA**  
Description: **Tap Factory Active**

Distance (ft): **215.9**  
Structural Grade: **0**  
O&M Grade: **0**  
Clock Start/From: **9**  
Clock To:  
1st Value: **4.000**  
2nd Value:  
Value Percent:  
Continuous Index:  
Within 8" of Joint:  
Remarks:

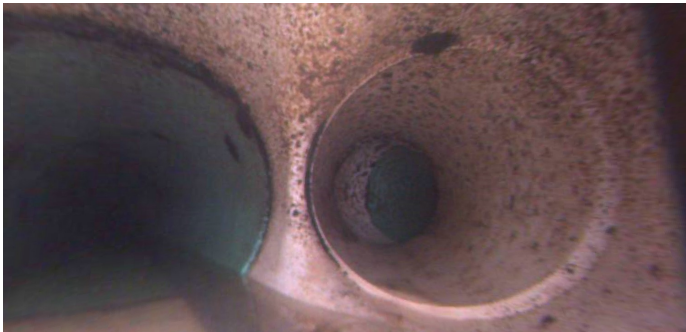
Code: **TF**  
Description: **Tap Factory**

Distance (ft): **220.5**  
Structural Grade: **0**  
O&M Grade: **0**  
Clock Start/From: **3**  
Clock To:  
1st Value: **4.000**  
2nd Value:  
Value Percent:  
Continuous Index:  
Within 8" of Joint:  
Remarks:

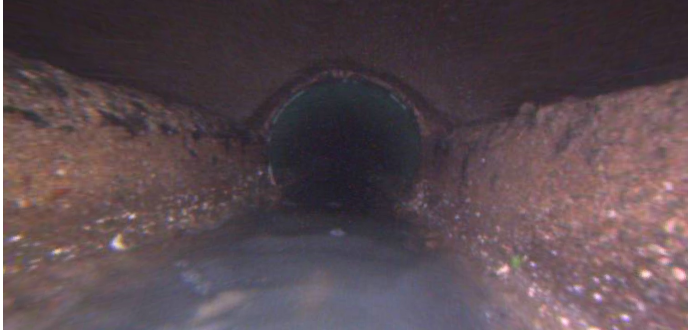
Code:	AMH
Description:	Manhole
Distance (ft):	336.5
Structural Grade:	0
O&M Grade:	0
Clock Start/From:	
Clock To:	
1st Value:	
2nd Value:	
Value Percent:	
Continuous Index:	
Within 8" of Joint:	NO
Remarks:	M-1004-085
