## Profile/Photo Observation Report

Street:	<b>Hemlock Dr.</b>	Flow Control:	<b>Not Controlled</b>
City:	<b>Hobart, IN</b>	Year Renewed:	
Location:	<b>Other</b>	Tape/Media #:	
Purpose:	<b>Not Known</b>	Dia/Height:	<b>10"</b>
Use:	<b>Sanitary</b>	Material:	<b>PVC</b>
Drain Area:	<b>NA</b>	Lining:	
Category:	<b>NA</b>		
Comment:

Location Details:		Direction of Survey:	<b>Downstream</b>
US MH:	<b>M-1004-052</b>	DS MH:	<b>M-1004-085</b>
		Total Length Surveyed (ft):	<b>336.5</b>

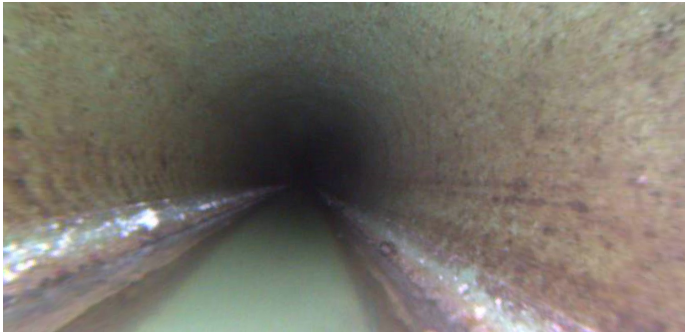
Code:	<b>MWL</b>
Description:	<b>Water Level</b>

Distance (ft):	<b>.0</b>
Structural Grade:	<b>0</b>
O&M Grade:	<b>0</b>
Clock Start/From:	
Clock To:	
1st Value:	
2nd Value:	
Value Percent:	<b>10.000</b>
Continuous Index:	
Within 8" of Joint:	<b>NO</b>
Remarks:

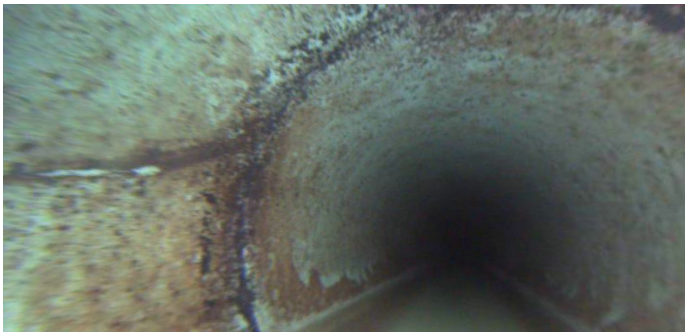
Code:	<b>RFJ</b>
Description:	<b>Roots Fine Joint</b>

Distance (ft):	<b>11.9</b>
Structural Grade:	<b>0</b>
O&M Grade:	<b>1</b>
Clock Start/From:	<b>10</b>
Clock To:	
1st Value:	
2nd Value:	
Value Percent:	
Continuous Index:	
Within 8" of Joint:	<b>YES</b>
Remarks:

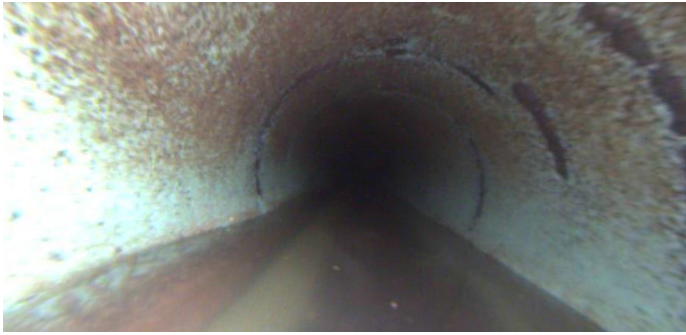
Code: **MWL**  
Description: **Water Level**

Distance (ft): **38.7**  
Structural Grade: **0**  
O&M Grade: **0**  
Clock Start/From:  
Clock To:  
1st Value:  
2nd Value:  
Value Percent: **20.000**  
Continuous Index:  
Within 8" of Joint: **NO**  
Remarks:

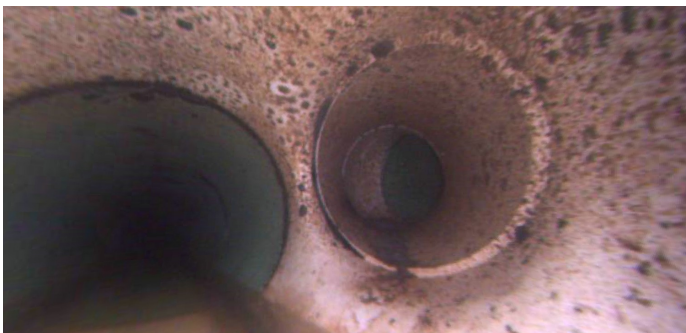
Code: **TF**  
Description: **Tap Factory**

Distance (ft): **99.9**  
Structural Grade: **0**  
O&M Grade: **0**  
Clock Start/From: **3**  
Clock To:  
1st Value: **4.000**  
2nd Value:  
Value Percent:  
Continuous Index:  
Within 8" of Joint:  
Remarks:

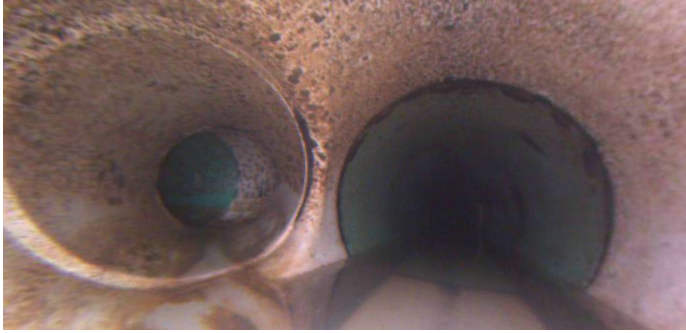
Code: **TFA**  
Description: **Tap Factory Active**

Distance (ft): **215.9**  
Structural Grade: **0**  
O&M Grade: **0**  
Clock Start/From: **9**  
Clock To:  
1st Value: **4.000**  
2nd Value:  
Value Percent:  
Continuous Index:  
Within 8" of Joint:  
Remarks:

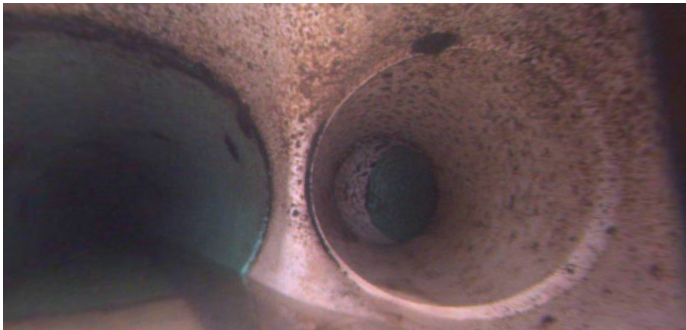
Code: **TF**  
Description: **Tap Factory**

Distance (ft): **220.5**  
Structural Grade: **0**  
O&M Grade: **0**  
Clock Start/From: **3**  
Clock To:  
1st Value: **4.000**  
2nd Value:  
Value Percent:  
Continuous Index:  
Within 8" of Joint:  
Remarks:

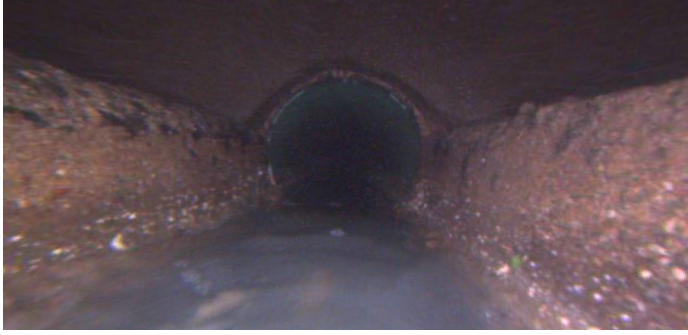
Code:	<b>AMH</b>
Description:	<b>Manhole</b>
Distance (ft):	<b>336.5</b>
Structural Grade:	<b>0</b>
O&M Grade:	<b>0</b>
Clock Start/From:	
Clock To:	
1st Value:	
2nd Value:	
Value Percent:	
Continuous Index:	
Within 8" of Joint:	<b>NO</b>
Remarks:	<b>M-1004-085</b>
