## Profile/Photo Observation Report

Street:	<b>Hemlock Dr.</b>	Flow Control:	<b>Not Controlled</b>
City:	<b>Hobart, IN</b>	Year Renewed:	
Location:	<b>Other</b>	Tape/Media #:	
Purpose:	<b>Not Known</b>	Dia/Height:	<b>8"</b>
Use:	<b>Sanitary</b>	Material:	<b>PVC</b>
Drain Area:	<b>NA</b>	Lining:	
Category:	<b>NA</b>		
Comment:

Location Details:		Direction of Survey:	<b>Downstream</b>
US MH:	<b>M-1004-053</b>	DS MH:	<b>M-1004-052</b>
		Total Length Surveyed (ft):	<b>123.2</b>

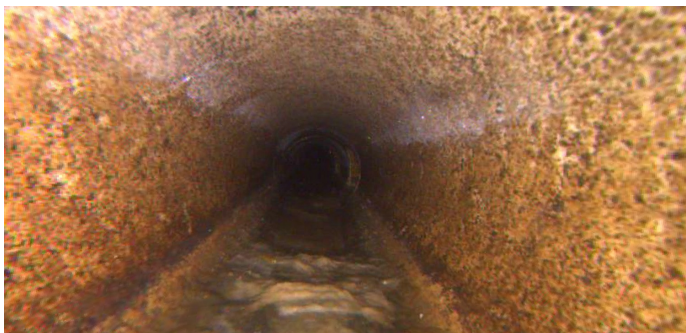
Code: **AMH**  
Description: **Manhole**

Distance (ft): **.0**  
Structural Grade: **0**  
O&M Grade: **0**  
Clock Start/From:  
Clock To:  
1st Value:  
2nd Value:  
Value Percent:  
Continuous Index:  
Within 8" of Joint: **NO**  
Remarks: **M-1004-053**

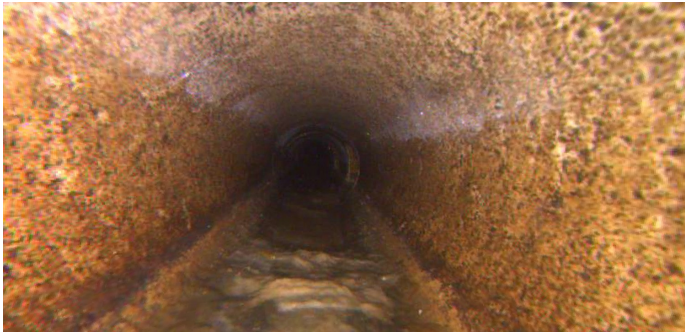
Code:	<b>MWL</b>
Description:	<b>Water Level</b>

Distance (ft):	<b>.0</b>
Structural Grade:	<b>0</b>
O&M Grade:	<b>0</b>
Clock Start/From:	
Clock To:	
1st Value:	
2nd Value:	
Value Percent:	<b>10.000</b>
Continuous Index:	
Within 8" of Joint:	<b>NO</b>
Remarks:

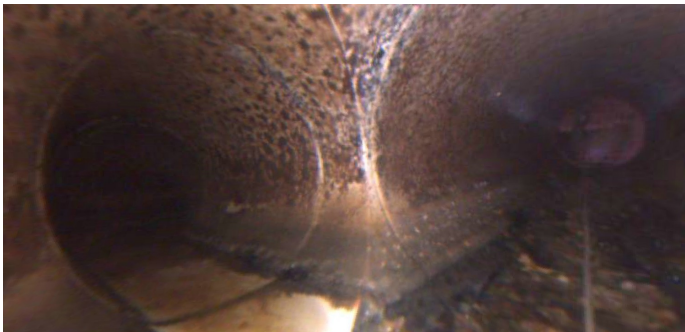
Code:	<b>TFA</b>
Description:	<b>Tap Factory Active</b>

Distance (ft):	<b>3.7</b>
Structural Grade:	<b>0</b>
O&M Grade:	<b>0</b>
Clock Start/From:	<b>3</b>
Clock To:	
1st Value:	<b>4.000</b>
2nd Value:	
Value Percent:	
Continuous Index:	
Within 8" of Joint:	
Remarks:

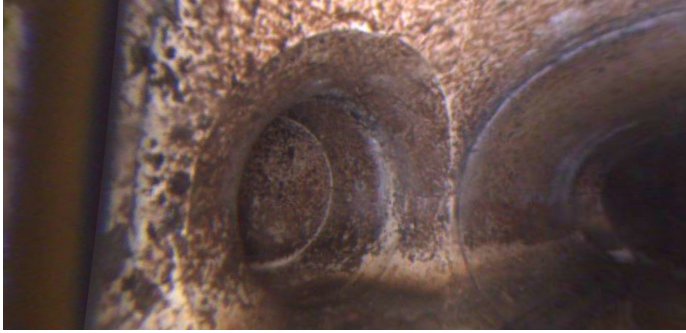
Code: **TFA**  
Description: **Tap Factory Active**

Distance (ft): **5.5**  
Structural Grade: **0**  
O&M Grade: **0**  
Clock Start/From: **3**  
Clock To:  
1st Value: **4.000**  
2nd Value:  
Value Percent:  
Continuous Index:  
Within 8" of Joint:  
Remarks:

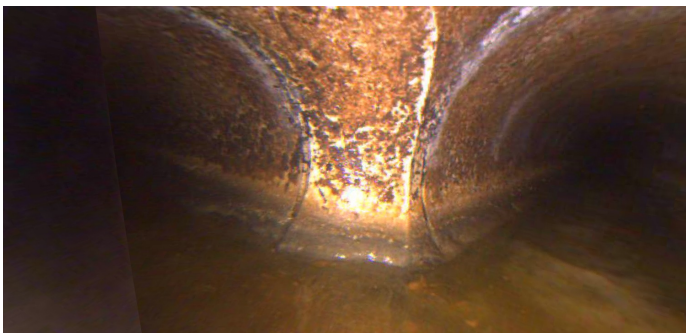
Code: **TFA**  
Description: **Tap Factory Active**

Distance (ft): **6.6**  
Structural Grade: **0**  
O&M Grade: **0**  
Clock Start/From: **9**  
Clock To:  
1st Value: **4.000**  
2nd Value:  
Value Percent:  
Continuous Index:  
Within 8" of Joint:  
Remarks:

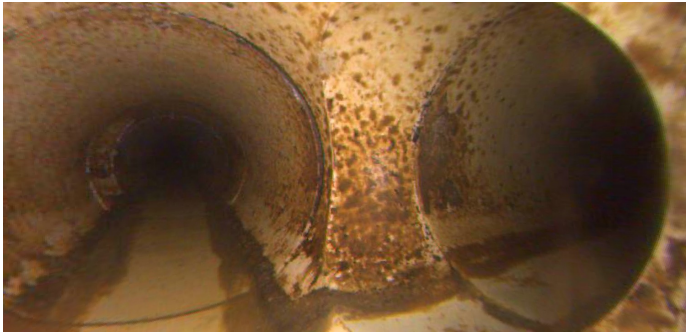
Code: **TF**  
Description: **Tap Factory**

Distance (ft): **24.4**  
Structural Grade: **0**  
O&M Grade: **0**  
Clock Start/From: **3**  
Clock To:  
1st Value: **4.000**  
2nd Value:  
Value Percent:  
Continuous Index:  
Within 8" of Joint:  
Remarks:

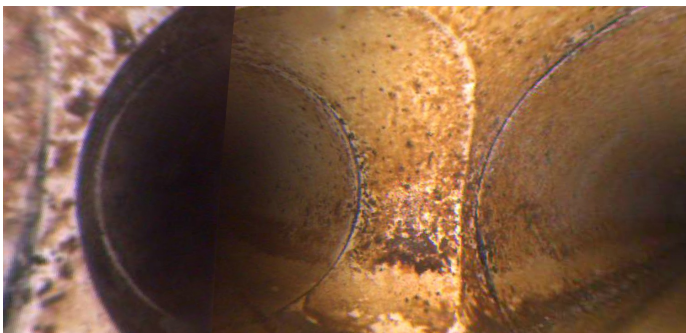
Code: **TF**  
Description: **Tap Factory**

Distance (ft): **26.2**  
Structural Grade: **0**  
O&M Grade: **0**  
Clock Start/From: **9**  
Clock To:  
1st Value: **4.000**  
2nd Value:  
Value Percent:  
Continuous Index:  
Within 8" of Joint:  
Remarks:

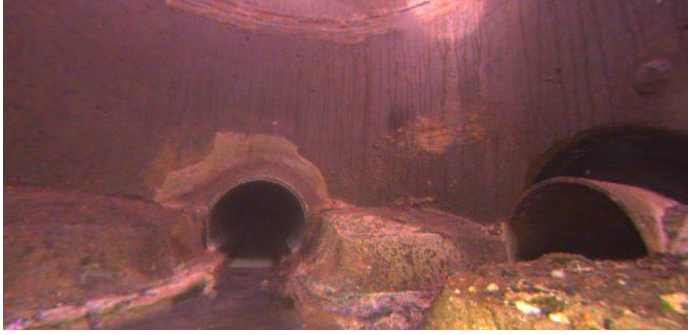
Code:	AMH
Description:	Manhole
Distance (ft):	123.2
Structural Grade:	0
O&M Grade:	0
Clock Start/From:	
Clock To:	
1st Value:	
2nd Value:	
Value Percent:	
Continuous Index:	
Within 8" of Joint:	NO
Remarks:	M-1004-052
