Profile/Photo Observation Report

Street:	Barberry Dr.	Flow Control:	Not Controlled
City:	Hobart, IN	Year Renewed:	
Location:	Other	Tape/Media #:	
Purpose:	Not Known	Dia/Height:	10"
Use:	Sanitary	Material:	PVC
Drain Area:	NA	Lining:	
Category:	NA		
Comment:

Location Details:		Direction of Survey:	Downstream
US MH:	M-1004-054	DS MH:	M-1004-055
		Total Length Surveyed (ft):	209.6

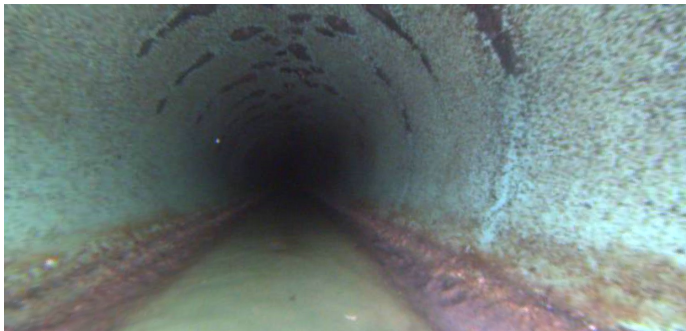
Code: **AMH**
Description: **Manhole**

Distance (ft): **.0**
Structural Grade: **0**
O&M Grade: **0**
Clock Start/From:
Clock To:
1st Value:
2nd Value:
Value Percent:
Continuous Index:
Within 8" of Joint: **NO**
Remarks: **M-1004-054**

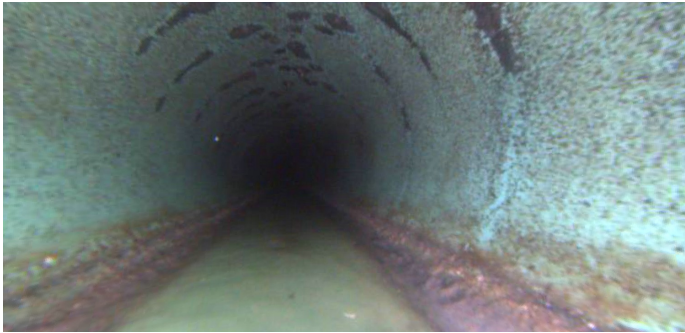
Code:	MWL
Description:	Water Level

Distance (ft):	.0
Structural Grade:	0
O&M Grade:	0
Clock Start/From:	
Clock To:	
1st Value:	
2nd Value:	
Value Percent:	5.000
Continuous Index:	
Within 8" of Joint:	NO
Remarks:

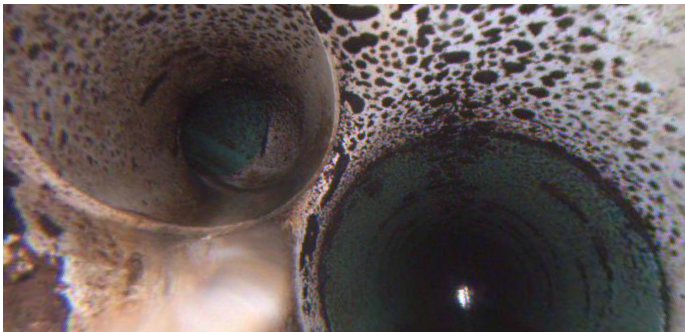
Code:	TF
Description:	Tap Factory

Distance (ft):	25.3
Structural Grade:	0
O&M Grade:	0
Clock Start/From:	2
Clock To:	
1st Value:	4.000
2nd Value:	
Value Percent:	
Continuous Index:	
Within 8" of Joint:	
Remarks:

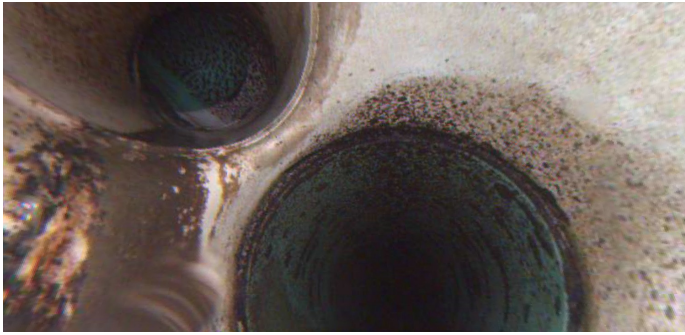
Code: **TF**
Description: **Tap Factory**

Distance (ft): **88.8**
Structural Grade: **0**
O&M Grade: **0**
Clock Start/From: **2**
Clock To:
1st Value: **4.000**
2nd Value:
Value Percent:
Continuous Index:
Within 8" of Joint:
Remarks:

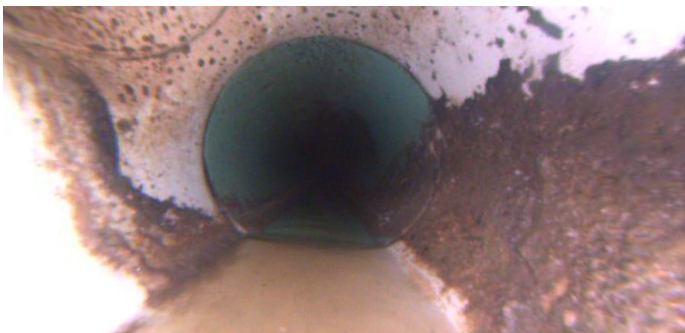
Code: **DAGS**
Description: **Deposits Attached Grease**

Distance (ft): **114.3**
Structural Grade: **0**
O&M Grade: **2**
Clock Start/From: **8**
Clock To: **4**
1st Value:
2nd Value:
Value Percent: **5.000**
Continuous Index:
Within 8" of Joint: **NO**
Remarks:

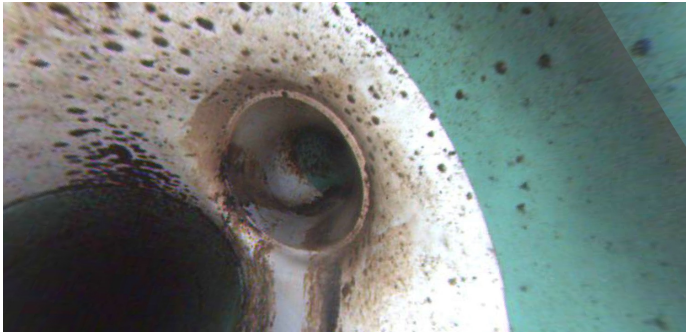
Code: **TF**
Description: **Tap Factory**

Distance (ft): **115.5**
Structural Grade: **0**
O&M Grade: **0**
Clock Start/From: **10**
Clock To:
1st Value: **4.000**
2nd Value:
Value Percent:
Continuous Index:
Within 8" of Joint:
Remarks:

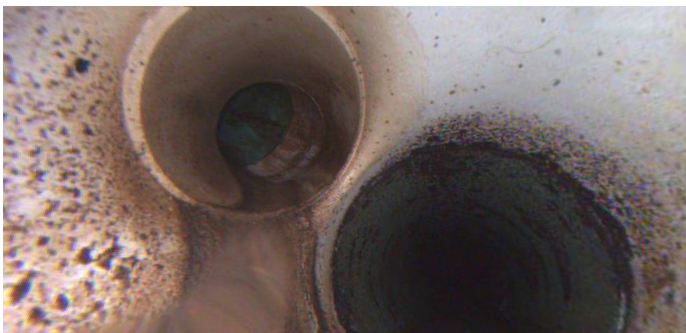
Code: **TF**
Description: **Tap Factory**

Distance (ft): **169.5**
Structural Grade: **0**
O&M Grade: **0**
Clock Start/From: **2**
Clock To:
1st Value: **4.000**
2nd Value:
Value Percent:
Continuous Index:
Within 8" of Joint:
Remarks:

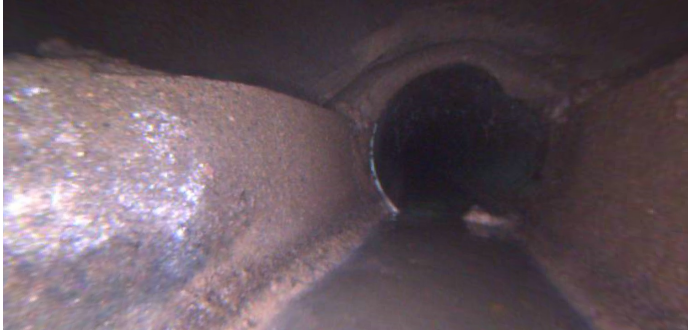
Code:	AMH
Description:	Manhole
Distance (ft):	209.6
Structural Grade:	0
O&M Grade:	0
Clock Start/From:	
Clock To:	
1st Value:	
2nd Value:	
Value Percent:	
Continuous Index:	
Within 8" of Joint:	NO
Remarks:	M-1004-055
