Profile/Photo Observation Report

Profile/Photo Observation Report							
Date: Pipe Length (ft) P.O.#: Customer:	01/14/2023 : 136.0 YES502259 City of Hobart	Weather: Owner: Surveyor: Clean Date:	City of Hobart S. Bucklin 10/29/2022	Coding: Pre Clean: PSR: Shape:	PACP 7.0 Heavy Cleaning P-1004-055-056 C		
Street: City: Location:	Barberry Drive Hobart, IN Easement/Right o	of Way	Flow Control: Year Renewed: Tape/Media #:	Not Controlled			
Purpose: Use:	Routine Assessme Sanitary Sewage P	ent	Dia/Height: Material:	10" PVC			
Drain Area: Category: Comment:	NA		Lining:	None			
Location Details US MH:	s: M-1004-055	DS MH:	Direction of Survey VI-1004-056	: Upstream Total Length Surveyed (ft)	: 134.4		
O&M Index:	0.00	O&M Quick:	0000	O&M Rating:	0.00		
Structural Index:	0.00	Structural Qui	ck: 0000	Structural Rating:	0.00		
Overall Index:	0.00	Overall Quick:	0000	Overall Rating:	0.00

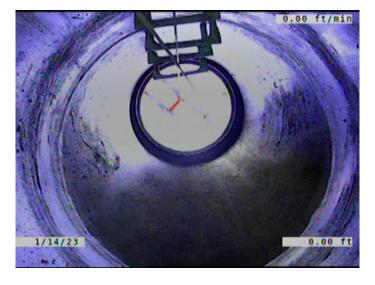
Code: Description:	AMH Manhole
·	
Distance (ft):	.0
Structural Grade:	0
O&M Grade:	0
Clock Start/From:	
Clock To:	
1st Value:	
2nd Value:	
Value Percent:	
Continuous Index:	
Within 8" of Joint:	NO
Remarks:	M-1004-056

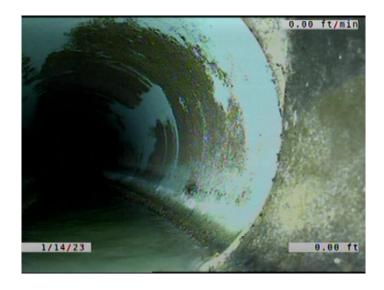
Code: MWL

Description: Miscellaneous Water Level

Distance (ft): .0
Structural Grade: 0
O&M Grade: 0

5.000

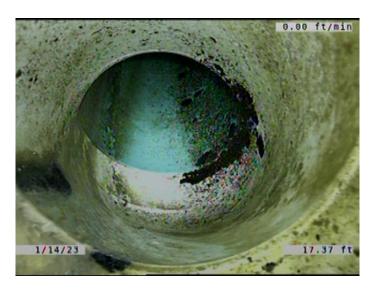
Code: **TF**

Description: Tap Factory

Distance (ft): 17.4
Structural Grade: 0

Clock Start/From: 10

1st Value: **6.000**

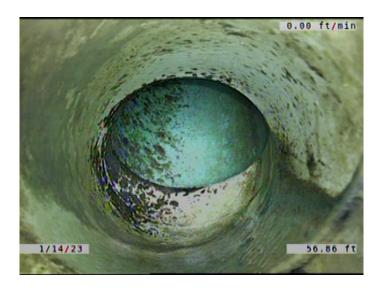
Code: **TF**

Description: Tap Factory

Distance (ft): 56.9
Structural Grade: 0

Clock Start/From: 2

1st Value: **6.000**

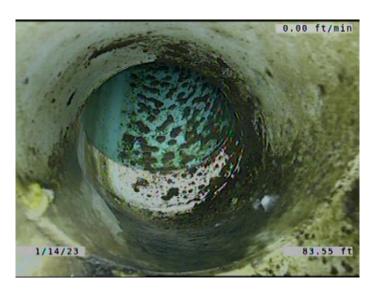
Code: **TF**

Description: Tap Factory

Distance (ft): 83.5
Structural Grade: 0
O&M Grade: 0
Clock Start/From: 10

1st Value: **6.000**

Within 8" of Joint: YES

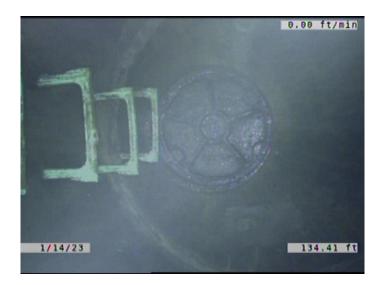
Code: AMH Description: Manhole

Distance (ft): 134.4 Structural Grade: 0 O&M Grade: 0

M-1004-055 Remarks:
