Profile/Photo Observation Report

Street:	Juniper Ct.	Flow Control:	Not Controlled
City:	Hobart, IN	Year Renewed:	
Location:	Other	Tape/Media #:	
Purpose:	Not Known	Dia/Height:	8"
Use:	Sanitary	Material:	PVC
Drain Area:	NA	Lining:	
Category:	NA		
Comment:

Location Details:		Direction of Survey:	Upstream
US MH:	M-1004-055	DS MH:	M-1004-096
		Total Length Surveyed (ft):	120.3

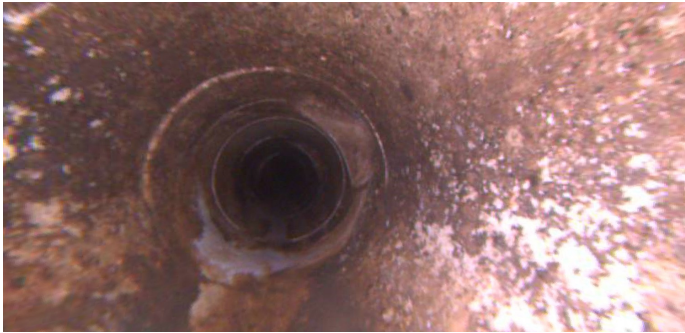
Code:	MWL
Description:	Water Level

Distance (ft):	.0
Structural Grade:	0
O&M Grade:	0
Clock Start/From:	
Clock To:	
1st Value:	
2nd Value:	
Value Percent:	5.000
Continuous Index:	
Within 8" of Joint:	NO
Remarks:

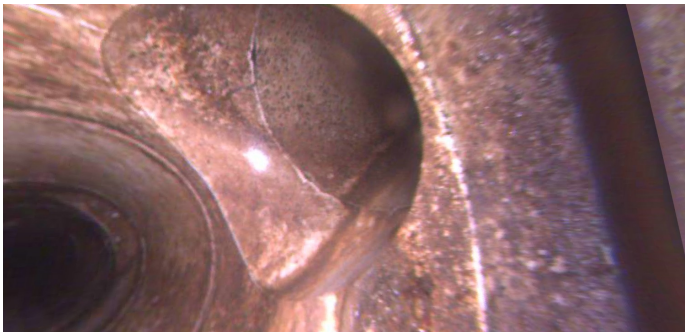
Code:	TF
Description:	Tap Factory

Distance (ft):	1.1
Structural Grade:	0
O&M Grade:	0
Clock Start/From:	2
Clock To:	
1st Value:	4.000
2nd Value:	
Value Percent:	
Continuous Index:	
Within 8" of Joint:	
Remarks:

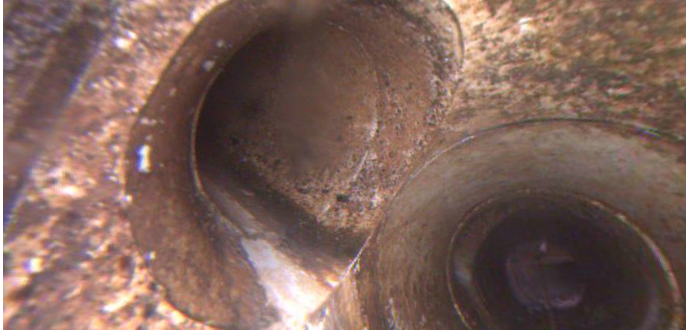
Code: **TF**
Description: **Tap Factory**

Distance (ft): **3.7**
Structural Grade: **0**
O&M Grade: **0**
Clock Start/From: **2**
Clock To:
1st Value: **4.000**
2nd Value:
Value Percent:
Continuous Index:
Within 8" of Joint:
Remarks:

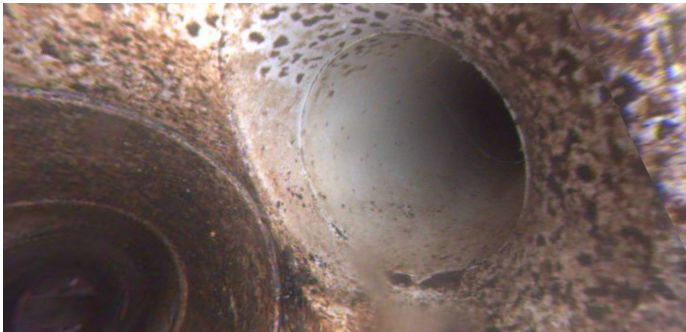
Code: **TF**
Description: **Tap Factory**

Distance (ft): **4.9**
Structural Grade: **0**
O&M Grade: **0**
Clock Start/From: **10**
Clock To:
1st Value: **4.000**
2nd Value:
Value Percent:
Continuous Index:
Within 8" of Joint:
Remarks:

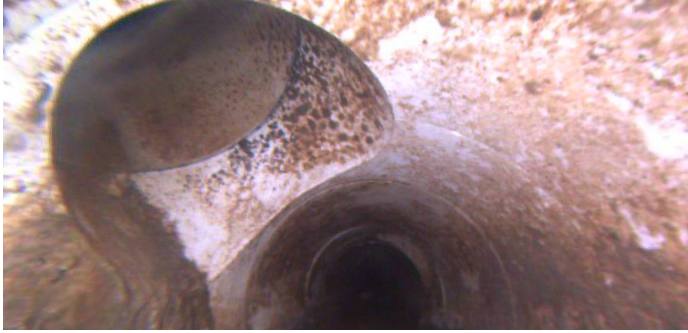
Code: **TF**
Description: **Tap Factory**

Distance (ft): **29.8**
Structural Grade: **0**
O&M Grade: **0**
Clock Start/From: **11**
Clock To:
1st Value: **4.000**
2nd Value:
Value Percent:
Continuous Index:
Within 8" of Joint:
Remarks:

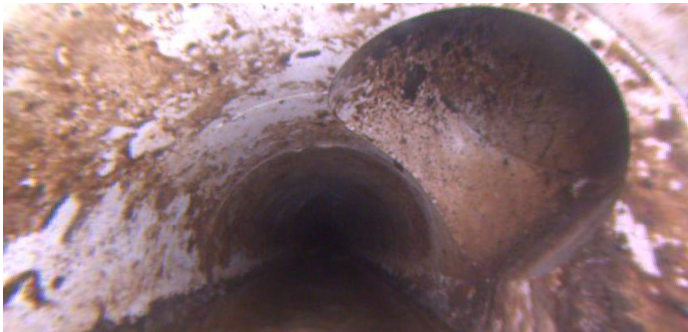
Code: **TF**
Description: **Tap Factory**

Distance (ft): **31.1**
Structural Grade: **0**
O&M Grade: **0**
Clock Start/From: **2**
Clock To:
1st Value: **4.000**
2nd Value:
Value Percent:
Continuous Index:
Within 8" of Joint:
Remarks:

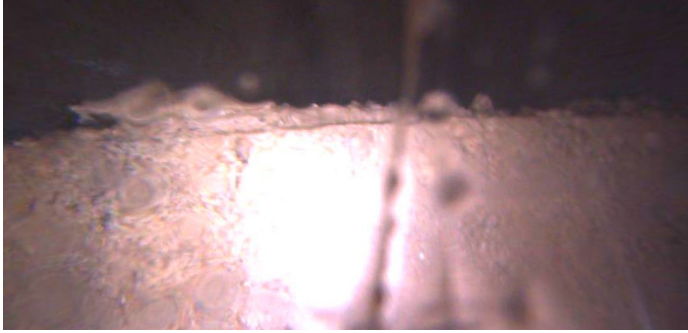
Code:	AMH
Description:	Manhole
Distance (ft):	120.3
Structural Grade:	0
O&M Grade:	0
Clock Start/From:	
Clock To:	
1st Value:	
2nd Value:	
Value Percent:	
Continuous Index:	
Within 8" of Joint:	NO
Remarks:	M-1004-055
