## Profile/Photo Observation Report

Street:	<b>BARBERRY DR</b>	Flow Control:	<b>Not Controlled</b>
City:	<b>Hobart, IN</b>	Year Renewed:	
Location:	<b>Other</b>	Tape/Media #:	
Purpose:	<b>Not Known</b>	Dia/Height:	<b>10"</b>
Use:	<b>Sanitary</b>	Material:	<b>PVC</b>
Drain Area:	<b>NA</b>	Lining:	
Category:	<b>NA</b>		
Comment:

Location Details:		Direction of Survey:	<b>Upstream</b>
US MH:	<b>M-1004-056</b>	DS MH:	<b>M-1004-057</b>
		Total Length Surveyed (ft):	<b>169.2</b>

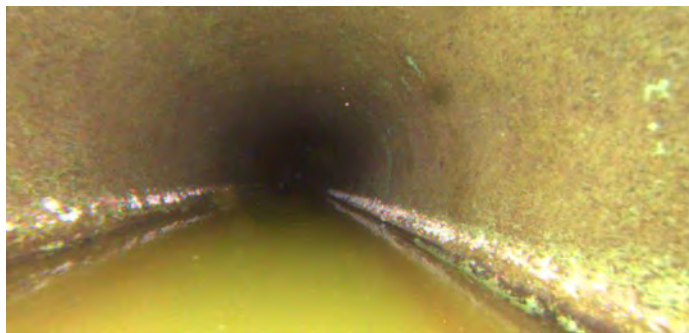
Code: **AMH**  
Description: **Manhole**

Distance (ft): **.0**  
Structural Grade: **0**  
O&M Grade: **0**  
Clock Start/From:  
Clock To:  
1st Value:  
2nd Value:  
Value Percent:  
Continuous Index:  
Within 8" of Joint: **NO**  
Remarks: **M-1004-057**

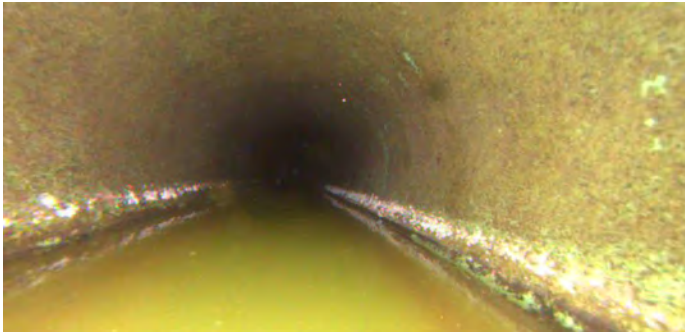
Code:	<b>MWL</b>
Description:	<b>Water Level</b>

Distance (ft):	<b>.0</b>
Structural Grade:	<b>0</b>
O&M Grade:	<b>0</b>
Clock Start/From:	
Clock To:	
1st Value:	
2nd Value:	
Value Percent:	<b>30.000</b>
Continuous Index:	
Within 8" of Joint:	<b>NO</b>
Remarks:

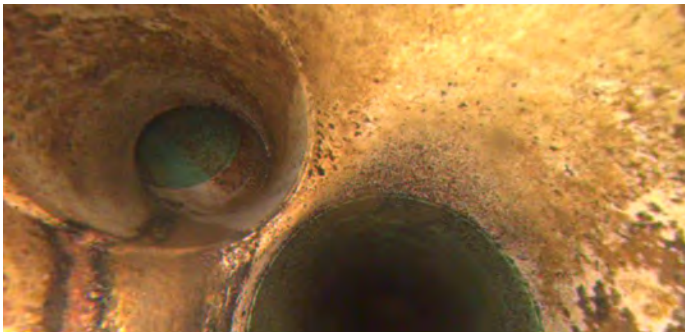
Code:	<b>TF</b>
Description:	<b>Tap Factory</b>

Distance (ft):	<b>18.1</b>
Structural Grade:	<b>0</b>
O&M Grade:	<b>0</b>
Clock Start/From:	<b>10</b>
Clock To:	
1st Value:	<b>4.000</b>
2nd Value:	
Value Percent:	
Continuous Index:	
Within 8" of Joint:	<b>NO</b>
Remarks:

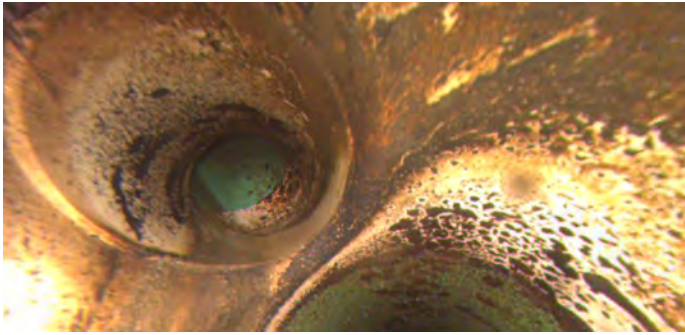
Code: **TF**  
Description: **Tap Factory**

Distance (ft): **94.9**  
Structural Grade: **0**  
O&M Grade: **0**  
Clock Start/From: **10**  
Clock To:  
1st Value: **4.000**  
2nd Value:  
Value Percent:  
Continuous Index:  
Within 8" of Joint:  
Remarks:

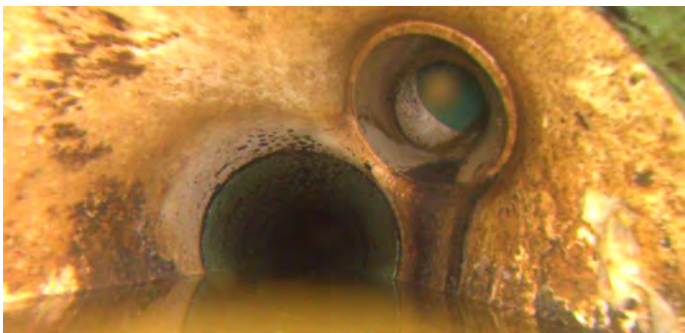
Code: **TF**  
Description: **Tap Factory**

Distance (ft): **107.7**  
Structural Grade: **0**  
O&M Grade: **0**  
Clock Start/From: **1**  
Clock To:  
1st Value: **4.000**  
2nd Value:  
Value Percent:  
Continuous Index:  
Within 8" of Joint:  
Remarks:

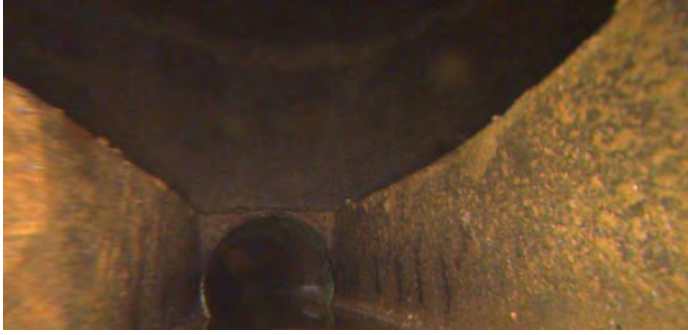
Code:	AMH
Description:	Manhole
Distance (ft):	169.2
Structural Grade:	0
O&M Grade:	0
Clock Start/From:	
Clock To:	
1st Value:	
2nd Value:	
Value Percent:	
Continuous Index:	
Within 8" of Joint:	NO
Remarks:	M-1004-056
