Profile/Photo Observation Report

Street:	Barberry Dr.	Flow Control:	Not Controlled
City:	Hobart, IN	Year Renewed:	
Location:	Other	Tape/Media #:	
Purpose:	Not Known	Dia/Height:	10"
Use:	Sanitary	Material:	PVC
Drain Area:	NA	Lining:	
Category:	NA		
Comment:

Location Details:		Direction of Survey:	Upstream
US MH:	M-1004-056	DS MH:	M-1004-057
		Total Length Surveyed (ft):	169.2

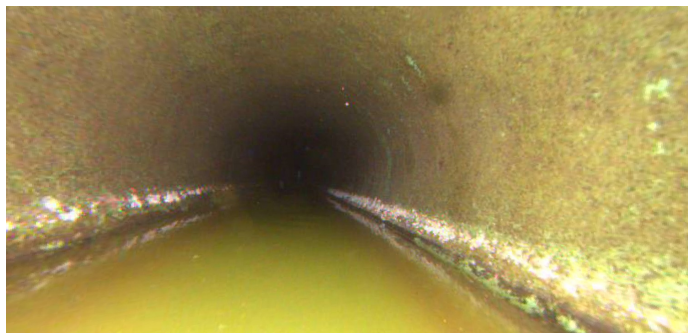
Code: **AMH**
Description: **Manhole**

Distance (ft): **.0**
Structural Grade: **0**
O&M Grade: **0**
Clock Start/From:
Clock To:
1st Value:
2nd Value:
Value Percent:
Continuous Index:
Within 8" of Joint: **NO**
Remarks: **M-1004-057**

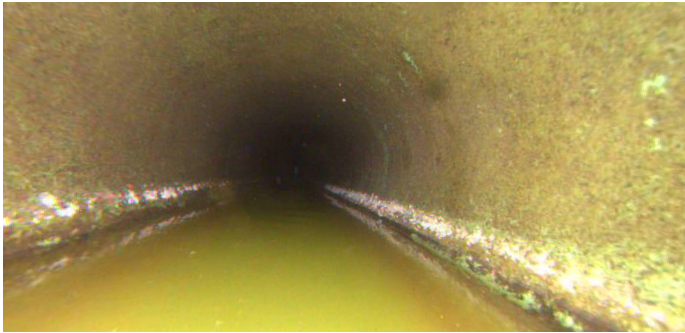
Code:	MWL
Description:	Water Level

Distance (ft):	.0
Structural Grade:	0
O&M Grade:	0
Clock Start/From:	
Clock To:	
1st Value:	
2nd Value:	
Value Percent:	30.000
Continuous Index:	
Within 8" of Joint:	NO
Remarks:

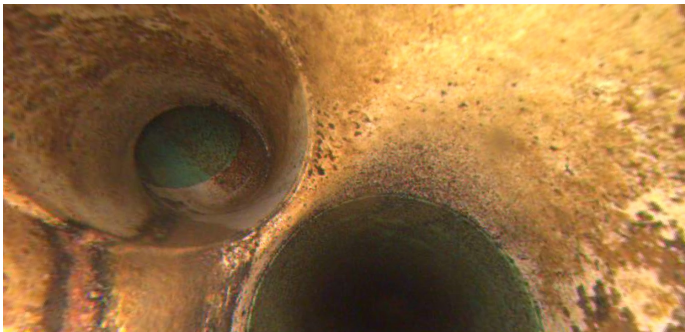
Code:	TF
Description:	Tap Factory

Distance (ft):	18.1
Structural Grade:	0
O&M Grade:	0
Clock Start/From:	10
Clock To:	
1st Value:	4.000
2nd Value:	
Value Percent:	
Continuous Index:	
Within 8" of Joint:	NO
Remarks:

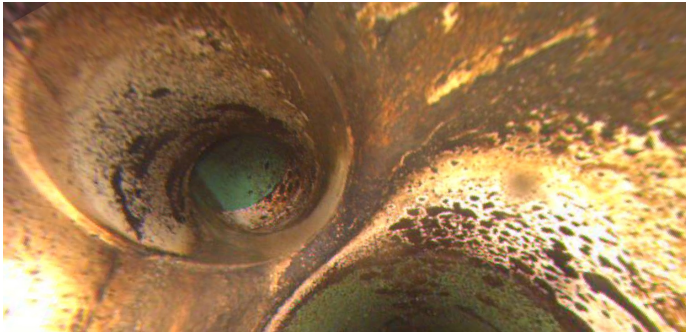
Code: **TF**
Description: **Tap Factory**

Distance (ft): **94.9**
Structural Grade: **0**
O&M Grade: **0**
Clock Start/From: **10**
Clock To:
1st Value: **4.000**
2nd Value:
Value Percent:
Continuous Index:
Within 8" of Joint:
Remarks:

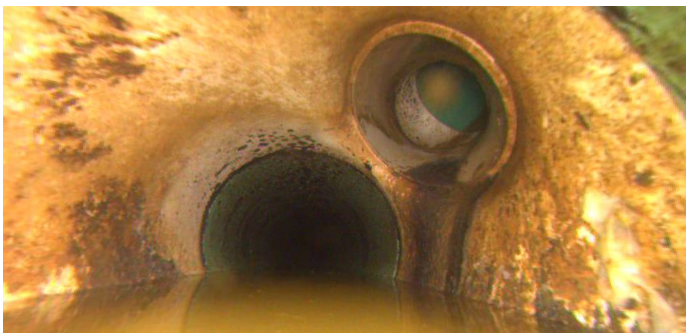
Code: **TF**
Description: **Tap Factory**

Distance (ft): **107.7**
Structural Grade: **0**
O&M Grade: **0**
Clock Start/From: **1**
Clock To:
1st Value: **4.000**
2nd Value:
Value Percent:
Continuous Index:
Within 8" of Joint:
Remarks:

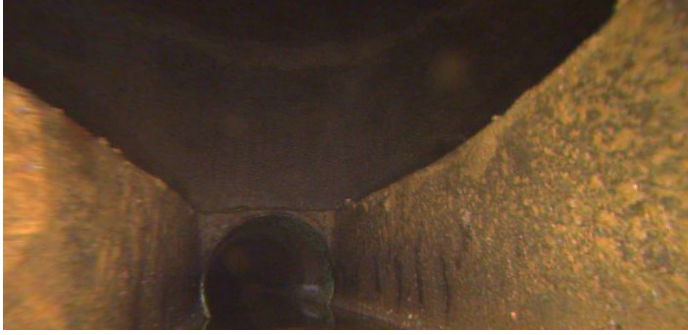
Code:	AMH
Description:	Manhole
Distance (ft):	169.2
Structural Grade:	0
O&M Grade:	0
Clock Start/From:	
Clock To:	
1st Value:	
2nd Value:	
Value Percent:	
Continuous Index:	
Within 8" of Joint:	NO
Remarks:	M-1004-056
