## Profile/Photo Observation Report

Date:	<b>04/12/2018</b>	Weather:		Coding:	<b>PACP 6.0</b>
Pipe Length (ft):	<b>148.4</b>	Owner:	<b>NA</b>	Pre Clean:	<b>Not Known</b>
P.O.#:		Surveyor:	<b>Jen Costello</b>	PSR:	<b>P-1004-057-058</b>
Customer:		Clean Date:	<b>01/01/1900</b>	Shape:	<b>C</b>

Street:	<b>BARBERRY DR</b>	Flow Control:	<b>Not Controlled</b>
City:	<b>Hobart, IN</b>	Year Renewed:	
Location:	<b>Other</b>	Tape/Media #:	
Purpose:	<b>Not Known</b>	Dia/Height:	<b>8"</b>
Use:	<b>Sanitary</b>	Material:	<b>PVC</b>
Drain Area:	<b>NA</b>	Lining:	
Category:	<b>NA</b>		
Comment:

Location Details:		Direction of Survey:	<b>Upstream</b>
US MH:	<b>M-1004-057</b>	DS MH:	<b>M-1004-058</b>
		Total Length Surveyed (ft):	<b>144.5</b>

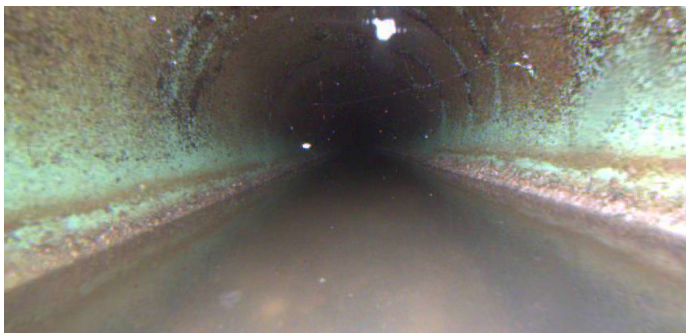
Code: **AMH**  
Description: **Manhole**

Distance (ft): **.0**  
Structural Grade: **0**  
O&M Grade: **0**  
Clock Start/From:  
Clock To:  
1st Value:  
2nd Value:  
Value Percent:  
Continuous Index:  
Within 8" of Joint: **NO**  
Remarks: **M-1004-058**

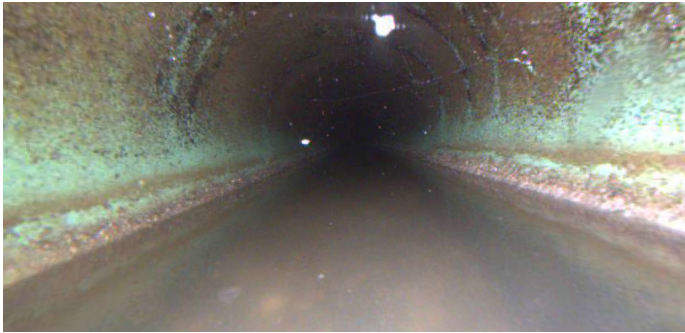
Code:	<b>MWL</b>
Description:	<b>Water Level</b>

Distance (ft):	<b>.0</b>
Structural Grade:	<b>0</b>
O&M Grade:	<b>0</b>
Clock Start/From:	
Clock To:	
1st Value:	
2nd Value:	
Value Percent:	<b>20.000</b>
Continuous Index:	
Within 8" of Joint:	<b>NO</b>
Remarks:

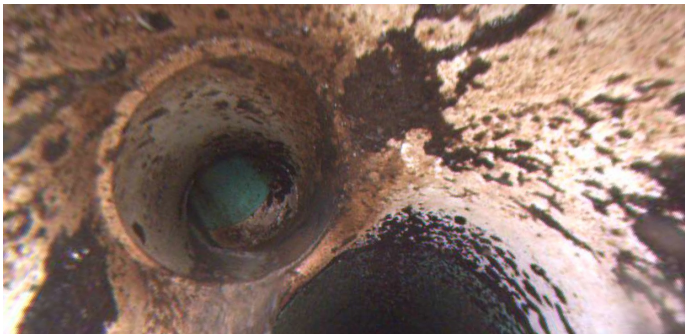
Code:	<b>TFA</b>
Description:	<b>Tap Factory Active</b>

Distance (ft):	<b>11.7</b>
Structural Grade:	<b>0</b>
O&M Grade:	<b>0</b>
Clock Start/From:	<b>11</b>
Clock To:	
1st Value:	<b>4.000</b>
2nd Value:	
Value Percent:	
Continuous Index:	
Within 8" of Joint:	
Remarks:

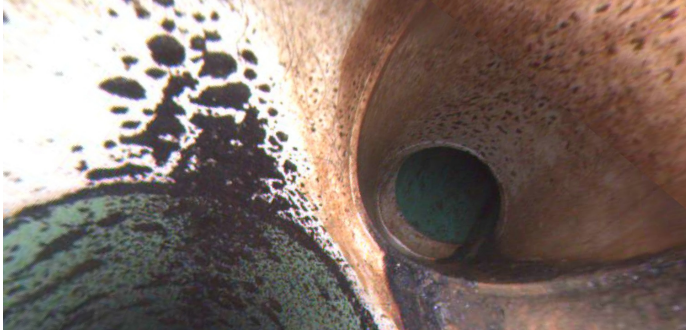
Code: **TF**  
Description: **Tap Factory**

Distance (ft): **66.8**  
Structural Grade: **0**  
O&M Grade: **0**  
Clock Start/From: **2**  
Clock To:  
1st Value: **4.000**  
2nd Value:  
Value Percent:  
Continuous Index:  
Within 8" of Joint:  
Remarks:

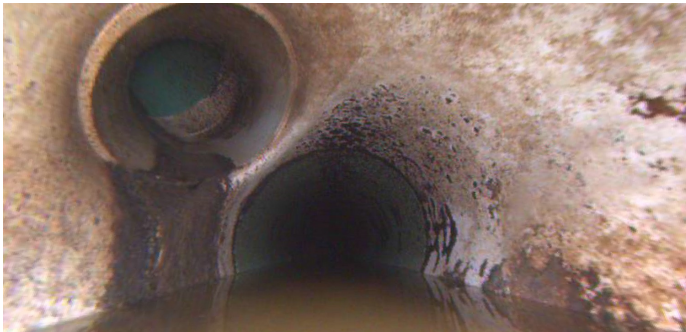
Code: **TF**  
Description: **Tap Factory**

Distance (ft): **89.1**  
Structural Grade: **0**  
O&M Grade: **0**  
Clock Start/From: **10**  
Clock To:  
1st Value: **4.000**  
2nd Value:  
Value Percent:  
Continuous Index:  
Within 8" of Joint:  
Remarks:

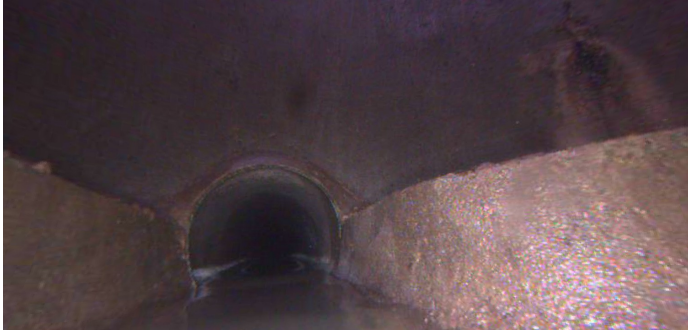
Code:	<b>AMH</b>
Description:	<b>Manhole</b>
Distance (ft):	<b>144.5</b>
Structural Grade:	<b>0</b>
O&M Grade:	<b>0</b>
Clock Start/From:	
Clock To:	
1st Value:	
2nd Value:	
Value Percent:	
Continuous Index:	
Within 8" of Joint:	<b>NO</b>
Remarks:	<b>M-1004-057</b>
