Profile/Photo Observation Report

Street:	BARBERRY DR	Flow Control:	Not Controlled
City:	Hobart, IN	Year Renewed:	
Location:	Other	Tape/Media #:	
Purpose:	Not Known	Dia/Height:	8"
Use:	Sanitary	Material:	PVC
Drain Area:	NA	Lining:	
Category:	NA		
Comment:

Location Details:		Direction of Survey:	Downstream
US MH:	M-1004-058	DS MH:	M-1004-059
		Total Length Surveyed (ft):	124.9

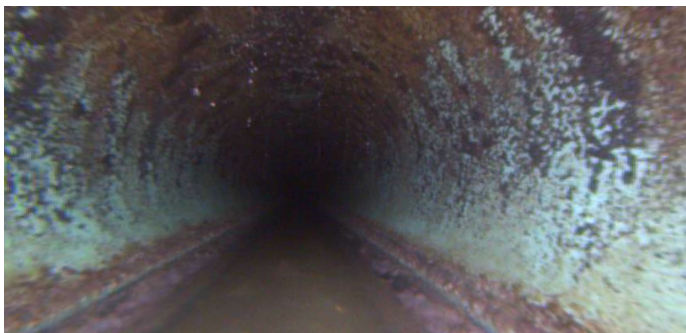
Code: **AMH**
Description: **Manhole**

Distance (ft): **.0**
Structural Grade: **0**
O&M Grade: **0**
Clock Start/From:
Clock To:
1st Value:
2nd Value:
Value Percent:
Continuous Index:
Within 8" of Joint: **NO**
Remarks: **M-1004-058**

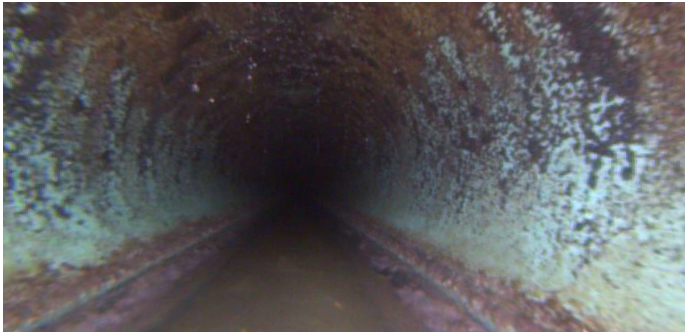
Code:	MWL
Description:	Water Level

Distance (ft):	.0
Structural Grade:	0
O&M Grade:	0
Clock Start/From:	
Clock To:	
1st Value:	
2nd Value:	
Value Percent:	5.000
Continuous Index:	
Within 8" of Joint:	NO
Remarks:

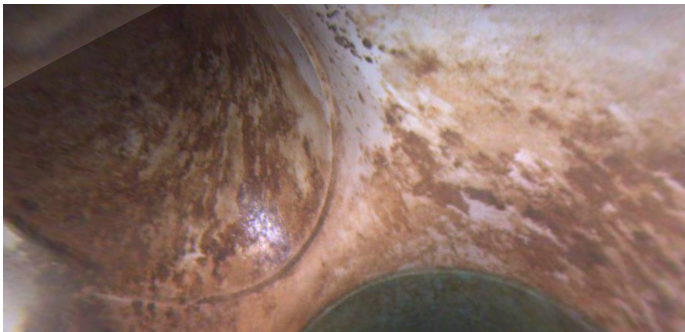
Code:	TF
Description:	Tap Factory

Distance (ft):	27.4
Structural Grade:	0
O&M Grade:	0
Clock Start/From:	11
Clock To:	
1st Value:	4.000
2nd Value:	
Value Percent:	
Continuous Index:	
Within 8" of Joint:	
Remarks:

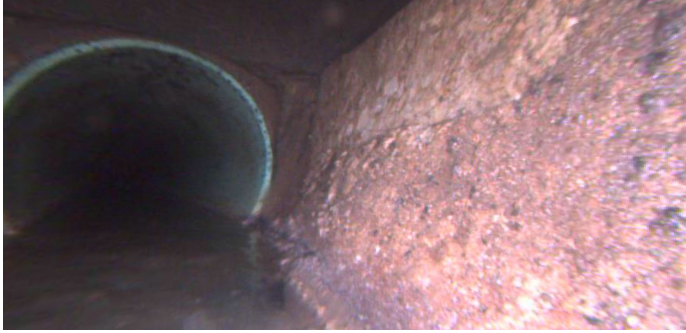
Code:	AMH
Description:	Manhole
Distance (ft):	124.9
Structural Grade:	0
O&M Grade:	0
Clock Start/From:	
Clock To:	
1st Value:	
2nd Value:	
Value Percent:	
Continuous Index:	
Within 8" of Joint:	NO
Remarks:	M-1004-059
