Profile/Photo Observation Report

Street:	Barberry Dr.	Flow Control:	Not Controlled
City:	Hobart, IN	Year Renewed:	
Location:	Other	Tape/Media #:	
Purpose:	Not Known	Dia/Height:	8"
Use:	Sanitary	Material:	PVC
Drain Area:	NA	Lining:	
Category:	NA		
Comment:

Location Details:		Direction of Survey:	Downstream
US MH:	M-1004-058	DS MH:	M-1004-059
		Total Length Surveyed (ft):	124.9

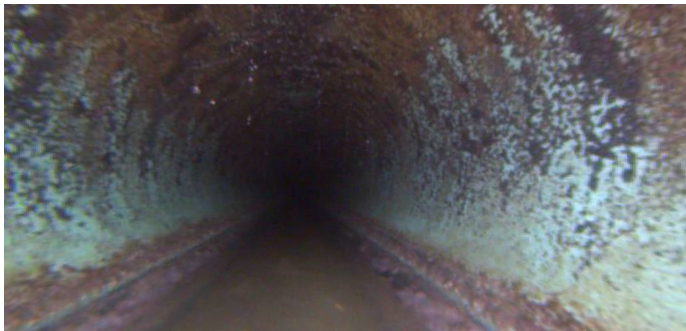
Code: **AMH**
Description: **Manhole**

Distance (ft): **.0**
Structural Grade: **0**
O&M Grade: **0**
Clock Start/From:
Clock To:
1st Value:
2nd Value:
Value Percent:
Continuous Index:
Within 8" of Joint: **NO**
Remarks: **M-1004-058**

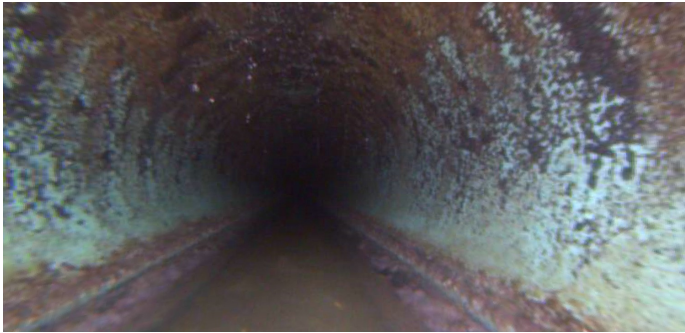
Code:	MWL
Description:	Water Level

Distance (ft):	.0
Structural Grade:	0
O&M Grade:	0
Clock Start/From:	
Clock To:	
1st Value:	
2nd Value:	
Value Percent:	5.000
Continuous Index:	
Within 8" of Joint:	NO
Remarks:

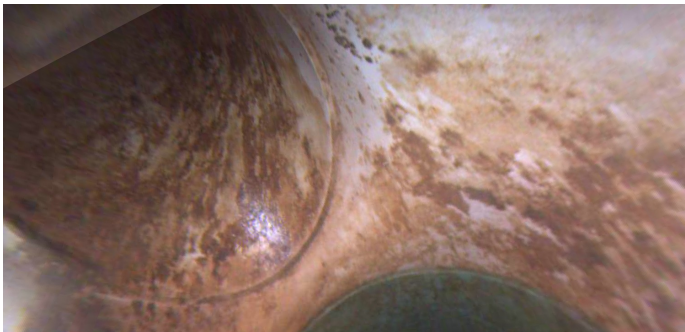
Code:	TF
Description:	Tap Factory

Distance (ft):	27.4
Structural Grade:	0
O&M Grade:	0
Clock Start/From:	11
Clock To:	
1st Value:	4.000
2nd Value:	
Value Percent:	
Continuous Index:	
Within 8" of Joint:	
Remarks:

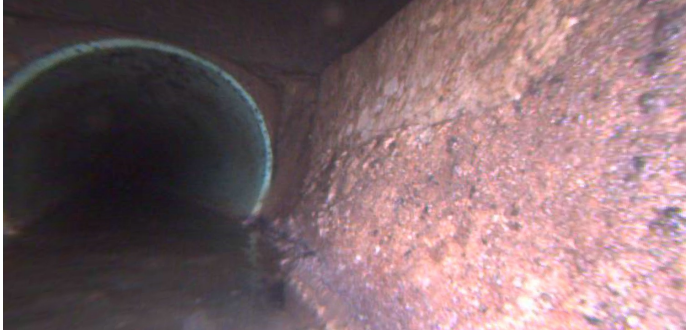
Code:	AMH
Description:	Manhole
Distance (ft):	124.9
Structural Grade:	0
O&M Grade:	0
Clock Start/From:	
Clock To:	
1st Value:	
2nd Value:	
Value Percent:	
Continuous Index:	
Within 8" of Joint:	NO
Remarks:	M-1004-059
