## Profile/Photo Observation Report

Street:	<b>Hillcrest Ave.</b>	Flow Control:	<b>Not Controlled</b>
City:	<b>Hobart, IN</b>	Year Renewed:	
Location:	<b>Other</b>	Tape/Media #:	
Purpose:	<b>Not Known</b>	Dia/Height:	<b>10"</b>
Use:	<b>Sanitary</b>	Material:	<b>PVC</b>
Drain Area:	<b>NA</b>	Lining:	
Category:	<b>NA</b>		
Comment:

Location Details:		Direction of Survey:	<b>Upstream</b>
US MH:	<b>M-1004-060</b>	DS MH:	<b>M-1004-061</b>
		Total Length Surveyed (ft):	<b>159.0</b>

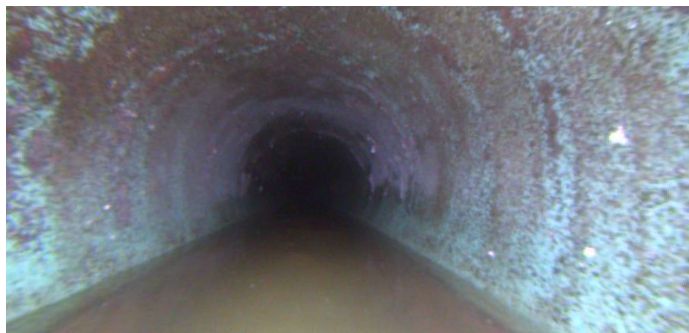
Code: **AMH**  
 Description: **Manhole**  
 Distance (ft): **.0**  
 Structural Grade: **0**  
 O&M Grade: **0**  
 Clock Start/From:  
 Clock To:  
 1st Value:  
 2nd Value:  
 Value Percent:  
 Continuous Index:  
 Within 8" of Joint: **NO**  
 Remarks: **M-1004-061**

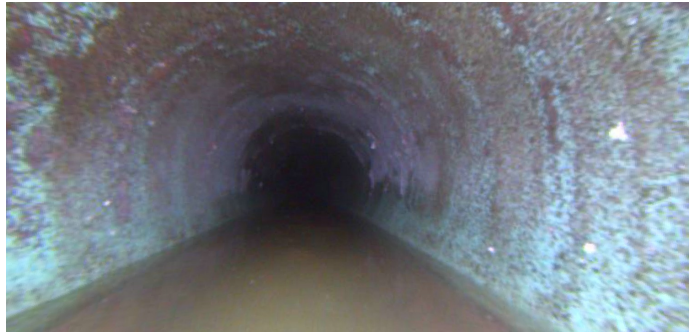
Code:	<b>MWL</b>
Description:	<b>Water Level</b>
Distance (ft):	<b>.0</b>
Structural Grade:	<b>0</b>
O&M Grade:	<b>0</b>
Clock Start/From:	
Clock To:	
1st Value:	
2nd Value:	
Value Percent:	<b>20.000</b>
Continuous Index:	
Within 8" of Joint:	<b>NO</b>
Remarks:

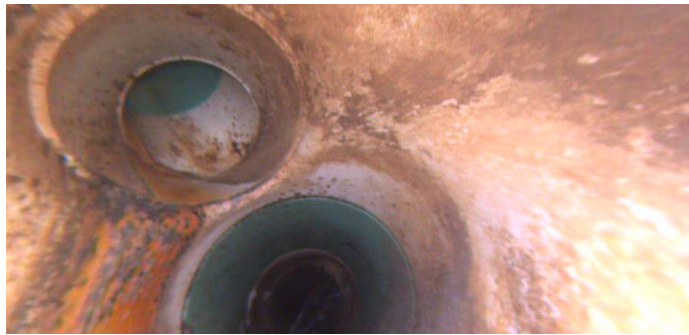
Code:	<b>TF</b>
Description:	<b>Tap Factory</b>
Distance (ft):	<b>19.1</b>
Structural Grade:	<b>0</b>
O&M Grade:	<b>0</b>
Clock Start/From:	<b>11</b>
Clock To:	
1st Value:	<b>4.000</b>
2nd Value:	
Value Percent:	
Continuous Index:	
Within 8" of Joint:	
Remarks:

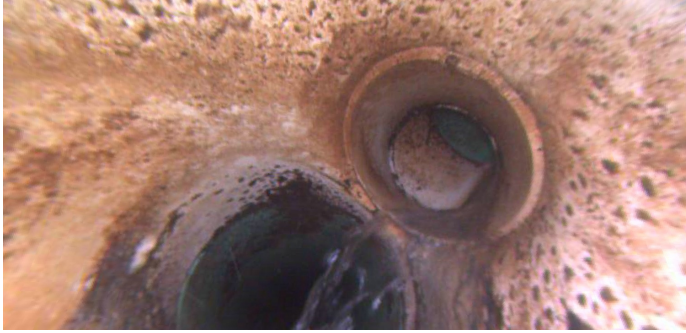
Code: **TFA**  
Description: **Tap Factory Active**

Distance (ft): **21.4**  
Structural Grade: **0**  
O&M Grade: **0**  
Clock Start/From: **1**  
Clock To:  
1st Value: **4.000**  
2nd Value:  
Value Percent:  
Continuous Index:  
Within 8" of Joint:  
Remarks:

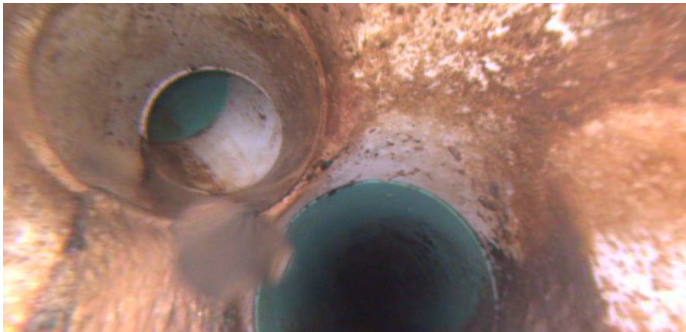
Code: **TF**  
Description: **Tap Factory**

Distance (ft): **93.1**  
Structural Grade: **0**  
O&M Grade: **0**  
Clock Start/From: **10**  
Clock To:  
1st Value: **4.000**  
2nd Value:  
Value Percent:  
Continuous Index:  
Within 8" of Joint:  
Remarks:

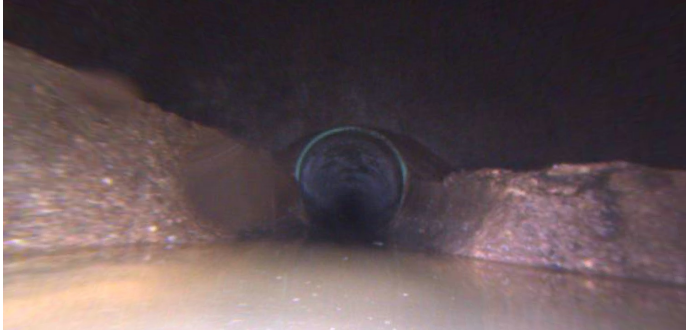
Code:	AMH
Description:	Manhole
Distance (ft):	159.0
Structural Grade:	0
O&M Grade:	0
Clock Start/From:	
Clock To:	
1st Value:	
2nd Value:	
Value Percent:	
Continuous Index:	
Within 8" of Joint:	NO
Remarks:	M-1004-060
