## Profile/Photo Observation Report

Street:	<b>HILLCREST AVE</b>	Flow Control:	<b>Not Controlled</b>
City:	<b>Hobart, IN</b>	Year Renewed:	
Location:	<b>Other</b>	Tape/Media #:	
Purpose:	<b>Not Known</b>	Dia/Height:	<b>8"</b>
Use:	<b>Sanitary</b>	Material:	<b>PVC</b>
Drain Area:	<b>NA</b>	Lining:	
Category:	<b>NA</b>		
Comment:

Location Details:		Direction of Survey:	<b>Downstream</b>
US MH:	<b>M-1004-060</b>	DS MH:	<b>M-1004-094</b>
		Total Length Surveyed (ft):	<b>241.6</b>

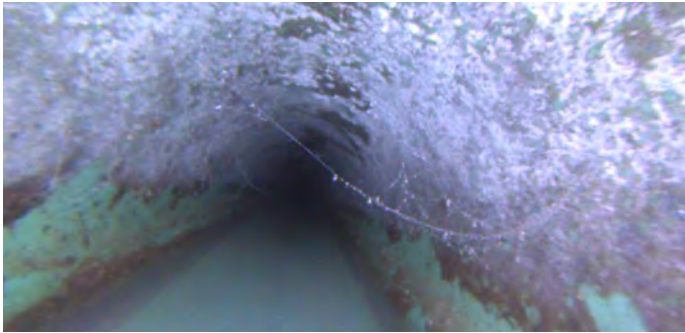
Code:	<b>MWL</b>
Description:	<b>Water Level</b>

Distance (ft):	<b>.0</b>
Structural Grade:	<b>0</b>
O&M Grade:	<b>0</b>
Clock Start/From:	
Clock To:	
1st Value:	
2nd Value:	
Value Percent:	<b>20.000</b>
Continuous Index:	
Within 8" of Joint:	<b>NO</b>
Remarks:

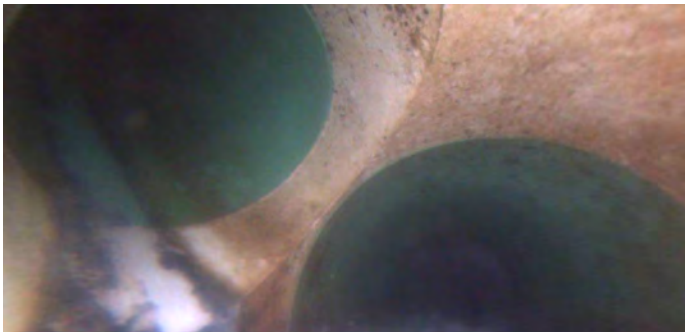
Code:	<b>TFA</b>
Description:	<b>Tap Factory Active</b>

Distance (ft):	<b>12.3</b>
Structural Grade:	<b>0</b>
O&M Grade:	<b>0</b>
Clock Start/From:	<b>11</b>
Clock To:	
1st Value:	<b>4.000</b>
2nd Value:	
Value Percent:	
Continuous Index:	
Within 8" of Joint:	
Remarks:

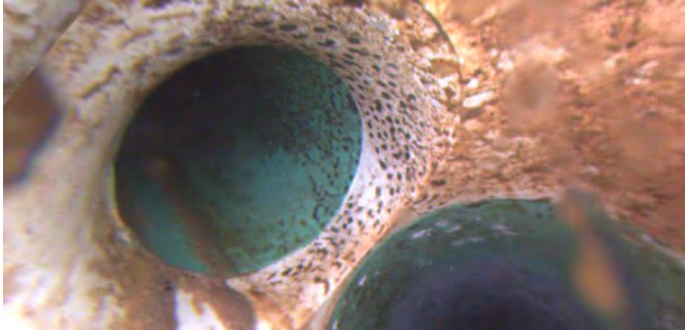
Code: **TF**  
Description: **Tap Factory**

Distance (ft): **80.4**  
Structural Grade: **0**  
O&M Grade: **0**  
Clock Start/From: **10**  
Clock To:  
1st Value: **4.000**  
2nd Value:  
Value Percent:  
Continuous Index:  
Within 8" of Joint:  
Remarks:

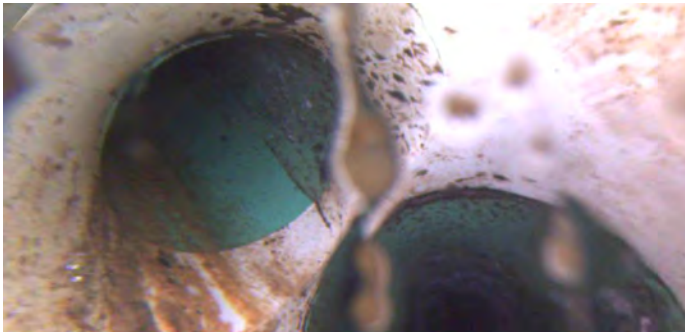
Code: **TF**  
Description: **Tap Factory**

Distance (ft): **145.0**  
Structural Grade: **0**  
O&M Grade: **0**  
Clock Start/From: **11**  
Clock To:  
1st Value: **4.000**  
2nd Value:  
Value Percent:  
Continuous Index:  
Within 8" of Joint:  
Remarks:

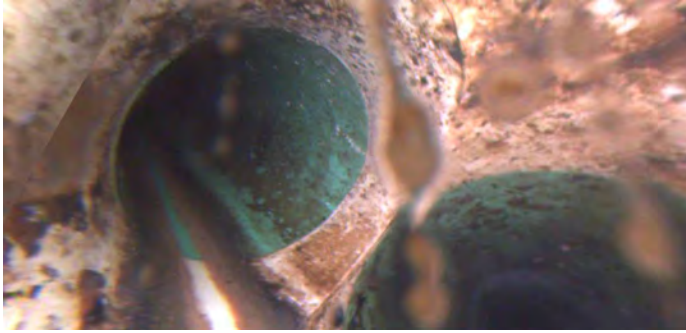
Code: **TF**  
Description: **Tap Factory**

Distance (ft): **218.1**  
Structural Grade: **0**  
O&M Grade: **0**  
Clock Start/From: **10**  
Clock To:  
1st Value: **4.000**  
2nd Value:  
Value Percent:  
Continuous Index:  
Within 8" of Joint:  
Remarks:

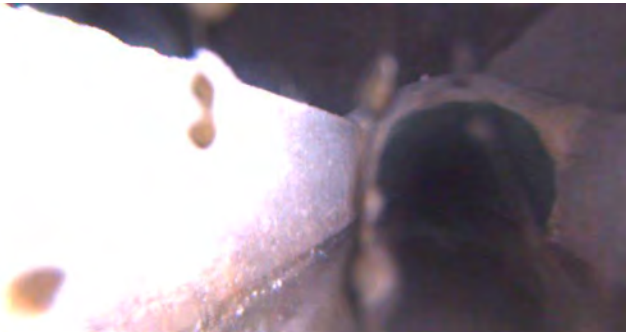
Code: **AMH**  
Description: **Manhole**

Distance (ft): **241.6**  
Structural Grade: **0**  
O&M Grade: **0**  
Clock Start/From:  
Clock To:  
1st Value:  
2nd Value:  
Value Percent:  
Continuous Index:  
Within 8" of Joint: **NO**  
Remarks: **M-1004-094**
