## Profile/Photo Observation Report

Street:	<b>Hillcrest Ave.</b>	Flow Control:	<b>Not Controlled</b>
City:	<b>Hobart, IN</b>	Year Renewed:	
Location:	<b>Other</b>	Tape/Media #:	
Purpose:	<b>Not Known</b>	Dia/Height:	<b>8"</b>
Use:	<b>Sanitary</b>	Material:	<b>PVC</b>
Drain Area:	<b>NA</b>	Lining:	
Category:	<b>NA</b>		
Comment:

Location Details:		Direction of Survey:	<b>Downstream</b>
US MH:	<b>M-1004-060</b>	DS MH:	<b>M-1004-094</b>
		Total Length Surveyed (ft):	<b>241.6</b>

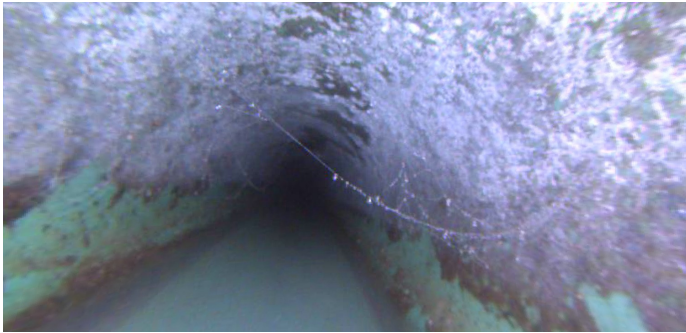
Code:	<b>MWL</b>
Description:	<b>Water Level</b>

Distance (ft):	<b>.0</b>
Structural Grade:	<b>0</b>
O&M Grade:	<b>0</b>
Clock Start/From:	
Clock To:	
1st Value:	
2nd Value:	
Value Percent:	<b>20.000</b>
Continuous Index:	
Within 8" of Joint:	<b>NO</b>
Remarks:

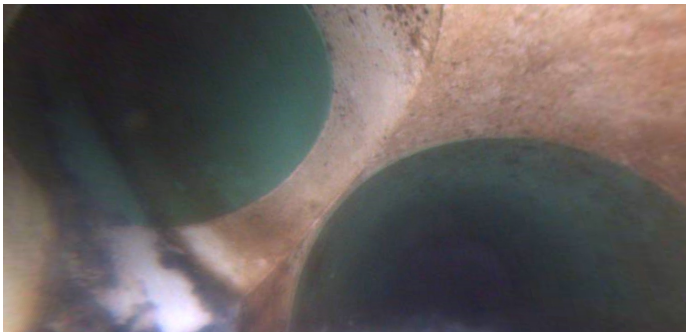
Code:	<b>TFA</b>
Description:	<b>Tap Factory Active</b>

Distance (ft):	<b>12.3</b>
Structural Grade:	<b>0</b>
O&M Grade:	<b>0</b>
Clock Start/From:	<b>11</b>
Clock To:	
1st Value:	<b>4.000</b>
2nd Value:	
Value Percent:	
Continuous Index:	
Within 8" of Joint:	
Remarks:

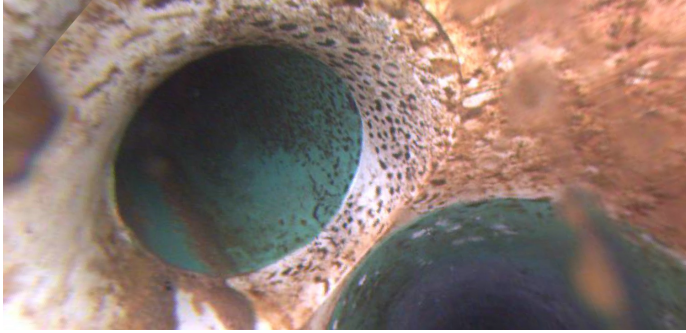
Code: **TF**  
Description: **Tap Factory**

Distance (ft): **80.4**  
Structural Grade: **0**  
O&M Grade: **0**  
Clock Start/From: **10**  
Clock To:  
1st Value: **4.000**  
2nd Value:  
Value Percent:  
Continuous Index:  
Within 8" of Joint:  
Remarks:

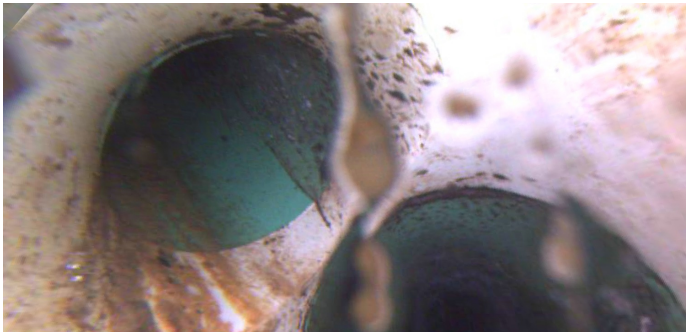
Code: **TF**  
Description: **Tap Factory**

Distance (ft): **145.0**  
Structural Grade: **0**  
O&M Grade: **0**  
Clock Start/From: **11**  
Clock To:  
1st Value: **4.000**  
2nd Value:  
Value Percent:  
Continuous Index:  
Within 8" of Joint:  
Remarks:

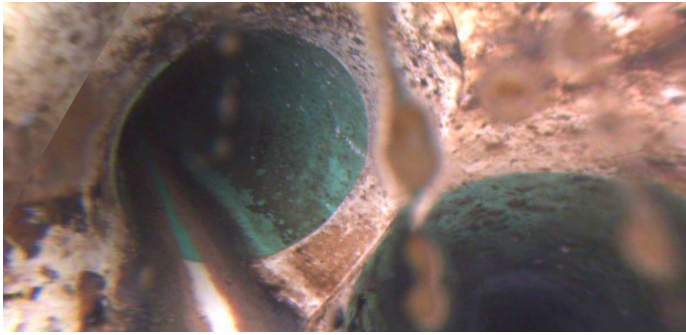
Code: **TF**  
Description: **Tap Factory**

Distance (ft): **218.1**  
Structural Grade: **0**  
O&M Grade: **0**  
Clock Start/From: **10**  
Clock To:  
1st Value: **4.000**  
2nd Value:  
Value Percent:  
Continuous Index:  
Within 8" of Joint:  
Remarks:

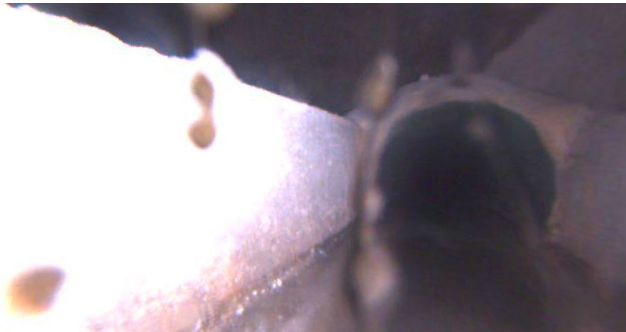
Code: **AMH**  
Description: **Manhole**

Distance (ft): **241.6**  
Structural Grade: **0**  
O&M Grade: **0**  
Clock Start/From:  
Clock To:  
1st Value:  
2nd Value:  
Value Percent:  
Continuous Index:  
Within 8" of Joint: **NO**  
Remarks: **M-1004-094**
