## Profile/Photo Observation Report

Street:	<b>HILLCREST AVE</b>	Flow Control:	<b>Not Controlled</b>
City:	<b>Hobart, IN</b>	Year Renewed:	
Location:	<b>Other</b>	Tape/Media #:	
Purpose:	<b>Not Known</b>	Dia/Height:	<b>10"</b>
Use:	<b>Sanitary</b>	Material:	<b>PVC</b>
Drain Area:	<b>NA</b>	Lining:	
Category:	<b>NA</b>		
Comment:

Location Details:		Direction of Survey:	<b>Downstream</b>
US MH:	<b>M-1004-061</b>	DS MH:	<b>M-1004-062</b>
		Total Length Surveyed (ft):	<b>140.9</b>

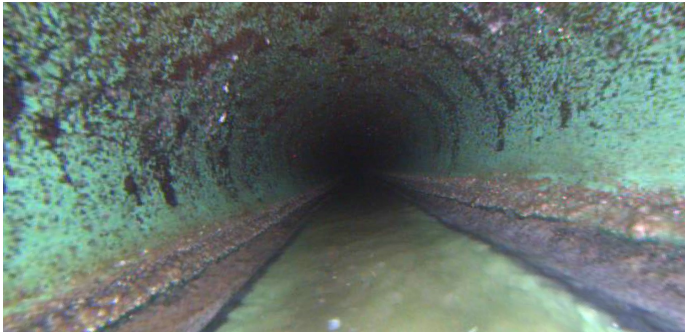
Code:	<b>MWL</b>
Description:	<b>Water Level</b>

Distance (ft):	<b>.0</b>
Structural Grade:	<b>0</b>
O&M Grade:	<b>0</b>
Clock Start/From:	
Clock To:	
1st Value:	
2nd Value:	
Value Percent:	<b>10.000</b>
Continuous Index:	
Within 8" of Joint:	<b>NO</b>
Remarks:

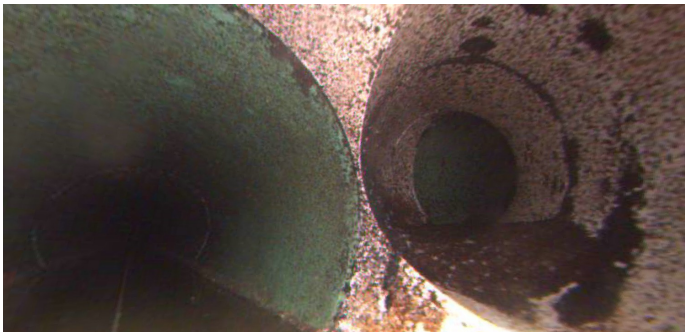
Code:	<b>TF</b>
Description:	<b>Tap Factory</b>

Distance (ft):	<b>37.9</b>
Structural Grade:	<b>0</b>
O&M Grade:	<b>0</b>
Clock Start/From:	<b>9</b>
Clock To:	
1st Value:	<b>4.000</b>
2nd Value:	
Value Percent:	
Continuous Index:	
Within 8" of Joint:	
Remarks:

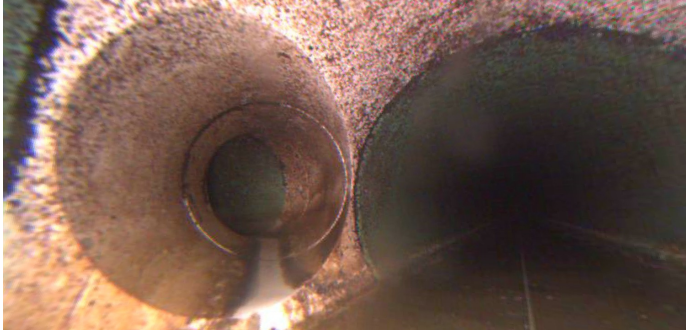
Code: **TFA**  
Description: **Tap Factory Active**

Distance (ft): **48.1**  
Structural Grade: **0**  
O&M Grade: **0**  
Clock Start/From: **3**  
Clock To:  
1st Value: **4.000**  
2nd Value:  
Value Percent:  
Continuous Index:  
Within 8" of Joint:  
Remarks:

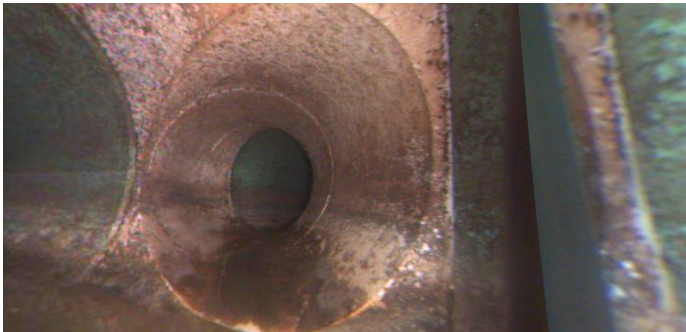
Code: **TF**  
Description: **Tap Factory**

Distance (ft): **110.4**  
Structural Grade: **0**  
O&M Grade: **0**  
Clock Start/From: **9**  
Clock To:  
1st Value: **4.000**  
2nd Value:  
Value Percent:  
Continuous Index:  
Within 8" of Joint:  
Remarks:

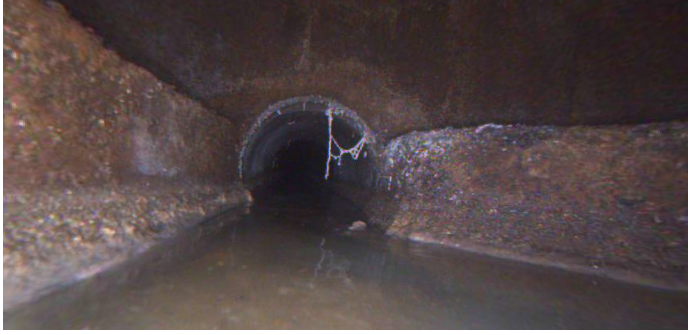
Code:	AMH
Description:	Manhole
Distance (ft):	140.9
Structural Grade:	0
O&M Grade:	0
Clock Start/From:	
Clock To:	
1st Value:	
2nd Value:	
Value Percent:	
Continuous Index:	
Within 8" of Joint:	NO
Remarks:	M-1004-062
