## Profile/Photo Observation Report

Location Details:		Direction of Survey:	<b>Downstream</b>
US MH:	<b>M-1004-061</b>	DS MH:	<b>M-1004-062</b>
		Total Length Surveyed (ft):	<b>140.9</b>

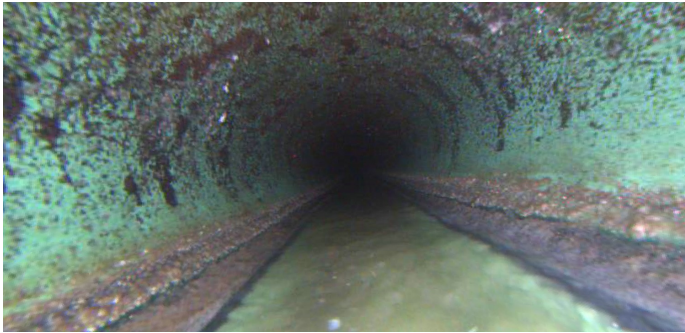
Code:	<b>MWL</b>
Description:	<b>Water Level</b>

Distance (ft):	<b>.0</b>
Structural Grade:	<b>0</b>
O&M Grade:	<b>0</b>
Clock Start/From:	
Clock To:	
1st Value:	
2nd Value:	
Value Percent:	<b>10.000</b>
Continuous Index:	
Within 8" of Joint:	<b>NO</b>
Remarks:

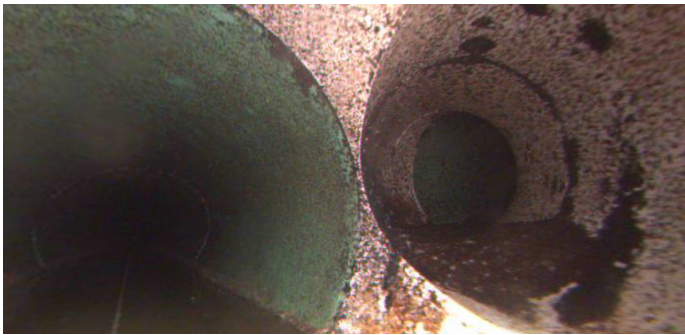
Code:	<b>TF</b>
Description:	<b>Tap Factory</b>

Distance (ft):	<b>37.9</b>
Structural Grade:	<b>0</b>
O&M Grade:	<b>0</b>
Clock Start/From:	<b>9</b>
Clock To:	
1st Value:	<b>4.000</b>
2nd Value:	
Value Percent:	
Continuous Index:	
Within 8" of Joint:	
Remarks:

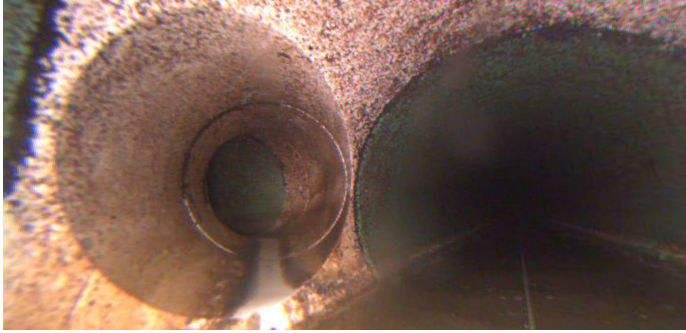
Code: **TFA**  
Description: **Tap Factory Active**

Distance (ft): **48.1**  
Structural Grade: **0**  
O&M Grade: **0**  
Clock Start/From: **3**  
Clock To:  
1st Value: **4.000**  
2nd Value:  
Value Percent:  
Continuous Index:  
Within 8" of Joint:  
Remarks:

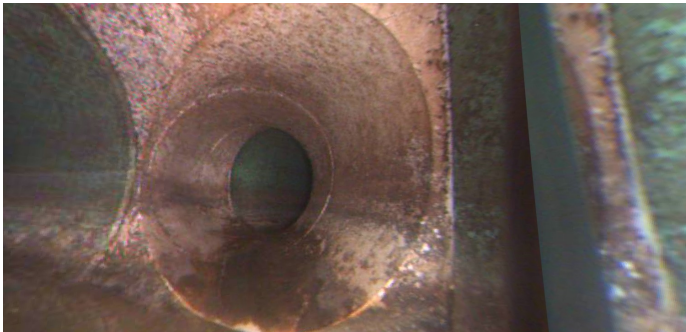
Code: **TF**  
Description: **Tap Factory**

Distance (ft): **110.4**  
Structural Grade: **0**  
O&M Grade: **0**  
Clock Start/From: **9**  
Clock To:  
1st Value: **4.000**  
2nd Value:  
Value Percent:  
Continuous Index:  
Within 8" of Joint:  
Remarks:

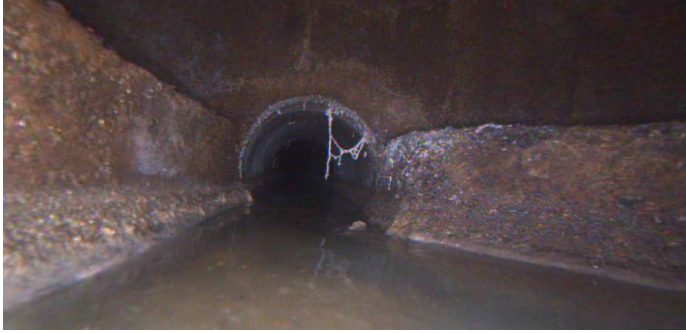
Code:	<b>AMH</b>
Description:	<b>Manhole</b>
Distance (ft):	<b>140.9</b>
Structural Grade:	<b>0</b>
O&M Grade:	<b>0</b>
Clock Start/From:	
Clock To:	
1st Value:	
2nd Value:	
Value Percent:	
Continuous Index:	
Within 8" of Joint:	<b>NO</b>
Remarks:	<b>M-1004-062</b>
