Profile/Photo Observation Report

Date:	04/11/2018	Weather:		Coding:	PACP 6.0
Pipe Length (ft):	236.3	Owner:	NA	Pre Clean:	Not Known
P.O.#:		Surveyor:	Jen Costello	PSR:	P-1004-064-062
Customer:		Clean Date:	01/01/1900	Shape:	C

Street:	POPLAR LN	Flow Control:	Not Controlled
City:	Hobart, IN	Year Renewed:	
Location:	Other	Tape/Media #:	
Purpose:	Not Known	Dia/Height:	8"
Use:	Sanitary	Material:	PVC
Drain Area:	NA	Lining:	
Category:	NA		
Comment:

Location Details:		Direction of Survey:	Upstream
US MH:	M-1004-062	DS MH:	M-1004-064
		Total Length Surveyed (ft):	230.6

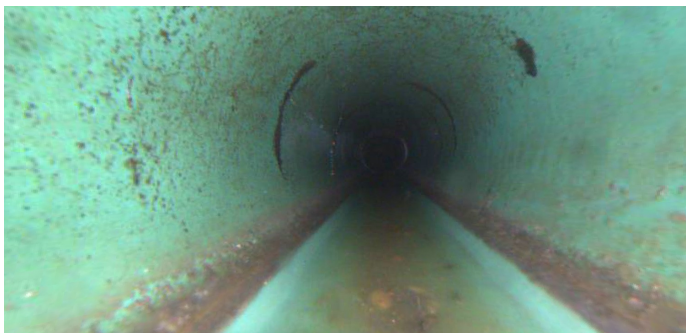
Code: **AMH**
Description: **Manhole**

Distance (ft): **.0**
Structural Grade: **0**
O&M Grade: **0**
Clock Start/From:
Clock To:
1st Value:
2nd Value:
Value Percent:
Continuous Index:
Within 8" of Joint: **NO**
Remarks: **M-1004-064**

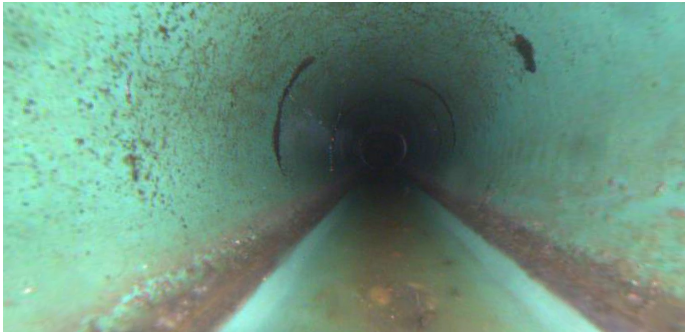
Code:	MWL
Description:	Water Level

Distance (ft):	.0
Structural Grade:	0
O&M Grade:	0
Clock Start/From:	
Clock To:	
1st Value:	
2nd Value:	
Value Percent:	5.000
Continuous Index:	
Within 8" of Joint:	NO
Remarks:	M-1004-062

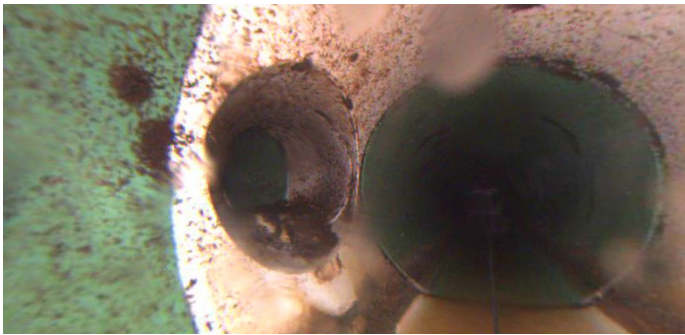
Code:	TFA
Description:	Tap Factory Active

Distance (ft):	6.8
Structural Grade:	0
O&M Grade:	0
Clock Start/From:	3
Clock To:	
1st Value:	4.000
2nd Value:	
Value Percent:	
Continuous Index:	
Within 8" of Joint:	
Remarks:

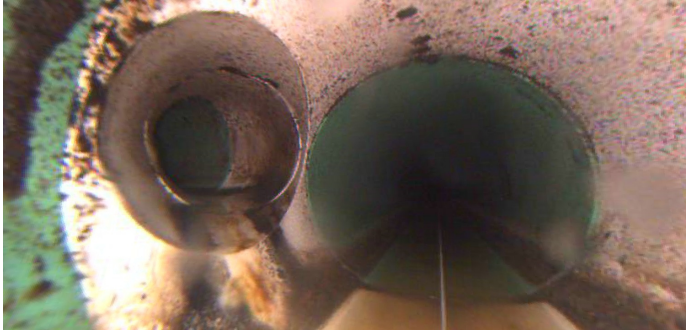
Code: **TFA**
Description: **Tap Factory Active**

Distance (ft): **38.8**
Structural Grade: **0**
O&M Grade: **0**
Clock Start/From: **3**
Clock To:
1st Value: **4.000**
2nd Value:
Value Percent:
Continuous Index:
Within 8" of Joint:
Remarks:

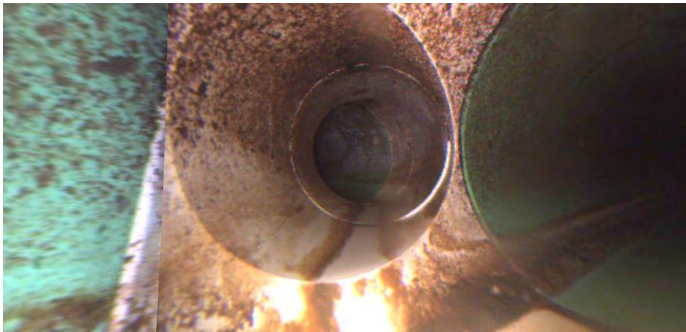
Code: **TF**
Description: **Tap Factory**

Distance (ft): **161.3**
Structural Grade: **0**
O&M Grade: **0**
Clock Start/From: **3**
Clock To:
1st Value: **4.000**
2nd Value:
Value Percent:
Continuous Index:
Within 8" of Joint:
Remarks:

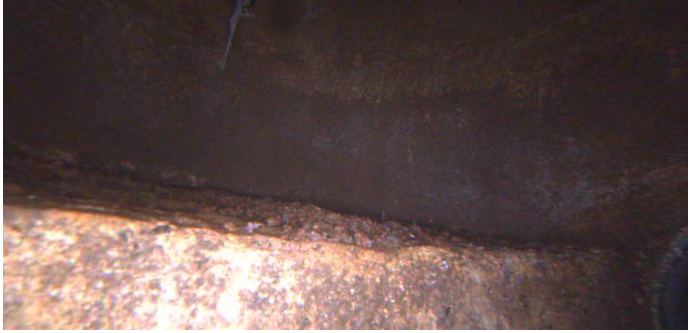
Code:	AMH
Description:	Manhole
Distance (ft):	230.6
Structural Grade:	0
O&M Grade:	0
Clock Start/From:	
Clock To:	
1st Value:	
2nd Value:	
Value Percent:	
Continuous Index:	
Within 8" of Joint:	NO
Remarks:	M-1004-062
