Profile/Photo Observation Report

Street:	Poplar Ln.	Flow Control:	Not Controlled
City:	Hobart, IN	Year Renewed:	
Location:	Other	Tape/Media #:	
Purpose:	Not Known	Dia/Height:	8"
Use:	Sanitary	Material:	PVC
Drain Area:	NA	Lining:	
Category:	NA		
Comment:

Location Details:		Direction of Survey:	Upstream
US MH:	M-1004-062	DS MH:	M-1004-064
		Total Length Surveyed (ft):	230.6

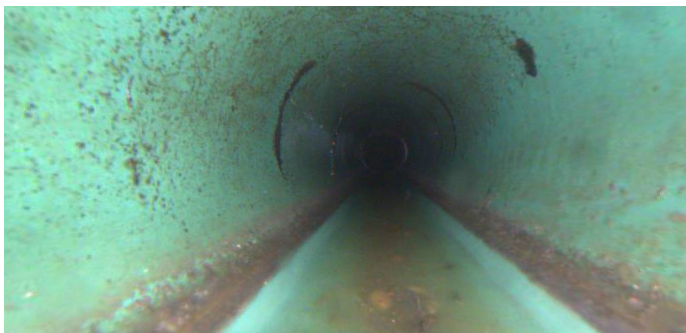
Code: **AMH**
Description: **Manhole**

Distance (ft): **.0**
Structural Grade: **0**
O&M Grade: **0**
Clock Start/From:
Clock To:
1st Value:
2nd Value:
Value Percent:
Continuous Index:
Within 8" of Joint: **NO**
Remarks: **M-1004-064**

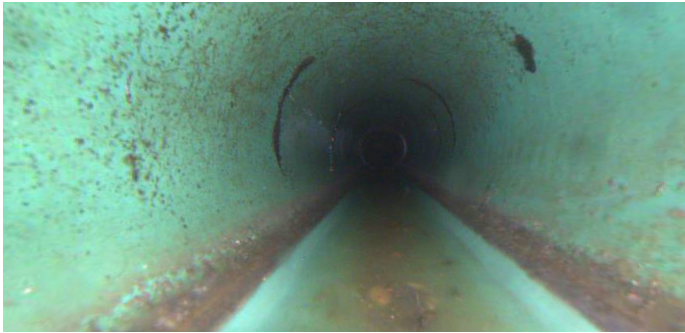
Code: **MWL**
Description: **Water Level**

Distance (ft): **.0**
Structural Grade: **0**
O&M Grade: **0**
Clock Start/From:
Clock To:
1st Value:
2nd Value:
Value Percent: **5.000**
Continuous Index:
Within 8" of Joint: **NO**
Remarks: **M-1004-062**

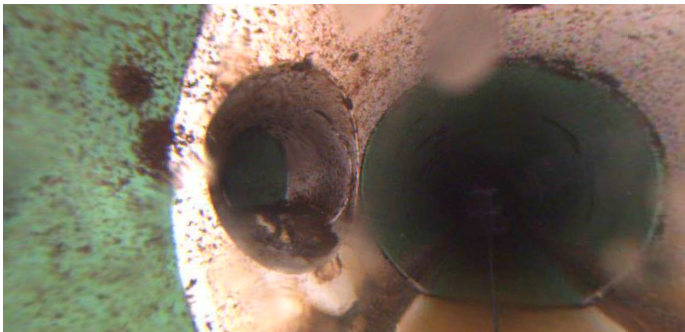
Code: **TFA**
Description: **Tap Factory Active**

Distance (ft): **6.8**
Structural Grade: **0**
O&M Grade: **0**
Clock Start/From: **3**
Clock To:
1st Value: **4.000**
2nd Value:
Value Percent:
Continuous Index:
Within 8" of Joint:
Remarks:

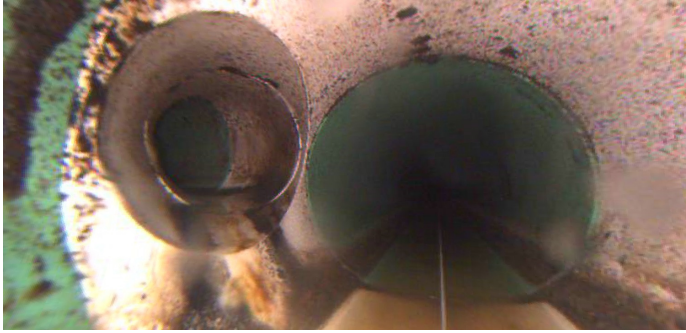
Code: **TFA**
Description: **Tap Factory Active**

Distance (ft): **38.8**
Structural Grade: **0**
O&M Grade: **0**
Clock Start/From: **3**
Clock To:
1st Value: **4.000**
2nd Value:
Value Percent:
Continuous Index:
Within 8" of Joint:
Remarks:

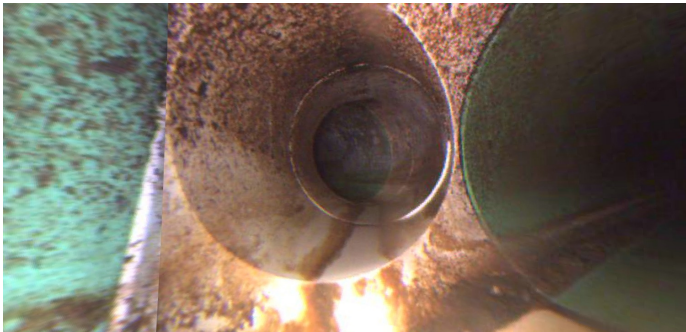
Code: **TF**
Description: **Tap Factory**

Distance (ft): **161.3**
Structural Grade: **0**
O&M Grade: **0**
Clock Start/From: **3**
Clock To:
1st Value: **4.000**
2nd Value:
Value Percent:
Continuous Index:
Within 8" of Joint:
Remarks:

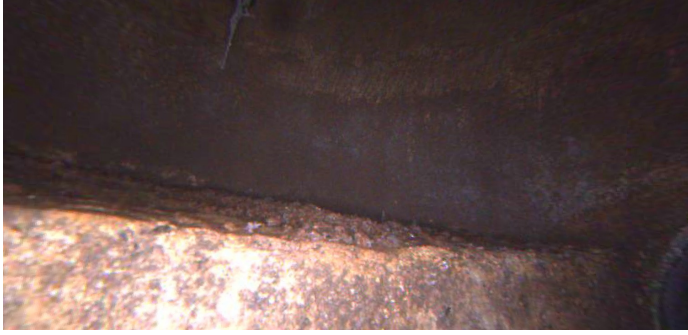
Code:	AMH
Description:	Manhole
Distance (ft):	230.6
Structural Grade:	0
O&M Grade:	0
Clock Start/From:	
Clock To:	
1st Value:	
2nd Value:	
Value Percent:	
Continuous Index:	
Within 8" of Joint:	NO
Remarks:	M-1004-062
