## Profile/Photo Observation Report

Street:	<b>HILLCREST AVE</b>	Flow Control:	<b>Not Controlled</b>
City:	<b>Hobart, IN</b>	Year Renewed:	
Location:	<b>Other</b>	Tape/Media #:	
Purpose:	<b>Not Known</b>	Dia/Height:	<b>10"</b>
Use:	<b>Sanitary</b>	Material:	<b>PVC</b>
Drain Area:	<b>NA</b>	Lining:	
Category:	<b>NA</b>		
Comment:

Location Details:		Direction of Survey:	<b>Downstream</b>
US MH:	<b>M-1004-063</b>	DS MH:	<b>M-1004-037</b>
		Total Length Surveyed (ft):	<b>132.9</b>

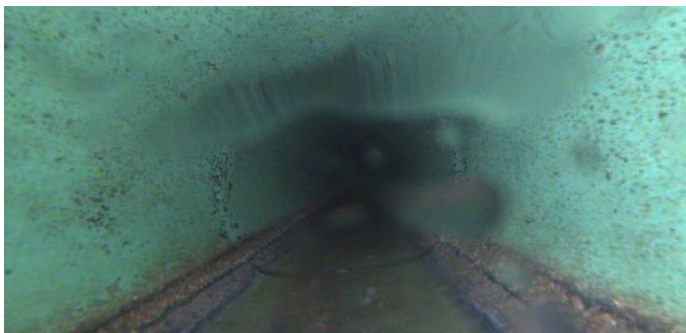
Code: **AMH**  
Description: **Manhole**

Distance (ft): **.0**  
Structural Grade: **0**  
O&M Grade: **0**  
Clock Start/From:  
Clock To:  
1st Value:  
2nd Value:  
Value Percent:  
Continuous Index:  
Within 8" of Joint: **NO**  
Remarks: **M-1004-063**

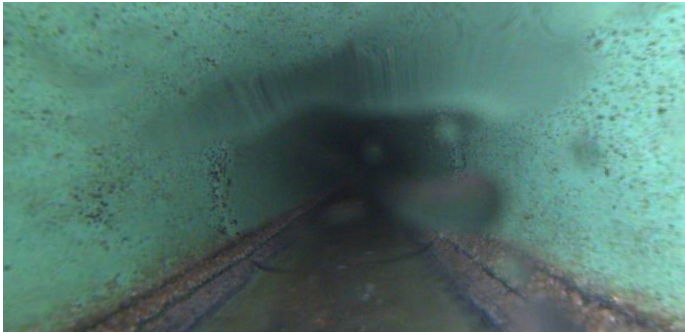
Code:	<b>MWL</b>
Description:	<b>Water Level</b>

Distance (ft):	<b>.0</b>
Structural Grade:	<b>0</b>
O&M Grade:	<b>0</b>
Clock Start/From:	
Clock To:	
1st Value:	
2nd Value:	
Value Percent:	<b>5.000</b>
Continuous Index:	
Within 8" of Joint:	<b>NO</b>
Remarks:

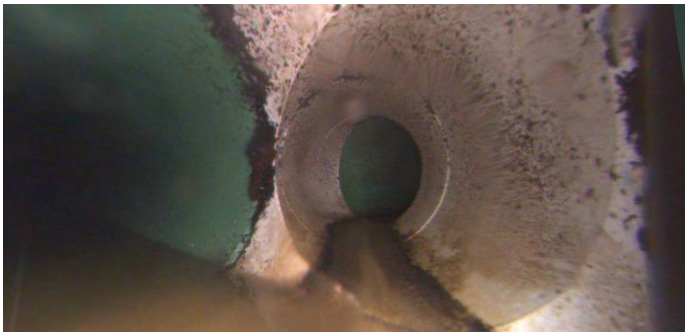
Code:	<b>TFA</b>
Description:	<b>Tap Factory Active</b>

Distance (ft):	<b>22.0</b>
Structural Grade:	<b>0</b>
O&M Grade:	<b>0</b>
Clock Start/From:	<b>9</b>
Clock To:	
1st Value:	<b>4.000</b>
2nd Value:	
Value Percent:	
Continuous Index:	
Within 8" of Joint:	
Remarks:

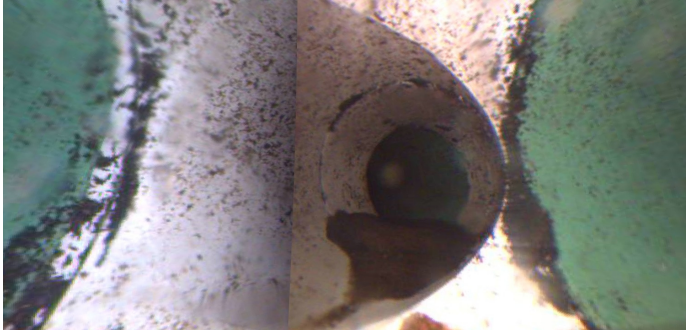
Code: **TF**  
Description: **Tap Factory**

Distance (ft): **31.2**  
Structural Grade: **0**  
O&M Grade: **0**  
Clock Start/From: **3**  
Clock To:  
1st Value: **4.000**  
2nd Value:  
Value Percent:  
Continuous Index:  
Within 8" of Joint:  
Remarks:

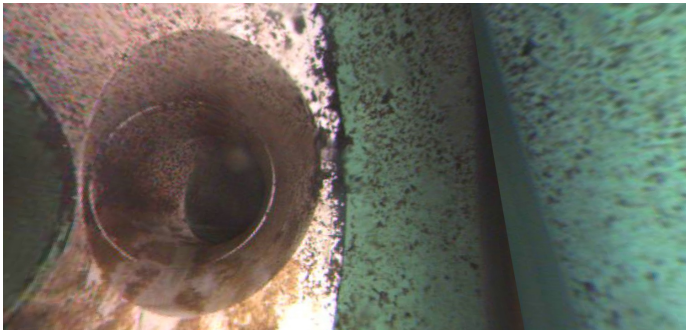
Code: **TFA**  
Description: **Tap Factory Active**

Distance (ft): **91.8**  
Structural Grade: **0**  
O&M Grade: **0**  
Clock Start/From: **9**  
Clock To:  
1st Value: **4.000**  
2nd Value:  
Value Percent:  
Continuous Index:  
Within 8" of Joint:  
Remarks:

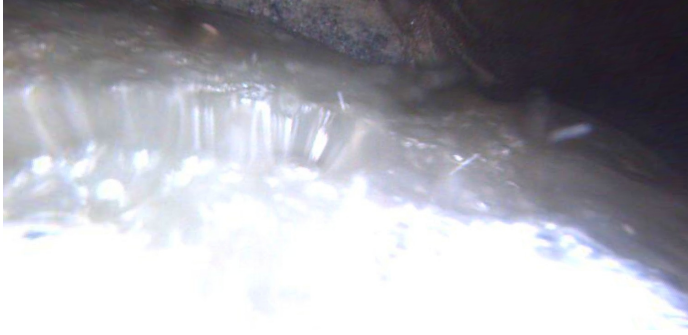
Code:	AMH
Description:	Manhole
Distance (ft):	132.9
Structural Grade:	0
O&M Grade:	0
Clock Start/From:	
Clock To:	
1st Value:	
2nd Value:	
Value Percent:	
Continuous Index:	
Within 8" of Joint:	NO
Remarks:	M-1004-037
