Profile/Photo Observation Report

Date:	04/11/2018	Weather:		Coding:	PACP 6.0
Pipe Length (ft):	137.6	Owner:	NA	Pre Clean:	Not Known
P.O.#:		Surveyor:	Jen Costello	PSR:	P-1004-063-037
Customer:		Clean Date:	01/01/1900	Shape:	C

Street:	Hillcrest Ave.	Flow Control:	Not Controlled
City:	Hobart, IN	Year Renewed:	
Location:	Other	Tape/Media #:	
Purpose:	Not Known	Dia/Height:	10"
Use:	Sanitary	Material:	PVC
Drain Area:	NA	Lining:	
Category:	NA		
Comment:

Location Details:		Direction of Survey:	Downstream
US MH:	M-1004-063	DS MH:	M-1004-037
		Total Length Surveyed (ft):	132.9

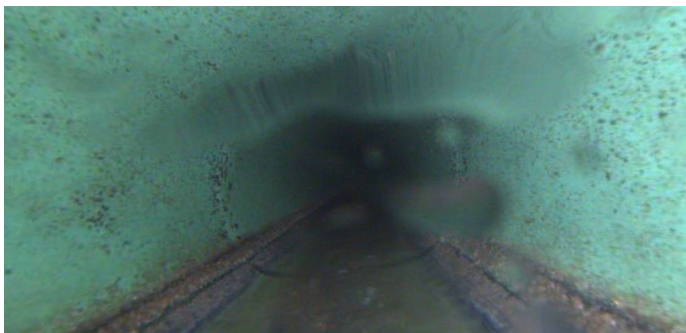
Code: **AMH**
Description: **Manhole**

Distance (ft): **.0**
Structural Grade: **0**
O&M Grade: **0**
Clock Start/From:
Clock To:
1st Value:
2nd Value:
Value Percent:
Continuous Index:
Within 8" of Joint: **NO**
Remarks: **M-1004-063**

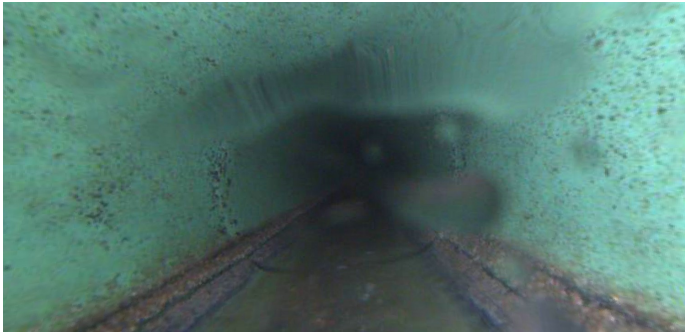
Code:	MWL
Description:	Water Level

Distance (ft):	.0
Structural Grade:	0
O&M Grade:	0
Clock Start/From:	
Clock To:	
1st Value:	
2nd Value:	
Value Percent:	5.000
Continuous Index:	
Within 8" of Joint:	NO
Remarks:

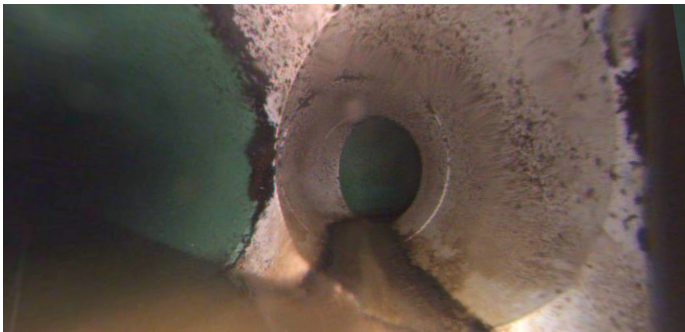
Code:	TFA
Description:	Tap Factory Active

Distance (ft):	22.0
Structural Grade:	0
O&M Grade:	0
Clock Start/From:	9
Clock To:	
1st Value:	4.000
2nd Value:	
Value Percent:	
Continuous Index:	
Within 8" of Joint:	
Remarks:

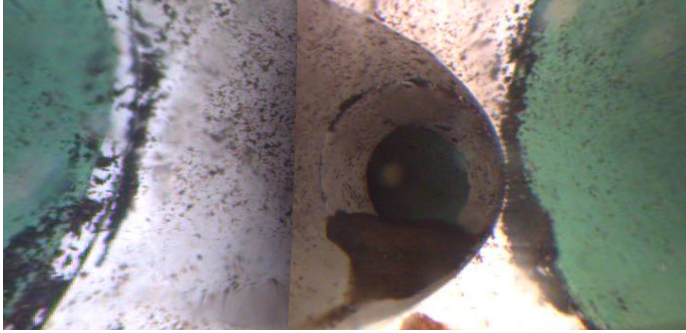
Code: **TF**
Description: **Tap Factory**

Distance (ft): **31.2**
Structural Grade: **0**
O&M Grade: **0**
Clock Start/From: **3**
Clock To:
1st Value: **4.000**
2nd Value:
Value Percent:
Continuous Index:
Within 8" of Joint:
Remarks:

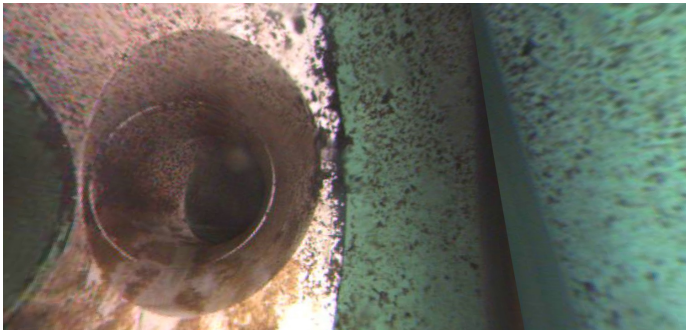
Code: **TFA**
Description: **Tap Factory Active**

Distance (ft): **91.8**
Structural Grade: **0**
O&M Grade: **0**
Clock Start/From: **9**
Clock To:
1st Value: **4.000**
2nd Value:
Value Percent:
Continuous Index:
Within 8" of Joint:
Remarks:

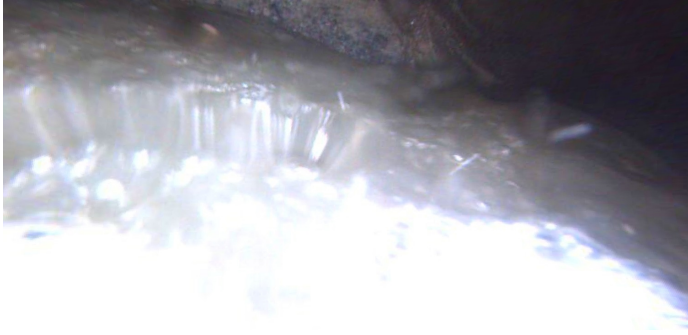
Code:	AMH
Description:	Manhole
Distance (ft):	132.9
Structural Grade:	0
O&M Grade:	0
Clock Start/From:	
Clock To:	
1st Value:	
2nd Value:	
Value Percent:	
Continuous Index:	
Within 8" of Joint:	NO
Remarks:	M-1004-037
