Profile/Photo Observation Report

Date:	04/11/2018	Weather:		Coding:	PACP 6.0
Pipe Length (ft):	351.8	Owner:	NA	Pre Clean:	Not Known
P.O.#:		Surveyor:	Jen Costello	PSR:	P-1004-065-064
Customer:		Clean Date:	01/01/1900	Shape:	C

Street:	Poplar Ln.	Flow Control:	Not Controlled
City:	Hobart, IN	Year Renewed:	
Location:	Other	Tape/Media #:	
Purpose:	Not Known	Dia/Height:	8"
Use:	Sanitary	Material:	PVC
Drain Area:	NA	Lining:	
Category:	NA		
Comment:

Location Details:		Direction of Survey:	Downstream
US MH:	M-1004-064	DS MH:	M-1004-065
		Total Length Surveyed (ft):	345.8

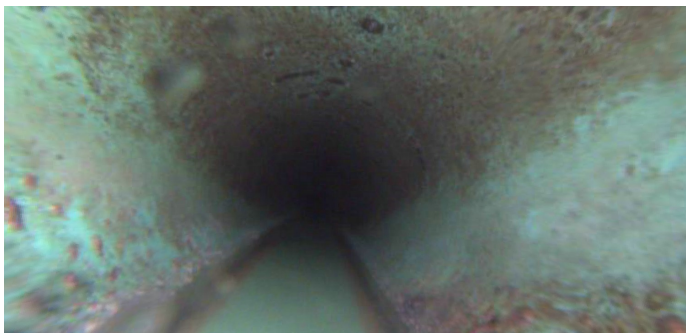
Code: **AMH**
Description: **Manhole**

Distance (ft): **.0**
Structural Grade: **0**
O&M Grade: **0**
Clock Start/From:
Clock To:
1st Value:
2nd Value:
Value Percent:
Continuous Index:
Within 8" of Joint: **NO**
Remarks: **M-1004-064**

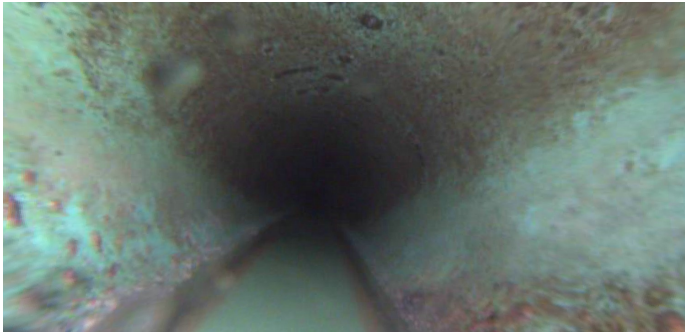
Code:	MWL
Description:	Water Level

Distance (ft):	.0
Structural Grade:	0
O&M Grade:	0
Clock Start/From:	
Clock To:	
1st Value:	
2nd Value:	
Value Percent:	5.000
Continuous Index:	
Within 8" of Joint:	NO
Remarks:

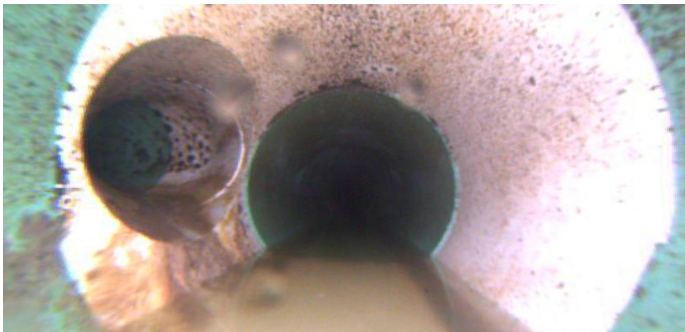
Code:	TFA
Description:	Tap Factory Active

Distance (ft):	42.5
Structural Grade:	0
O&M Grade:	0
Clock Start/From:	9
Clock To:	
1st Value:	4.000
2nd Value:	
Value Percent:	
Continuous Index:	
Within 8" of Joint:	
Remarks:

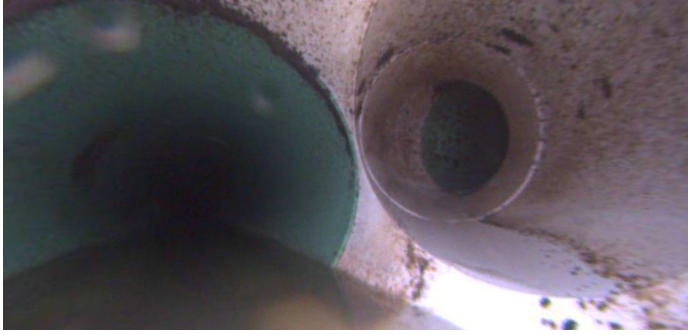
Code: **TF**
Description: **Tap Factory**

Distance (ft): **57.8**
Structural Grade: **0**
O&M Grade: **0**
Clock Start/From: **3**
Clock To:
1st Value: **4.000**
2nd Value:
Value Percent:
Continuous Index:
Within 8" of Joint:
Remarks:

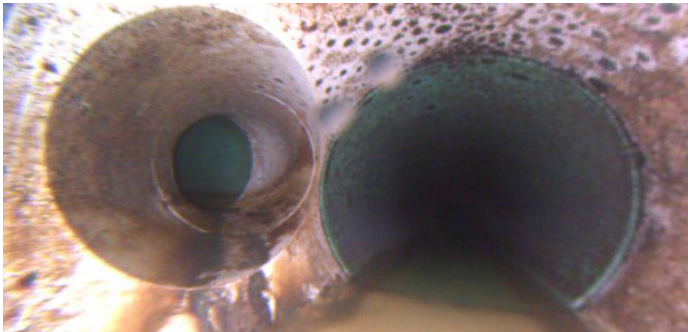
Code: **TF**
Description: **Tap Factory**

Distance (ft): **121.0**
Structural Grade: **0**
O&M Grade: **0**
Clock Start/From: **9**
Clock To:
1st Value: **4.000**
2nd Value:
Value Percent:
Continuous Index:
Within 8" of Joint:
Remarks:

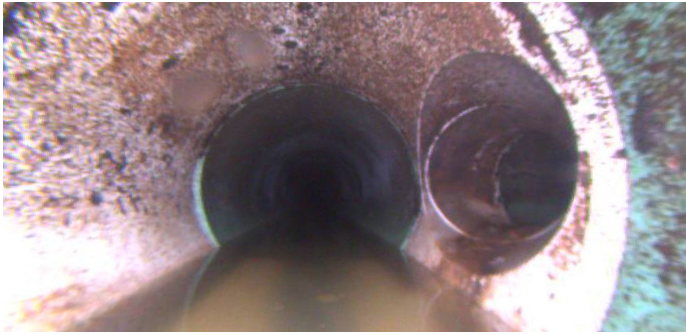
Code: **TF**
Description: **Tap Factory**

Distance (ft): **138.8**
Structural Grade: **0**
O&M Grade: **0**
Clock Start/From: **3**
Clock To:
1st Value: **4.000**
2nd Value:
Value Percent:
Continuous Index:
Within 8" of Joint:
Remarks:

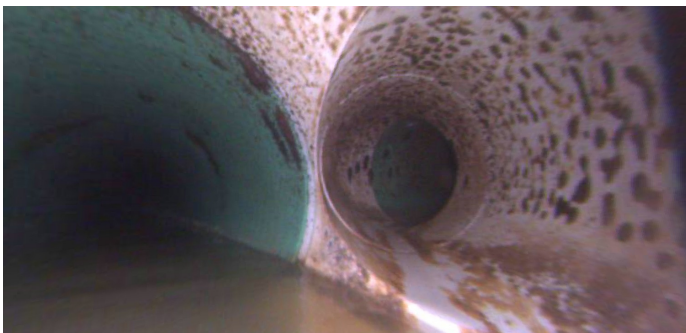
Code: **TFA**
Description: **Tap Factory Active**

Distance (ft): **205.2**
Structural Grade: **0**
O&M Grade: **0**
Clock Start/From: **3**
Clock To:
1st Value: **4.000**
2nd Value:
Value Percent:
Continuous Index:
Within 8" of Joint:
Remarks:

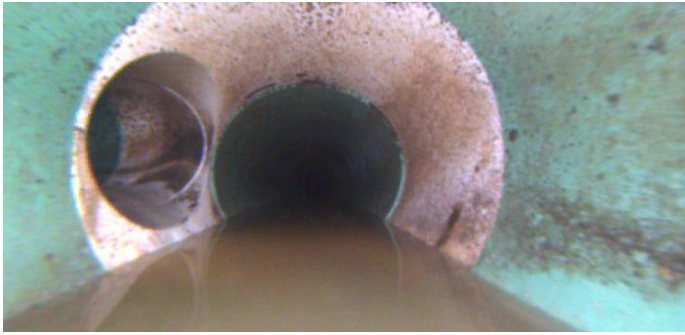
Code: **TF**
Description: **Tap Factory**

Distance (ft): **254.0**
Structural Grade: **0**
O&M Grade: **0**
Clock Start/From: **9**
Clock To:
1st Value: **4.000**
2nd Value:
Value Percent:
Continuous Index:
Within 8" of Joint:
Remarks:

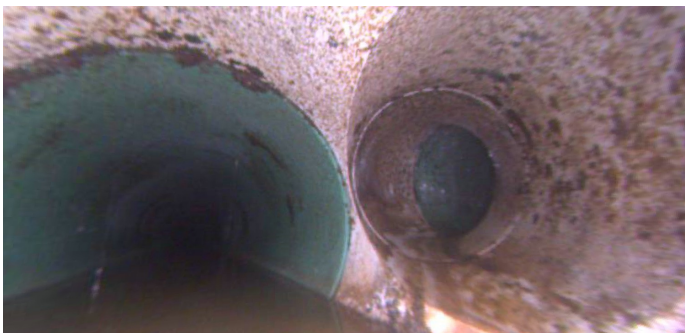
Code: **TF**
Description: **Tap Factory**

Distance (ft): **274.0**
Structural Grade: **0**
O&M Grade: **0**
Clock Start/From: **3**
Clock To:
1st Value: **4.000**
2nd Value:
Value Percent:
Continuous Index:
Within 8" of Joint:
Remarks:

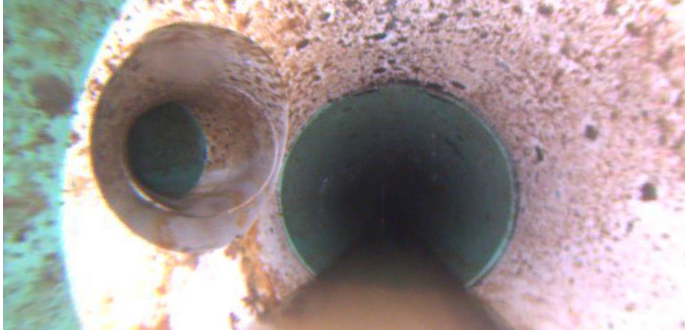
Code: **TFA**
Description: **Tap Factory Active**

Distance (ft): **326.4**
Structural Grade: **0**
O&M Grade: **0**
Clock Start/From: **9**
Clock To:
1st Value: **4.000**
2nd Value:
Value Percent:
Continuous Index:
Within 8" of Joint:
Remarks:

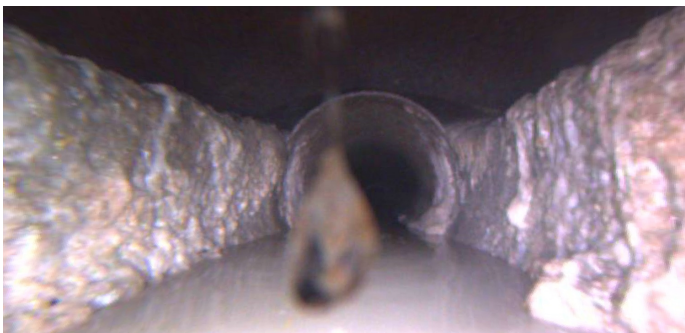
Code: **AMH**
Description: **Manhole**

Distance (ft): **345.8**
Structural Grade: **0**
O&M Grade: **0**
Clock Start/From:
Clock To:
1st Value:
2nd Value:
Value Percent:
Continuous Index:
Within 8" of Joint: **NO**
Remarks: **M-1004-065**
